RECALL CAMPAIGN BULLETIN

NTB08-095a

VOLUNTARY RECALL CAMPAIGN 2007 – 2009 PASSENGER AIR BAG OCCUPANT CLASSIFICATION SYSTEM (OCS)

CAMPAIGN ID #: PB090 (Altima)
P8242 (Murano, Rogue, 350Z)

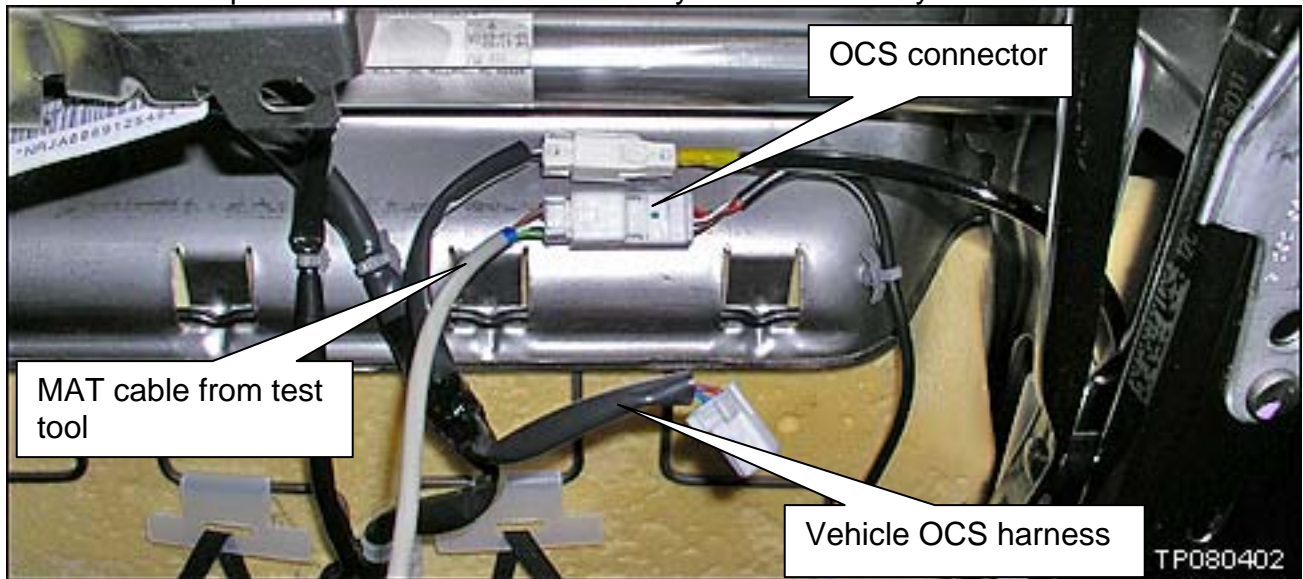
Figure 2

8. Look under the passenger seat; locate and disconnect the OCS connector and connect the MAT cable.
 - The OCS connector is an 8 pin white connector (only 3 of the pins are used/filled).

This is an example – the connector location may be different for your vehicle.

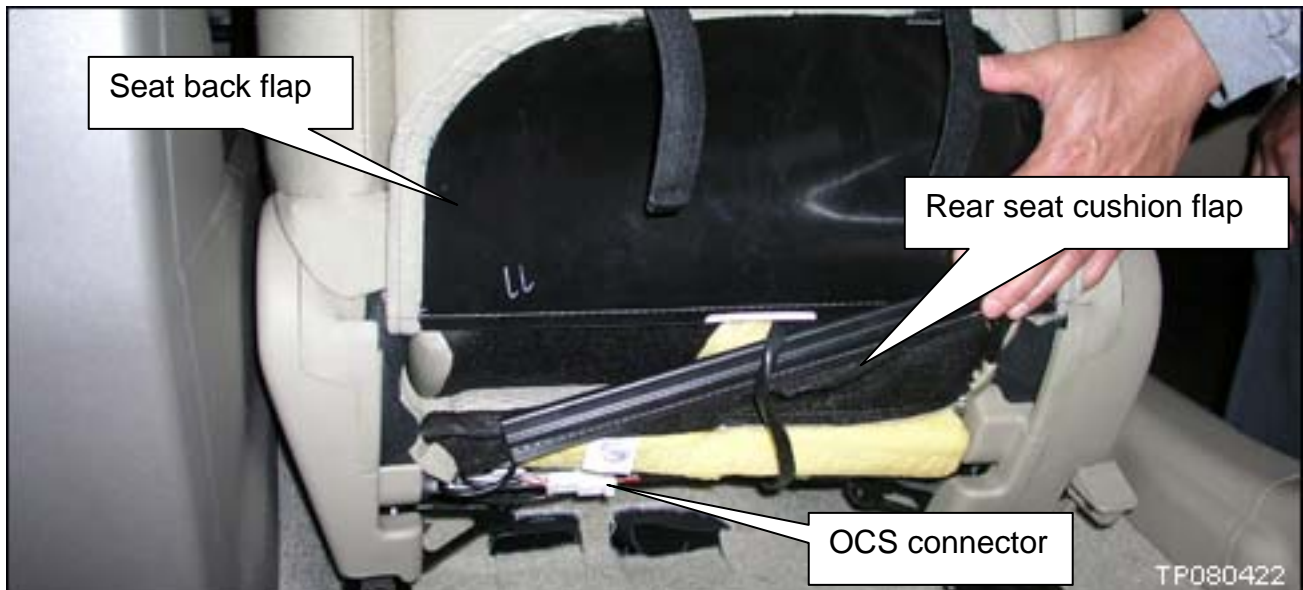
Figure 3

NOTE for Altima Coupe: The OCS connector is located at the rear of the seat cushion.

- Adjust the seat all the way forward; unhook the seat back flap and the rear seat cushion flap.

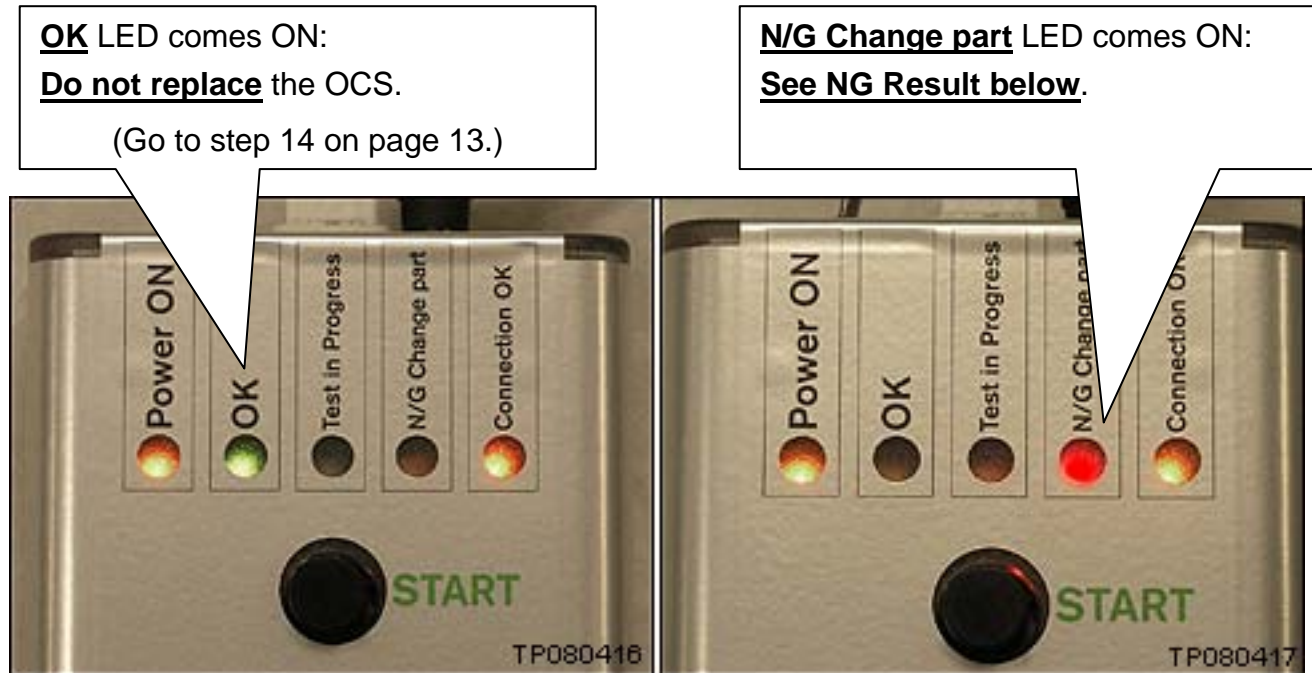
Figure 7

Actual inspection results:

NG results:

NG results are expected to be very low (less than 1% of vehicles tested).

- a. Remove / disconnect both ends of the MAT cable that you are using.
- b. Get another serviceable new MAT cable and connect it to the Varistor Test Tool and the vehicle seat.
 - Make sure to mark the usage card for each MAT cable connection.
- c. Repeat the OCS inspection test (steps 9 through 13).
- d. After repeating the test with a second MAT cable (NG result 2 times), replace the OCS / seat cushion.
 - See OCS / seat cushion replacement on the next page.

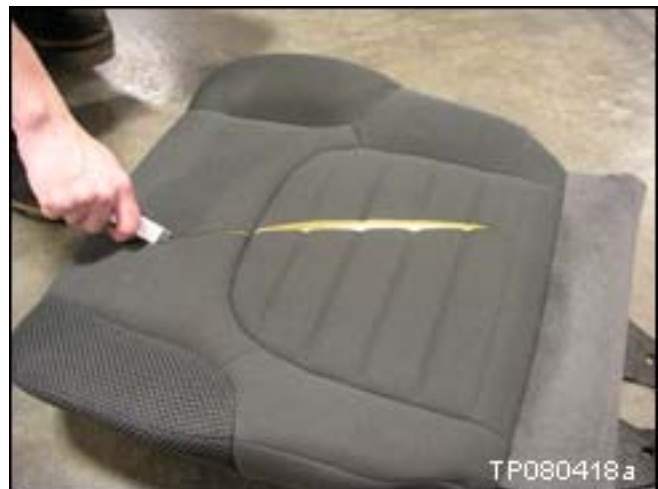
Figure 8

Only for N/G test results in step 13, or DTC B1022 is stored

NOTE: The Service Manual may caution against disassembly of the passenger seat cushion from the seat frame. It may also instruct that the cushion and frame be replaced as an assembly. Due to changes in parts manufacturing and availability, the seat cushion can now be replaced separately from the seat frame on Model and Year vehicles affected by this campaign.

- If not already done:
 - Record radio station presets.
 - Turn the ignition OFF, disconnect both battery cables – negative cable first.
 - Wait at least 3 minutes.
- Be careful: Do not scratch or otherwise damage interior parts.
- Refer to the SE section of the appropriate Service Manual for Seat Cushion replacement information.

- Make sure each seat cushion hook and strap is properly connected/attached in its original location.
- Torque mounting bolts according to the appropriate Service Manual.
- **WARNING:** Make sure all mounting and support clips for electrical connectors and harness are reinstalled in their original locations.

- Render the old seat cushion unusable. Use a sharp cutting tool to cut the seat cloth.

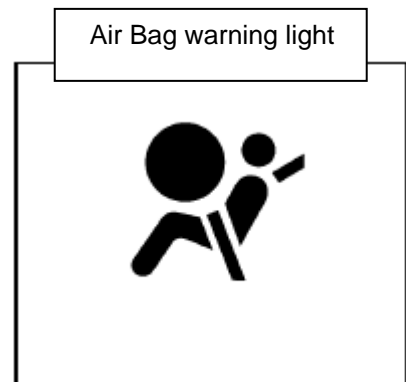
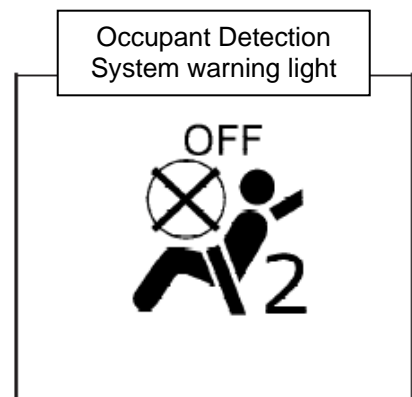
16. Check the Air Bag warning light and the Occupant Detection System warning light as follows:

- a. Sit in the driver seat and watch the warning lights as you turn the ignition ON.
- b. Both warning lights should turn ON for 5 – 7 seconds, and then go OFF.
- c. If either warning light does not turn ON at all, does not turn OFF, or blinks, refer to the Service Manual for diagnosis and repair.
