ITB08-045e

December 2, 2015

## VOLUNTARY RECALL CAMPAIGN 2007 – 2008 PASSENGER AIR BAG OCCUPANT CLASSIFICATION SYSTEM (OCS)

CAMPAIGN ID #: P8243  
NHTSA #: 08-521  
APPLIED VEHICLES: 2007 – 2008 G35 Sedan (V36)  
2008 G37 Coupe (V36)  
2008 EX35 (J50)

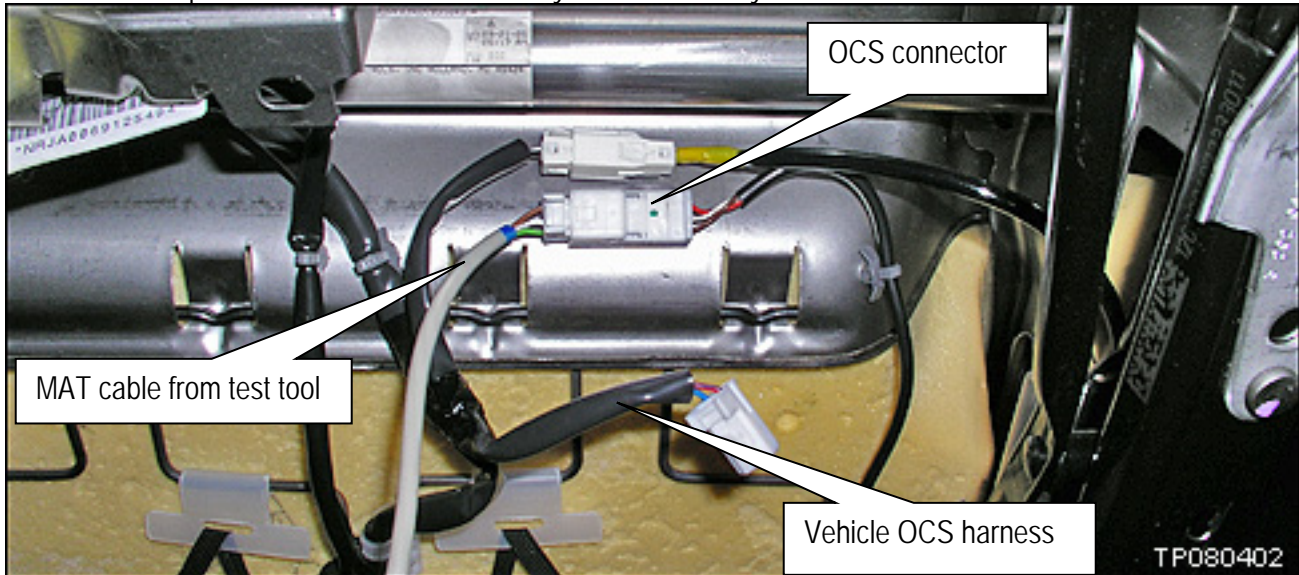
Figure 2

8. Look under the passenger seat; locate and disconnect the OCS connector and connect the MAT cable.

- The OCS connector is an 8 pin white connector (only 3 of the pins are used/filled).

This is an example – the connector location may be different for your vehicle.

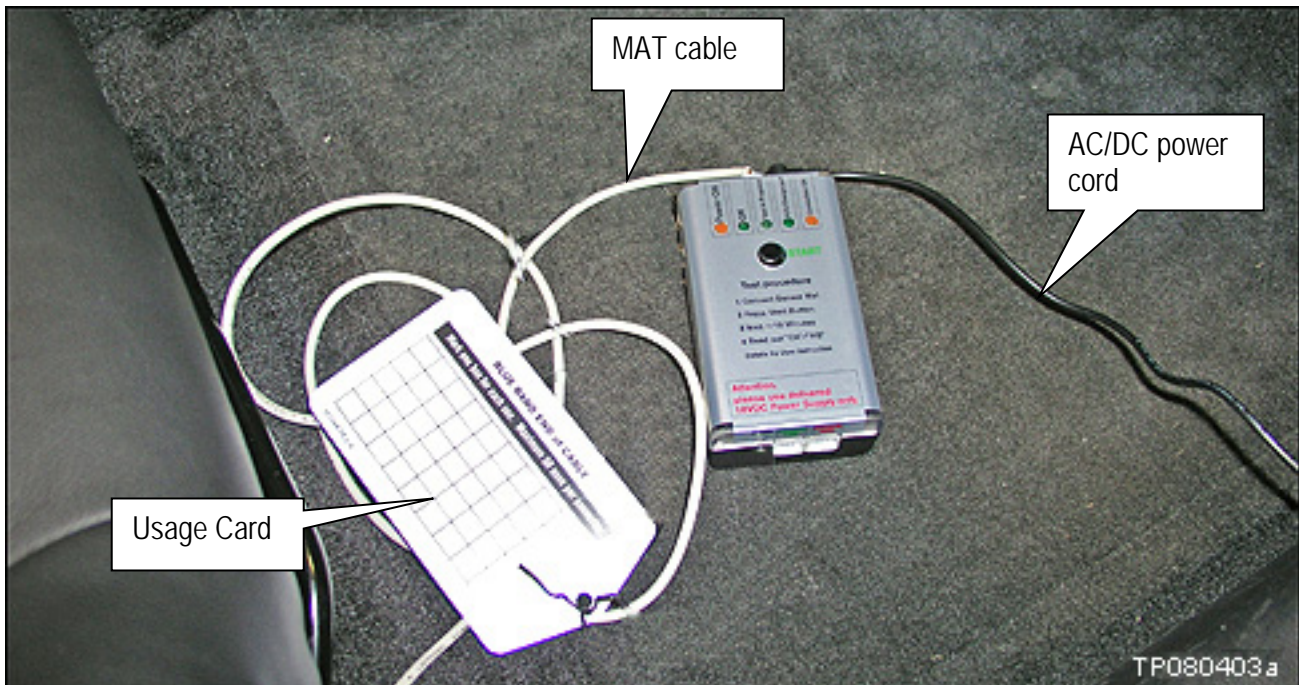
- Figure 3 shows the Varistor Test Tool connected to a vehicle.
- Make sure to mark the "Usage Card". Refer to Required Special Tools on pages 2 and 3 for Usage Card information.

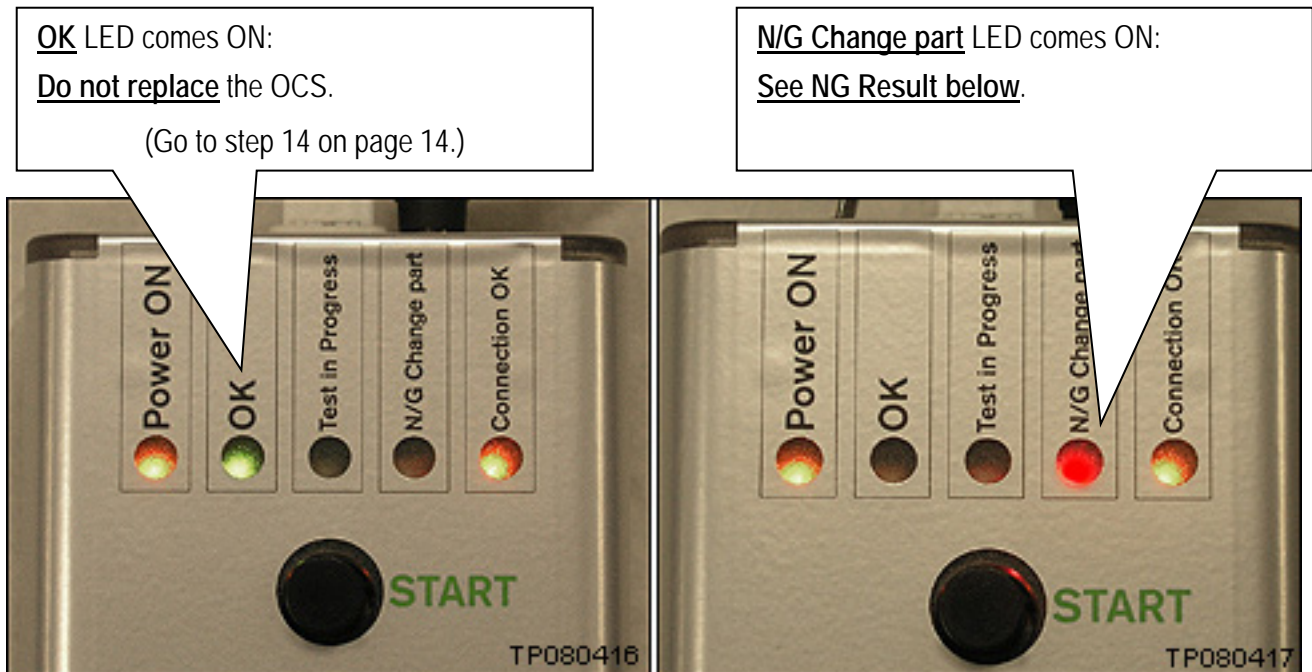
Figure 7

Actual inspection results:

### NG results:

NG results are expected to be very low (less than 1% of vehicles tested).

If you get a NG result, do the following:

- a. Remove / disconnect both ends of the MAT cable that you are using.
- b. Get another serviceable new MAT cable and connect it to the Varistor Test Tool and the vehicle seat.
  - Make sure to mark the usage card for each MAT cable connection.
- c. Repeat the OCS inspection test (steps 9 though 13).
- d. After repeating the test with a second MAT cable (NG result 2 times), replace the OCS / seat cushion.
  - See OCS / seat cushion replacement on the next page.
