RECALL CAMPAIGN BULLETIN

NTB08-095d

VOLUNTARY RECALL CAMPAIGN 2007 – 2009 PASSENGER AIR BAG OCCUPANT CLASSIFICATION SYSTEM (OCS)

CAMPAIGN ID #: PB090 (Altima)
P8242 (Murano, Rogue, 350Z)

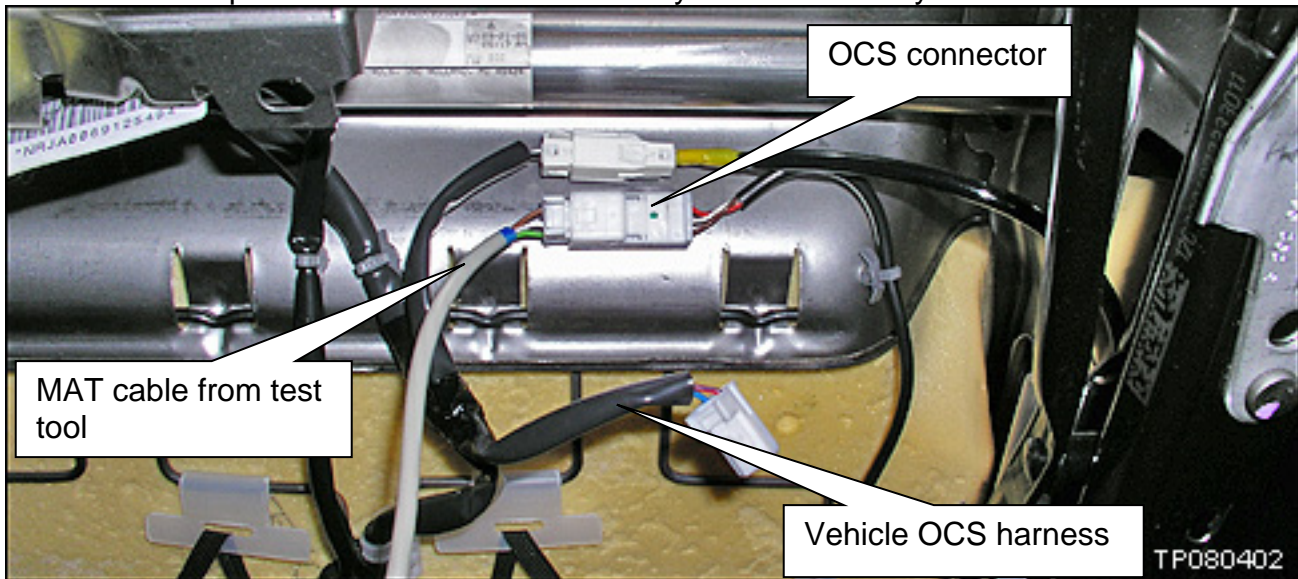
Figure 2

8. Look under the passenger seat; locate and disconnect the OCS connector and connect the MAT cable.
- The OCS connector is an 8 pin white connector (only 3 of the pins are used/filled).

This is an example – the connector location may be different for your vehicle.

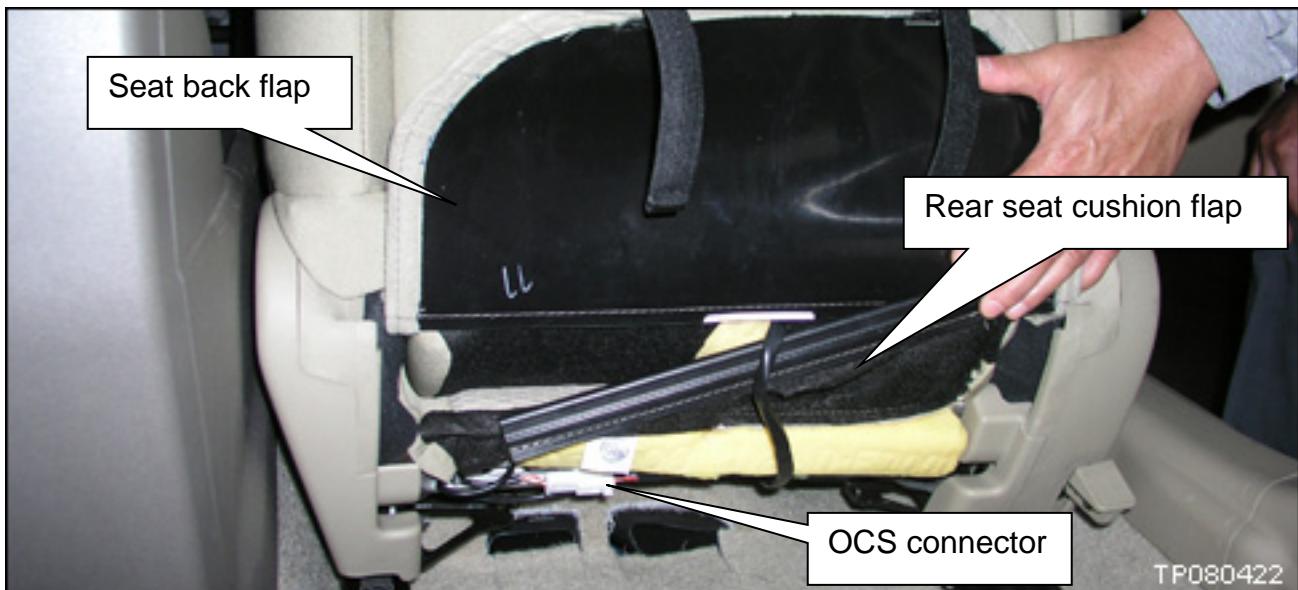
Figure 3

NOTE for Altima Coupe: The OCS connector is located at the rear of the seat cushion.

- Adjust the seat all the way forward; unhook the seat back flap and the rear seat cushion flap.

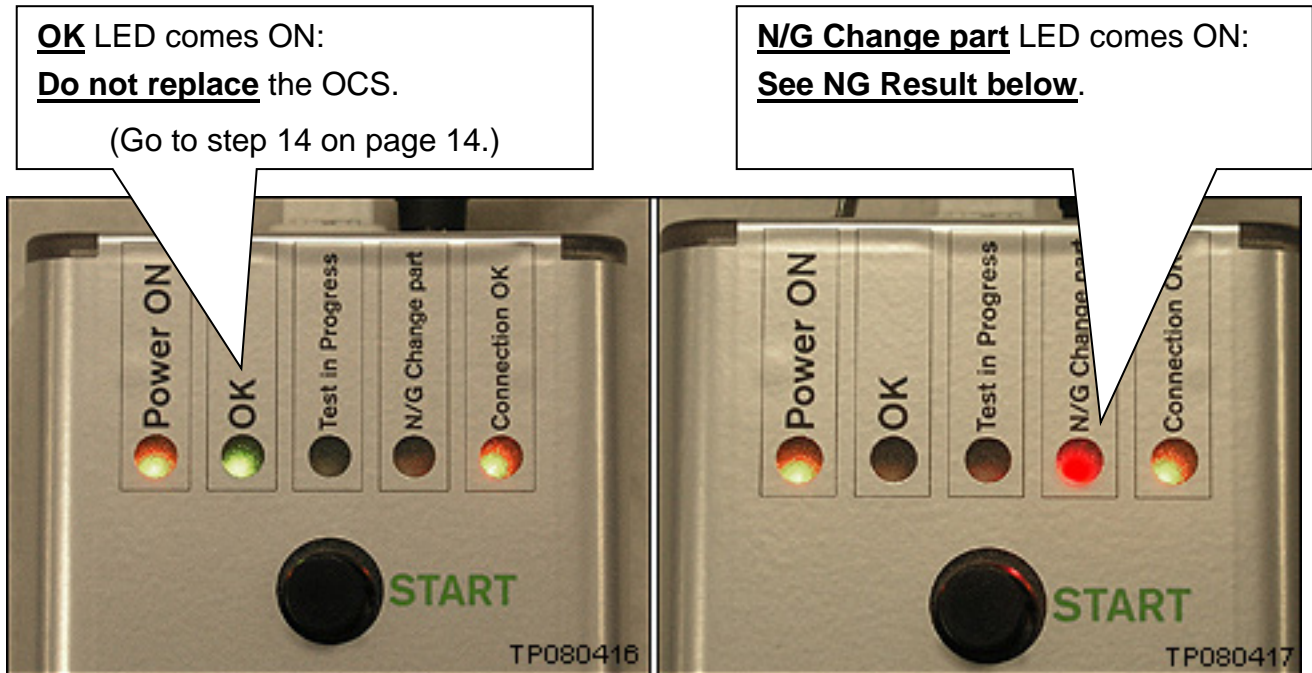
Figure 7

NOTE: Expected results - **Less than 1% will test NG.** More than 99% will test OK.

NG results:

NG results are expected to be very low (less than 1% of vehicles tested).

- a. Remove / disconnect both ends of the MAT cable that you are using.
- b. Get another serviceable new MAT cable and connect it to the Varistor Test Tool and the vehicle seat.
 - Make sure to mark the usage card for each MAT cable connection.
- c. Repeat the OCS inspection test (steps 9 though 13).
- d. After repeating the test with a second MAT cable (NG result 2 times), replace the OCS / seat cushion.
 - See OCS / seat cushion replacement on the next page.
