ITB08-045b

**VOLUNTARY RECALL CAMPAIGN
2007 – 2008 PASSENGER AIR BAG
OCCUPANT CLASSIFICATION SYSTEM (OCS)**

CAMPAIGN ID #: P8243
NHTSA #: 08-521
APPLIED VEHICLES: 2007 – 2008 G35 Sedan (V36)
2008 G37 Coupe (CV36)
2008 EX35 (J50)

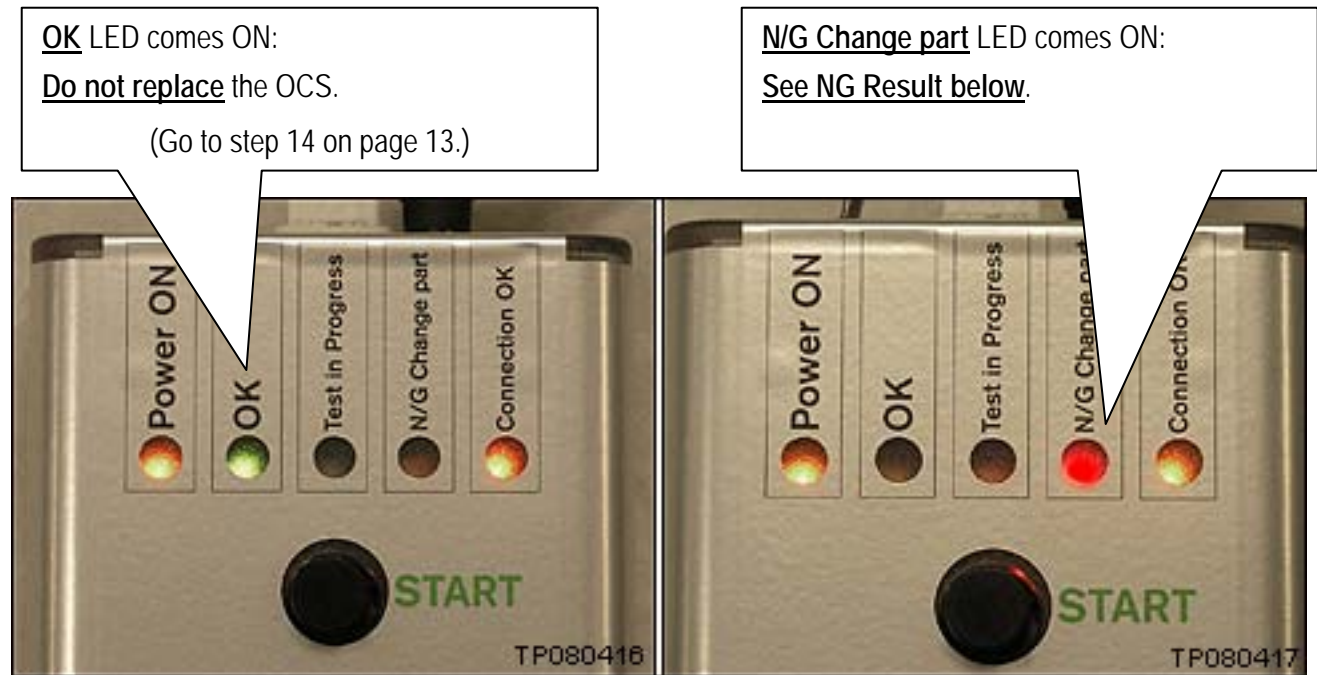
Figure 7

Actual inspection results:

NG results are expected to be very low (less than 1% of vehicles tested).

If you get a NG result, do the following:

- a. Remove / disconnect both ends of the MAT cable that you are using.
- b. Get another serviceable new MAT cable and connect it to the Varistor Test Tool and the vehicle seat.
 - Make sure to mark the usage card for each MAT cable connection.
- c. Repeat the OCS inspection test (steps 9 though 13).
- d. After repeating the test with a second MAT cable (NG result 2 times), replace the OCS / seat cushion.
 - See OCS / seat cushion replacement on the next page.

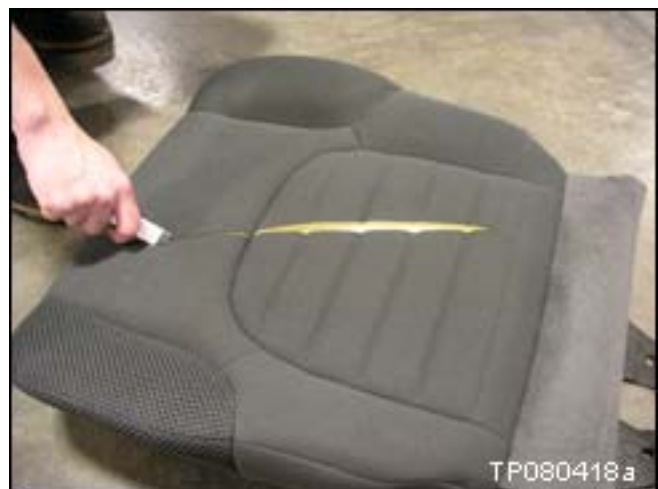
Figure 8

Only for N/G test results in step 13, or DTC B1022 is stored

- If not already done:
 - Record radio station presets.
 - Turn the ignition OFF, disconnect both battery cables – negative cable first.
 - Wait at least 3 minutes.
- Be careful: Do not scratch or otherwise damage interior parts.
- Refer to the SE section of the appropriate Service Manual for Seat Cushion replacement information.

NOTE: The Service Manual may caution against disassembly of the passenger seat cushion from the seat frame. It may also instruct that the cushion and frame be replaced as an assembly. Due to changes in parts manufacturing and availability, the seat cushion can now be replaced separately from the seat frame on Model and Year vehicles affected by this campaign.

- Make sure each seat cushion hook and strap is properly connected/attached in its original location.
- Torque mounting bolts according to the appropriate Service Manual.
- **WARNING:** Make sure all mounting and support clips for electrical connectors and harness are reinstalled in their original locations.

- Render the old seat cushion unusable. Use a sharp cutting tool to cut the seat cloth.
