ITB08-045

**VOLUNTARY RECALL CAMPAIGN  
2007 – 2008 PASSENGER AIR BAG  
OCCUPANT CLASSIFICATION SYSTEM (OCS)**

**CAMPAIGN ID #:** P8243**NHTSA #:** 08-521**APPLIED VEHICLES:** 2007 – 2008 G35 Sedan (V36)  
2008 G37 Coupe (CV36)  
2008 EX35 (J50)

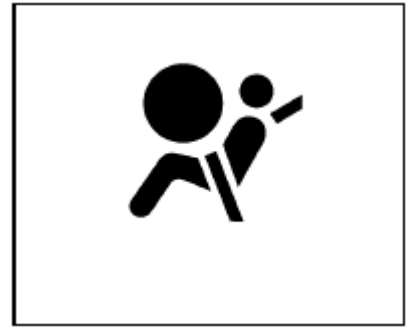
Figure 9

16. Check the Air Bag warning light as follows:

- a. Sit in the driver seat and watch the air bag warning light as you turn the ignition ON.
- b. The air bag warning light should turn ON for 5 – 7 seconds, and then go OFF.
- c. If the air bag warning light does not turn ON at all, does not turn OFF, or blinks, refer to the Service Manual for diagnosis and repair.

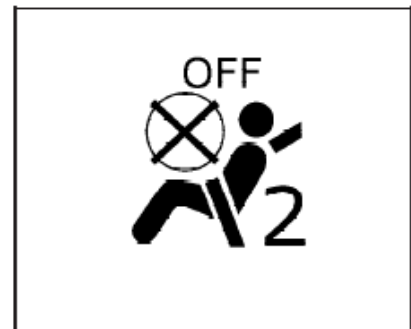
Figure 10

17. Check the occupant detection system warning light as follows:

- a. Turn the ignition OFF.
- b. Make sure no one is sitting in the passenger front seat.
- c. Sit in the driver seat and watch the occupant detection system warning light as you turn the ignition ON.
  - The occupant detection system warning light should turn ON for 5 – 7 seconds, and then go OFF.

- d. Have someone who weighs approximately 150 lbs or greater sit in the passenger front seat in accordance with the recommended seating position in the Owners Manual.
  - The Occupant Detection System Warning Light should remain OFF (warning light may turn ON >OFF>ON>OFF for only a few seconds).
- e. If the Occupant Detection System Warning Light correctly operates as described in c and d above, proceed with the next step.
  - If the Occupant Detection System Warning Light does NOT operate correctly as described in c and d above, refer to the Service Manual for diagnosis and repair.
