ITB08-045a

## VOLUNTARY RECALL CAMPAIGN 2007 – 2008 PASSENGER AIR BAG OCCUPANT CLASSIFICATION SYSTEM (OCS)

**CAMPAIGN ID #:** P8243

**APPLIED VEHICLES:** 2007 – 2008 G35 Sedan (V36)  
2008 G37 Coupe (CV36)  
2008 EX35 (J50)

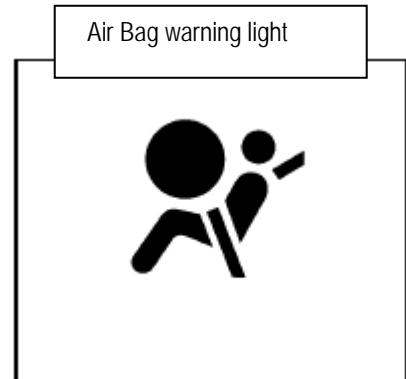
Figure 9

16. Check the Air Bag warning light and the Occupant Detection System warning light as follows:

- a. Sit in the driver seat and watch the warning lights as you turn the ignition ON.
- b. Both warning lights should turn ON for 5 – 7 seconds, and then go OFF.
- c. If either warning light does not turn ON at all, does not turn OFF, or blinks, refer to the Service Manual for diagnosis and repair.
