RE: NHTSA Recalls 08V-532 and 08V-533, Hyundai Recall 088

# HYUNDAI Technical Service Bulletin

Group	CAMPAIGN
Number	08-01-025
Date	NOVEMBER, 2008
Model	2001 - 2002 ELANTRA

Subject  
**AIRBAG CONTROL UNIT VINYL COVER INSTALLATION AND SIDE AIRBAG CONNECTOR CLIP REPLACEMENT (CAMPAIGN 088)**

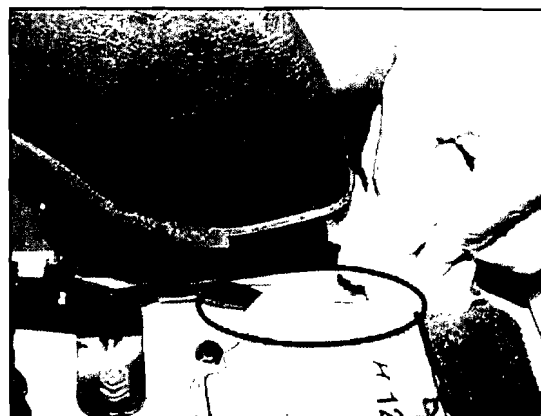
6. Using a clean dry cloth, wipe the airbag control module top surface near the connector to remove any dirt or contaminants.

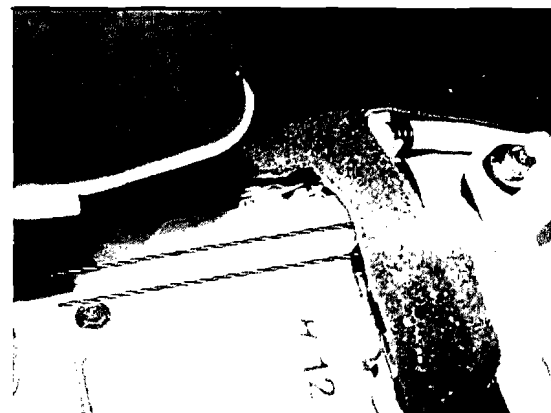
8. Align the adhesive section of the vinyl cover to the edge of the airbag control module near the connector and attach the vinyl cover to the top surface of the airbag control module.

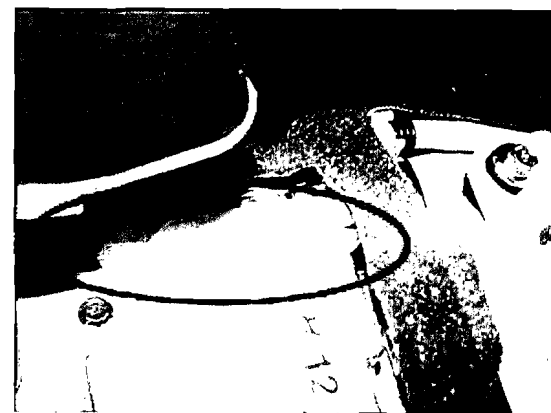
9. Make sure the vinyl cover is centered and extends over the edge of the airbag control module to shield the airbag control module wiring connector.

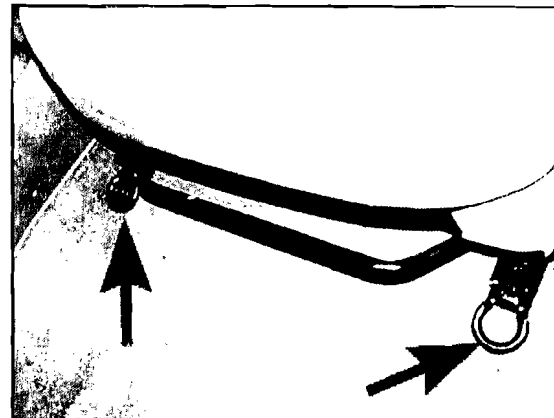
3. Slide the driver's seat fully rearward and remove the 2 front seat track mounting bolts.

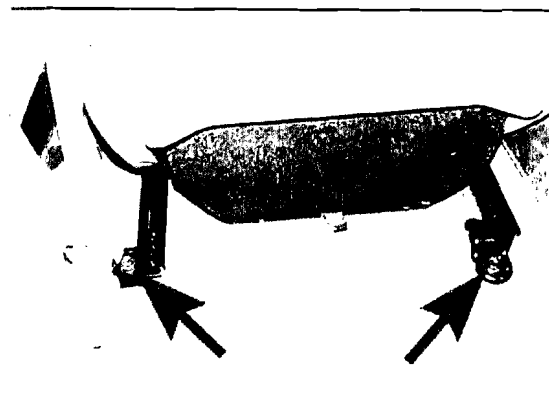
4. Slide the driver's seat fully forward and remove the 2 rear seat track mounting bolts.

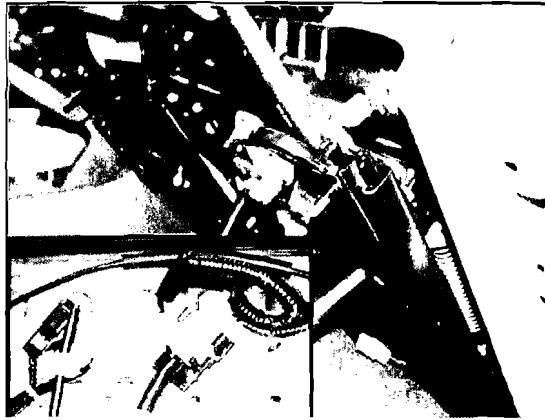
5. Tilt the driver's seat assembly rearward and disconnect the Buckle Switch, the Buckle Sensor and the side airbag (SAB) wiring connectors on the seat under frame.

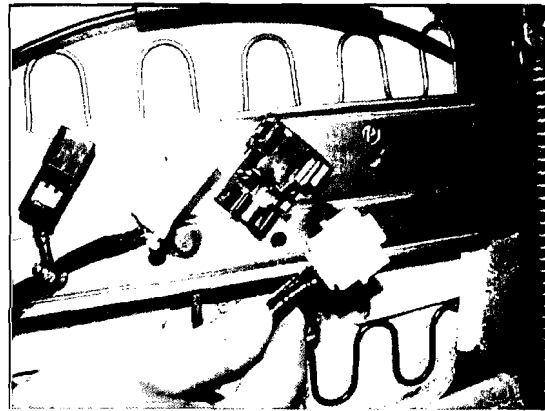
6. Remove the SAB module wiring connector from the SAB wiring connector clip.

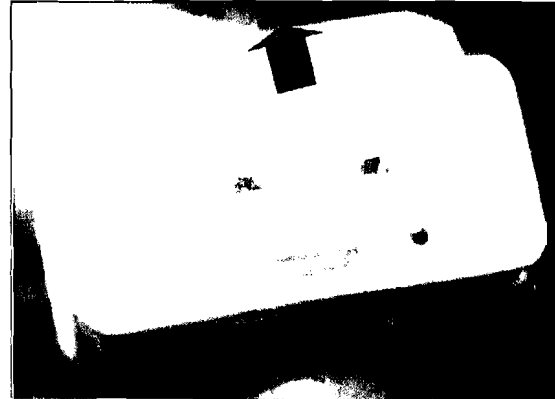
8. Reinstall the SAB module wiring connector to the new wiring connector clip in the direction of the arrow.

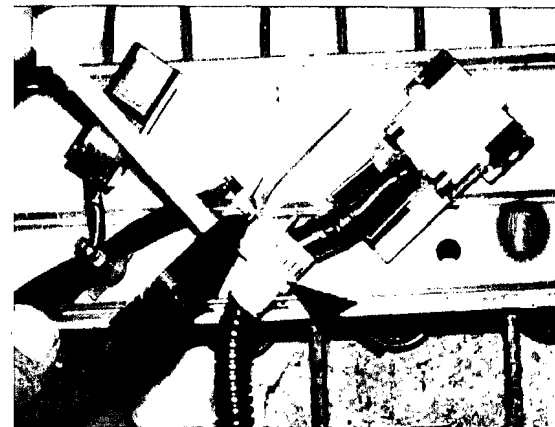
9. Tie the SAB wire loosely with the new wire tie supplied in the kit and insert the wire tie anchor point into the seat frame hole until it snaps into place (see photo). Adjust the SAB wire and tighten the wire tie. Cut off the excess wire tie using a wire clipper.

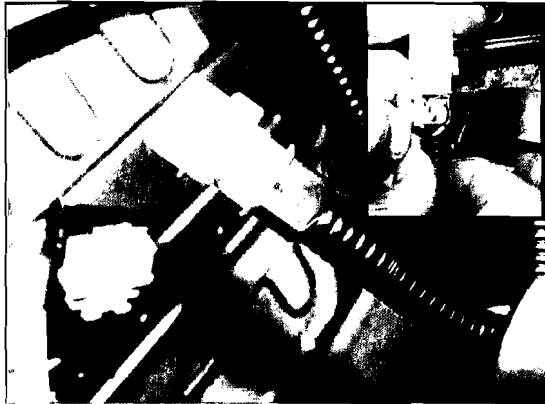
11. Using new electrical tape, tape the airbag floor wire, covering the connector and the end of the corrugated tube as shown in the photo.

**NOTE:** Be sure to push the corrugated tube end against the connector when taping.

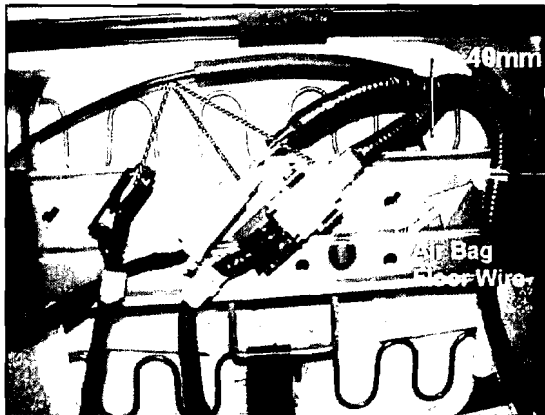
12. Reconnect the 3 wiring connectors and loosely tie the airbag floor wire with a wire tie. Insert the wire tie anchor point into the seat frame hole until it snaps into place. Adjust the airbag wiring and tighten the wire tie. Cut off the excess cable using a wire clipper.

**NOTE:** Be careful not to bend the wire harness at the connector.

**NOTE:** Be sure to tie the air bag floor wire approximately 1 3/4 inches (40mm) from the point it splits to the 3 connectors.

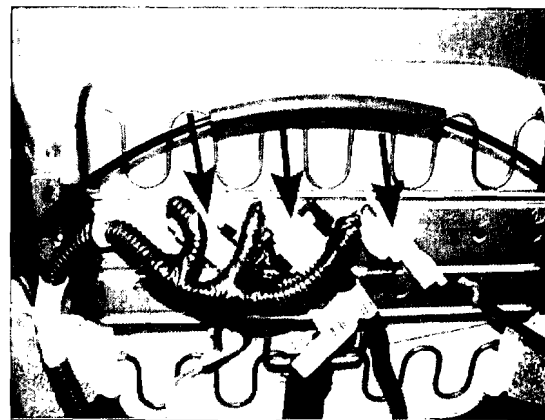
14. Using the recliner lever, tilt the passenger's seatback fully forward.
15. Slide the passenger's seat fully rearward and remove the 2 front seat track mounting bolts.
16. Slide the passenger's seat fully forward and remove the 2 rear seat track mounting bolts.
17. Tilt the front passenger's seat assembly rearward and disconnect the Passenger Presence Device (PPD) Sensor, SAB Module and Buckle Sensor wiring connectors on the seat under frame.

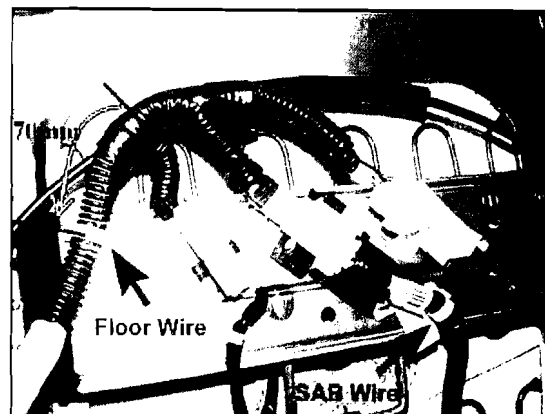
18. Apply steps 6 through 11 to the front passenger's seat SAB wiring connector
19. Reconnect the 3 wiring connectors.
20. Using the wire tie supplied in the kit, loosely tie the air bag floor wire. Insert the wire tie anchor point into the seat frame hole until it snaps into place. Adjust the air bag floor wire and tighten the wire tie. Cut off the excess wire tie using a wire clipper.

**NOTE:** Be careful not to bend the wire harness at the connector.

**NOTE: Be sure to connect the air bag wiring about 2 ¾ inches (70mm) from the point it splits to the 3 connectors.**
