# NEWMAR CORPORATION WARRANTY DEPARTMENT

<b>TECHNICAL SERVICE BULLETIN</b>																	
DATE ISSUED	MODEL YEAR(S) AFFECTED		MODEL(S) AFFECTED			TSB #											
2/17/09	2004 - 2009		ATME, DADP DSDP, KSDP, MADP, VTDP			360											
BRAND						TYPE											
All <input type="checkbox"/>	American Star <input type="checkbox"/>	Mountain Aire <input checked="" type="checkbox"/>	All <input type="checkbox"/>	TT <input type="checkbox"/>													
Cypress <input type="checkbox"/>	Dutch Star <input checked="" type="checkbox"/>	Kountry Aire <input checked="" type="checkbox"/>	FW <input type="checkbox"/>	CA <input type="checkbox"/>													
Northern Star <input checked="" type="checkbox"/>	Kountry Star <input checked="" type="checkbox"/>	Essex <input checked="" type="checkbox"/>	DP <input checked="" type="checkbox"/>	DB <input type="checkbox"/>													
Scottsdale <input type="checkbox"/>	King Aire <input type="checkbox"/>	London Aire <input type="checkbox"/>															
All Star ME <input checked="" type="checkbox"/>	Ventana <input checked="" type="checkbox"/>	Bay Star <input type="checkbox"/>

## RECALL SERVICE BULLETIN

**SUBJECT:** Hitch

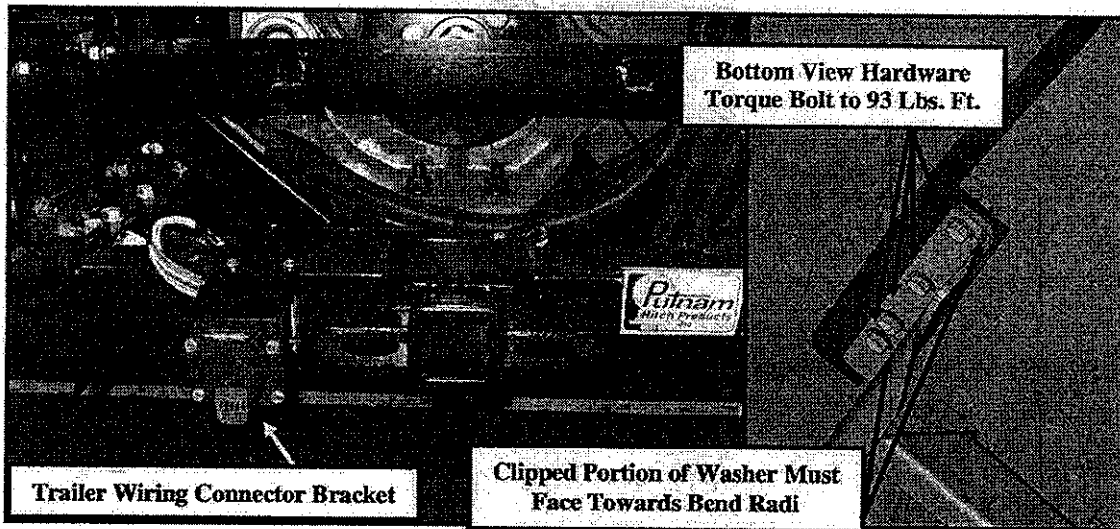
**TRAILER HITCH MOUNTING**  
**FIG. 4-1**

**CONDITION:** End plates on trailer hitches are fracturing at the 90 degree bend of the mounting flange.

**CAUSE:** Radii too sharp causing high amount of stress in the bend area

1. Observe all applicable industry safety standards and secure vehicle to allow for installation of a new trailer hitch.
2. Refer to FIG. 4-1. If trailer hitch is equipped with a trailer wiring connector mounting bracket, make note of its location and remove bracket from hitch. Retain bracket and hardware for reuse.
3. Remove trailer hitch from vehicle and discard mounting hardware. Cut trailer hitch in two and properly discard trailer hitch.
4. Refer to FIG. 4-1. Install new trailer hitch using new mounting hardware. Bolts must be installed from bottom side (bolt head toward ground) with clipped flat washer installed between bolt head and mounting flange of hitch with clip toward bend. Torque nuts to 74 lbs. ft., or from bolt head side 93 lbs. ft.

5. Refer to FIG. 4-1. If a trailer wiring connector mounting bracket was removed from the original hitch locate the connector mounting bracket on the new trailer hitch in the same location as it was on the original hitch and secure as needed.
