Subject: Recall Campaign 08V-577 (48J1/P3)

Subject: Safety Recall 48J1/P3
2009 Passat, Passat Wagon and Passat CC
Inspect and Replace Steering Gear if Necessary

IMPORTANT NOTICE TO DEALERS - FOR IMMEDIATE DISTRIBUTION Safety Recall 48J1/P3

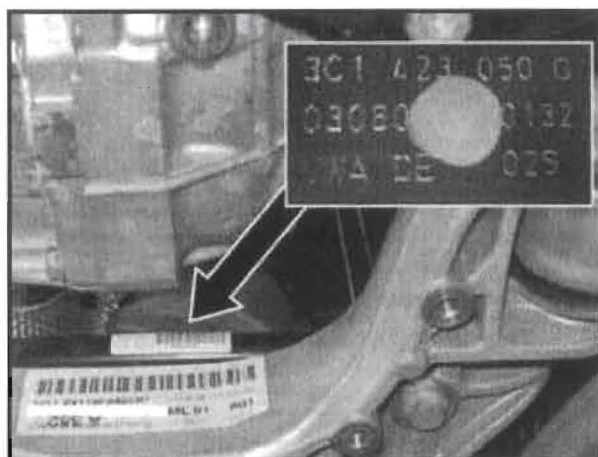
- ⇐ Check for yellow paint mark located on front of steering gear (as pictured):
 - If paint mark is present, call **Campaign Helpline @ (800) 741-2919**
 - If paint mark is not present, **continue with work procedure**

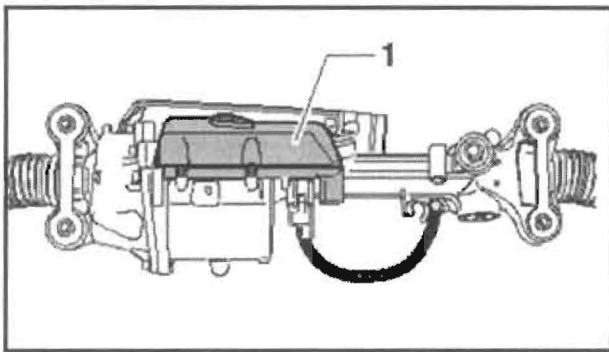
- Disconnect wiring harness at mounting points and remove connectors
- Remove original steering gear from subframe and replace with new steering gear part number (3C1 423 050 G)

- Lay removed steering gear aside (as shown in illustration) to avoid damage to control module -1-

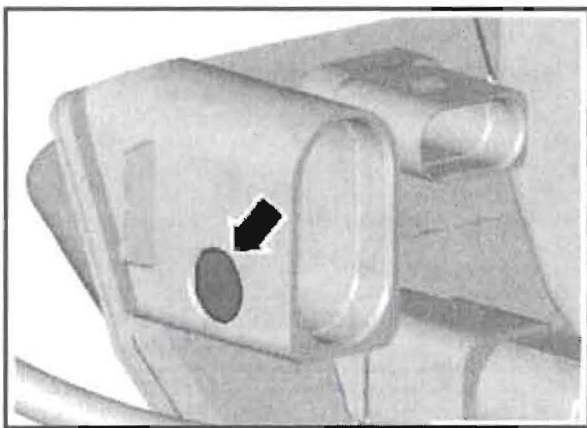
- ← Make sure the white pressure membrane -arrow- is clean and not damaged
- If necessary, carefully clean the pressure membrane

Note: If the pressure membrane is damaged, then the steering gear cannot be used. Contact the Campaign Helpline at (800) 741-2919
