**Re: Service Bulletin 08-11-01
Recall 08V578000 US / 08-396 CN**

Workhorse Steering Linkage Castle Nut

SAFETY RECALL 20801-C

BULLETIN NO: 20801-C

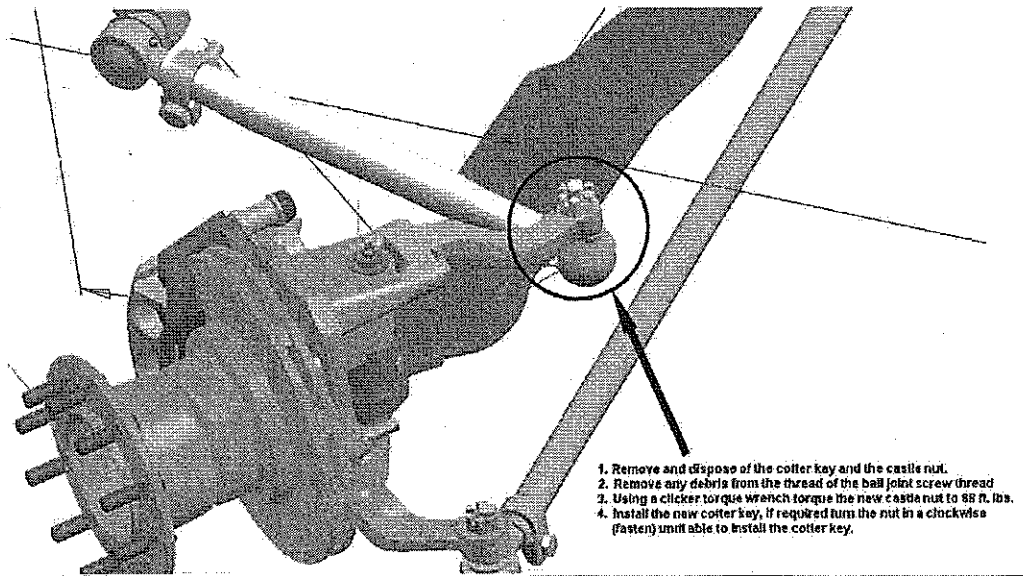
It is possible that the above models may have had a drag link to steering arm castle nut stripped from an over-torque condition. If the castle nut is stripped, it can become loose from the drag link stud allowing the drag link to separate from the steering arm. This will result in a loss of steering control and a possible vehicle crash.

1. Refer to the appropriate Service Repair Manual for general information involving steering system repairs.
2. Remove existing castle nut and cotter pin as shown in graphic below.
3. Check ball joint threads for any metal contamination from the nut and clean as necessary. (The ball threads are very hard material and the castle nut is soft material. A stripped nut will not damage the ball joint threads, but may contaminate the threads.)
4. Install new castle nut and torque to 88 ft-lbs. (120 nM).
5. **USE CLICKER WRENCH TO TIGHTEN**
6. Install cotter key. If necessary, turn nut clockwise (tighten) until nut slots align with cotter pin hole.
