Reference: NHTSA Identification Number 08V-583

Safety Recall H37 Gearshift Cable

2006-2009 (LX) Dodge Charger and Magnum

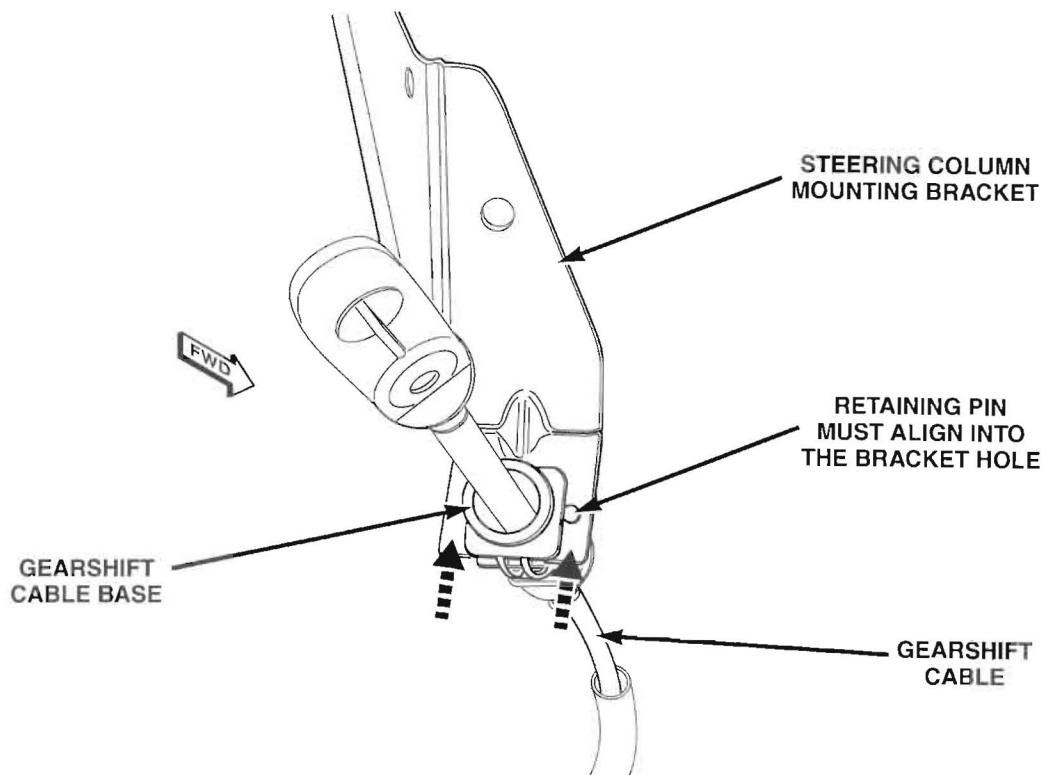
**Figure 4**

The gearshift cable on about 20,100 of the above vehicles may become disengaged from the steering column mounting bracket and cause an incorrect transmission gearshift position display. This could allow the vehicle to move inadvertently and cause a crash without warning.

8. Verify that the gearshift cable base is fully seated into the steering column mounting bracket and that the cable retaining pin is aligned to the bracket hole (Figure 4).
