Reference: NHTSA Identification Number 08V-583

Safety Recall H37

Gearshift Cable

2006-2009 (LX) Dodge Charger and Magnum

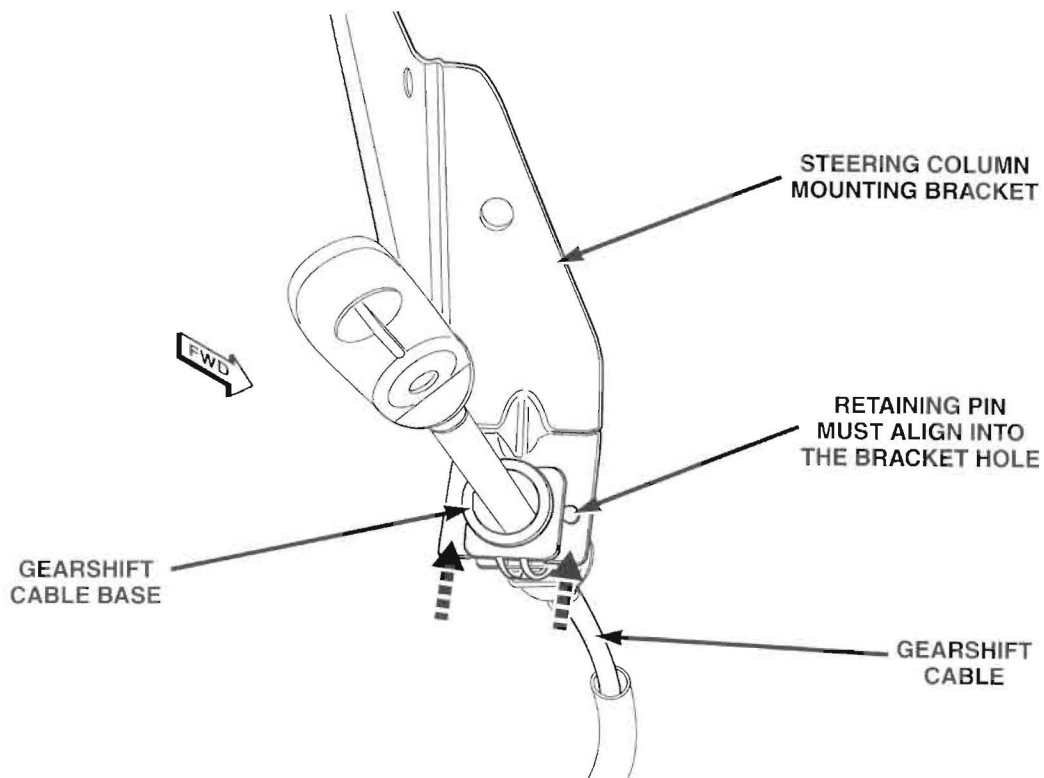
**Figure 4**

The gearshift cable on about 20,100 of the above vehicles may become disengaged from the steering column mounting bracket and cause an incorrect transmission gearshift position display. This could allow the vehicle to move inadvertently and cause a crash without warning.

8. Verify that the gearshift cable base is fully seated into the steering column mounting bracket and that the cable retaining pin is aligned to the bracket hole (Figure 4).

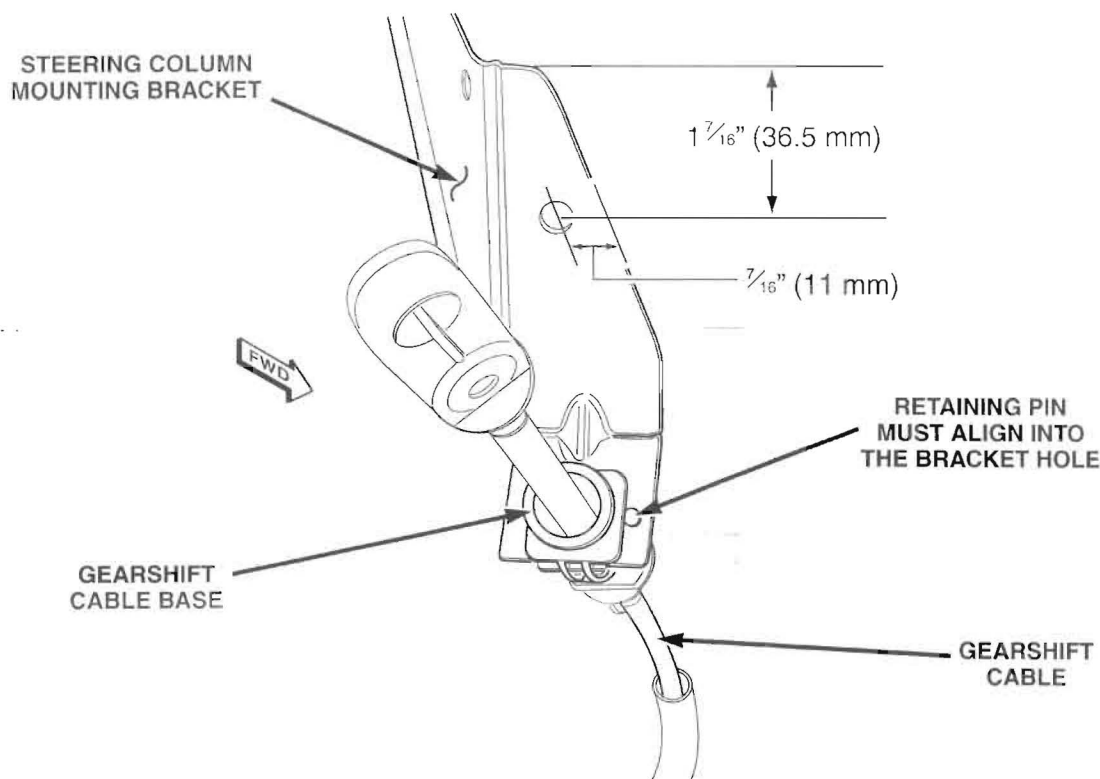
**Figure 5**

9. Some early built 2006 model year vehicles do not have a hole in the gear shift bracket to install the tie strap. If the vehicle does not have the required hole in the gear shift bracket, use the following procedure to modify the shift cable bracket:
 - a. Place a fender cover or large shop towel on the floor below the gear shift bracket to catch any metal chips created during the drilling process.
 - b. Using a 5/16 in. (8 mm) drill bit, drill a hole in the bracket as shown in Figure 5.

CAUTION: Do not remove the bracket from the vehicle during the drilling process.

- c. Using a small round file or deburring tool, deburr the hole drilled into the bracket.
 - d. Carefully remove the fender cover or large shop towel from the vehicle.
