**NEW** Recall Campaign 08V-595: M3 with M DCT – Reprogramming for Incorrect DCT Clutch Operation

E90, E92, E93 M3 with S65 and M DCT transmission produced up to 09/10/08

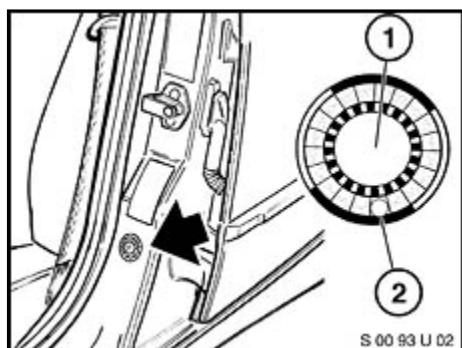
This **NEW** Recall Campaign has been assigned code number **529**. After the vehicle has been checked and/or corrected, obtain a label (SD 92-352) and:

- Emboss your BMW center warranty number in the middle of the label (1);
- Punch out code number **529** (2), printed on the label; and
- Affix the label to the **B**-pillar as shown.
