Service Bulletin No. 308

MODEL D / E / J Series Coaches	TYPE Field Change Program	SECTION/GROUP 13- Transmission	DATE Dec.16, 2008
SUBJECT ZF SOFTWARE UPDATE CAMPAIGN FOR CELL PHONE & RADIO INTERFERENCE			
CONDITIONS

Ref. NHTSA MCI Recall No.: 08V-603

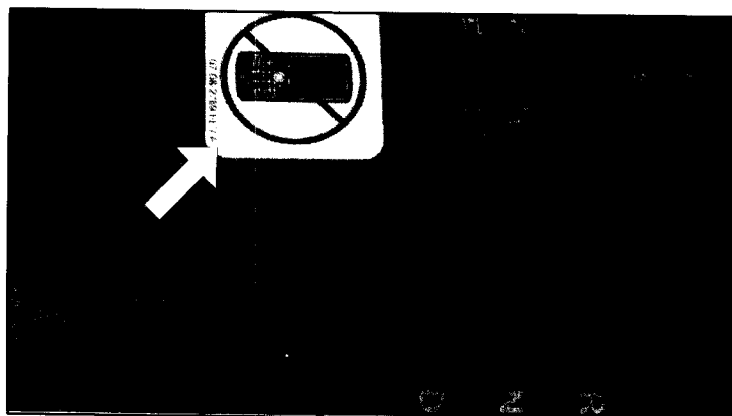
Figure 1. NO cellular phone decal.

The only part required for this change is the 07-08-2789 Decal.
