Service Bulletin No. 308

MODEL D / E / J Series Coaches	TYPE Field Change Program	SECTION/GROUP 13-Transmission	DATE Dec.16, 2008
SUBJECT ZF SOFTWARE UPDATE CAMPAIGN FOR CELL PHONE & RADIO INTERFERENCE			
CONDITIONS

Ref. ZF NHTSA Recall No.: 06E-100
 Ref. NHTSA MCI Recall No.: 08V-603
 Ref. Transport Canada MCI Recall No.: 08-404

Software Update campaign because of cell phone and radio interference (NHTSA no.06E100)

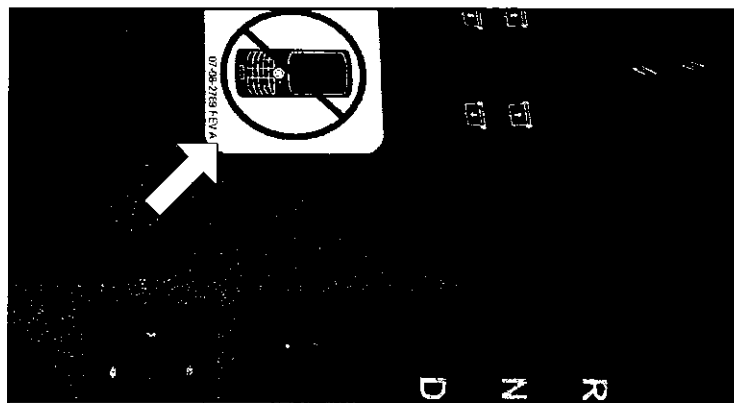
Figure 1. NO cellular phone decal.

The only part required for this change is the 07-08-2789 Decal.

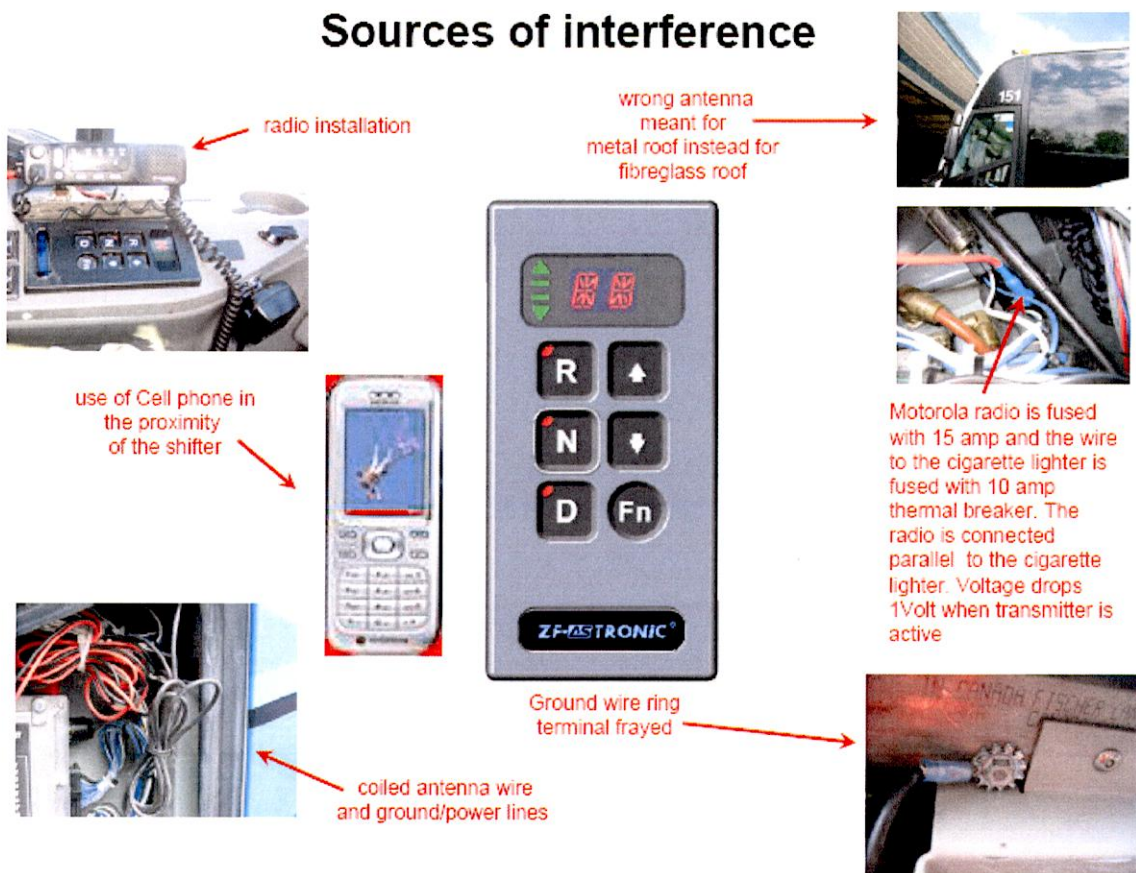
Sources of interference

It has been identified, that there is a potential for the ASTRONIC shift selector to malfunction as a result of cell phone or radio interference, improper radio, antenna and power supply installation beyond the automotive requirements. For this malfunction to occur, a GSM network cell phone or a Blackberry (PDA) must be placed on or in the proximity of the touch pad of the Arens shifter.
