Service Bulletin No. 308

| SUBJECT ZF SOFTWARE UPDATE CAMPAIGN FOR CELL PHONE & RADIO INTERFERENCE | | | |

Software Update campaign because of cell phone and radio interference (NHTSA no.06E100)

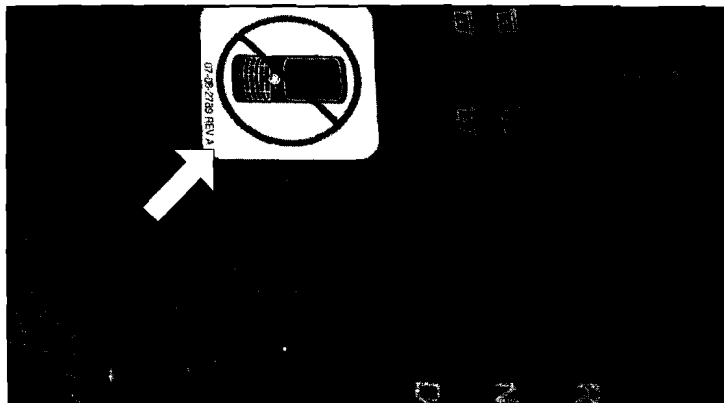
Figure 1. NO cellular phone decal.

Installation of a warning sticker onto the dashboard area

- to avoid any malfunction due to the use of electronic equipment (ZF part no.: 1348 753 101)
