Campaign No. 2009010002, February 2009

SUBJECT: **Model 221, Model Year 2007**  
**Check Both Front ABC Struts,**  
**Replace Front Strut Ball Joints if Necessary**

Recall Campaign Bulletin

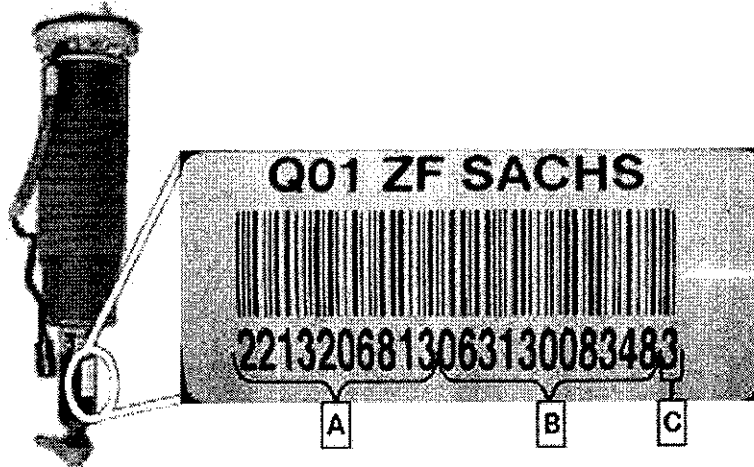
**Figure 1**

- **If only one of the of the front strut ball joints requires replacement (as indicated above), replace both front strut ball joints.**
- Disregard the last number (C, Figure 1) when checking the part number (this is a check digit)

1. Check part number on both ABC struts and write it down on paper:
  - If part number is **not** included in table below procedure is complete (front strut ball joint does not require replacement).
  - If part number is included in table proceed to Step 2.

2. In the table (above) Check whether the production number is lower than listed in the line of the existing part number:
  - If production number higher than or the same procedure is complete.
  - If production number is lower than listed proceed to Subject B (Replace Both ABC Front Strut Ball Joints).
