Subject: 08387 – Noncompliance Recall

Second and Third Row Safety Belt Buckle Rivet Missing

Models: 2009 Buick Enclave

SUBJECT: Second and Third Row Safety Belt Buckle Rivet Missing – Inspect Buckles

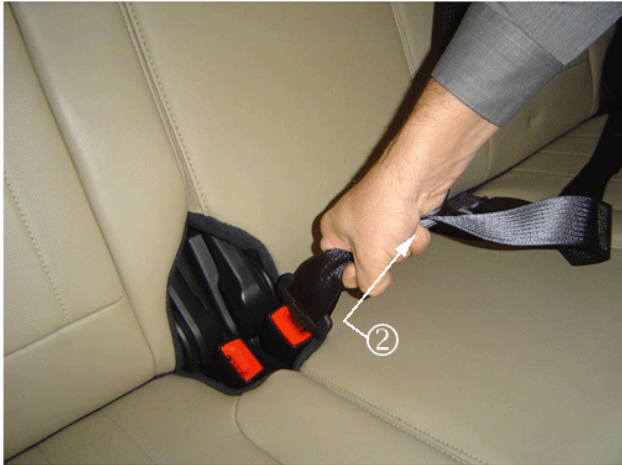
2208126

Note: The buckle (2) will **NOT** separate from the steel mounting strap unless the buckle assembly was assembled without a rivet. If the buckle assembly was assembled without a rivet, the buckle should separate from the steel mounting strap when approximately 20-30 pounds of force is applied to the buckle assembly. To ensure that the buckle assembly was assembled with a rivet, perform the buckle assembly tug test three times on each buckle assembly.

To perform the buckle assembly tug test, insert the latch plate from the outboard seat belt into the buckle (2) and pull upward or away from the seat with as much force as you can apply with your hand. The buckle assembly is designed to withstand more force than can be applied during the buckle assembly tug test. Perform the tug test three times on every seat buckle assembly in the third row.

- If the buckle assembly does **NOT** separate, the buckle passes the inspection and no further action is required.
- If the buckle assembly separates from the mounting strap, replacement of the buckle assembly is required. Refer to the appropriate seat buckle removal and installation procedure in SI.
