SUBJECT: 08387A – Noncompliance Recall

Second and Third Row Safety Belt Buckle

Rivet Missing –Inspect Buckles

MODELS: 2009 Buick Enclave, 2009 Chevrolet Traverse

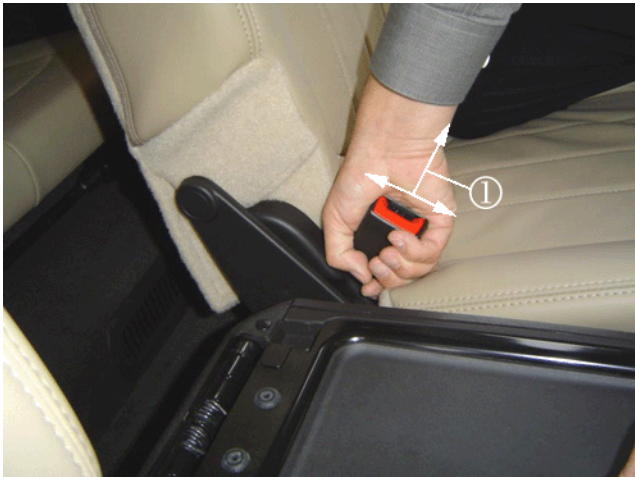
2208120

**Note:** The buckle (1) will **NOT** separate from the mounting strap unless the buckle assembly was assembled without a rivet. If the buckle assembly was assembled without a rivet, the buckle should separate from the mounting strap when approximately 20-30 pounds of force is applied to the buckle assembly. To ensure that the buckle assembly was assembled with a rivet, perform the buckle assembly tug test three times on each buckle assembly.

To perform the buckle assembly tug test, grasp the base of the buckle (1) and rock the buckle up and down while pulling the buckle upward or away from the seat with as much force as you can apply with your hand. The buckle assembly is designed to withstand more force than can be applied during the buckle assembly tug test. Perform the tug test three times on every seat buckle assembly in the second row.

- If the buckle assembly does **NOT** separate, the buckle passes the inspection and no further action is required.
- If the buckle assembly separates from the mounting strap, replacement of the buckle assembly is required. Refer to the appropriate seat buckle removal and installation procedure in SI.

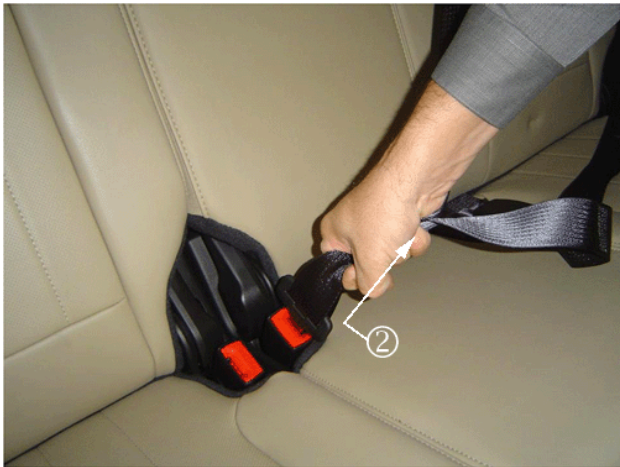
2208126

**Note:** The buckle (2) will **NOT** separate from the steel mounting strap unless the buckle assembly was assembled without a rivet. If the buckle assembly was assembled without a rivet, the buckle should separate from the steel mounting strap when approximately 20-30 pounds of force is applied to the buckle assembly. To ensure that the buckle assembly was assembled with a rivet, perform the buckle assembly tug test three times on each buckle assembly.

To perform the buckle assembly tug test, insert the latch plate from the outboard seat belt into the buckle (2) and pull upward or away from the seat with as much force as you can apply with your hand. The buckle assembly is designed to withstand more force than can be applied during the buckle assembly tug test. Perform the tug test three times on every seat buckle assembly in the third row.

- If the buckle assembly does **NOT** separate, the buckle passes the inspection and no further action is required.
- If the buckle assembly separates from the mounting strap, replacement of the buckle assembly is required. Refer to the appropriate seat buckle removal and installation procedure in SI.
