Subject: 08389 – Product Safety Recall  
Incorrect Steering Knuckle - Change in Vehicle Handling

Models: 2009 Chevrolet Captiva Sport  
2009 Saturn VUE

# Recall Bulletin

**SUBJECT:** Incorrect Steering Knuckle – Change in Vehicle Handling

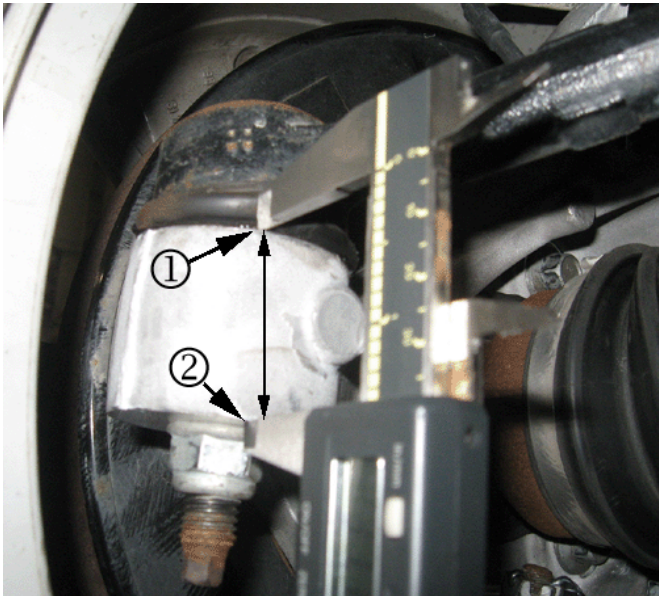
2208830

General Motors has decided that a defect, which relates to motor vehicle safety, exists in **certain** 2009 model year Chevrolet Captiva Sport and Saturn VUE vehicles. Some of these vehicles may have been built with an incorrect right and/or left front steering knuckle. As a result of the incorrect knuckle and resulting inadequate clearance, the tie rod ball stud could pull out of, or fracture the tie rod housing. This could cause the tie rod to separate from the knuckle. Although steering control of the vehicle could be maintained after a tie rod separation by the unaffected wheel on smooth roads or during light braking, with more significant suspension or braking inputs, the affected wheel could turn out and skid. If a vehicle built with two incorrect steering knuckles had both tie rods separate at the same time, steering control of the vehicle would be lost and a crash could occur without warning.

**Note:** It is essential to measure the left and right knuckle boss height in order to properly complete this recall.

2. Measure the outer tie rod end to steering knuckle connection boss height – both the left and right. Refer to the illustration for measurement reference points (1) and (2).
  - If a boss height of **37.5 mm to 38 mm** (1.47 in to 1.49 in) is measured, replace both the **steering knuckle and steering linkage outer tie rod** on this side of the vehicle. Refer to *Steering Knuckle and Steering Linkage Outer Tie Rod Replacement* in SI.
  - A boss height of **30 mm to 30.5 mm** (1.18 in to 1.2 in) is correct, and no action is required on any knuckle or tie rod with this measurement. Replacement of the knuckle and tie rod is **only** required on the side of the vehicle with the 37.5 to 38 mm boss height.
3. Perform the wheel alignment **only** if one or both knuckle(s) required replacement.
