Recall BulletinRCL-08-005DNA

Date:December 4, 2008To:Service Manager
Dealer Principal, North American Ducati Dealer NetworkSubject:Voltage Regulator

Models: 1098, 1098 S, 1098 TRICOLORE, 1098 R M.Y.'07 AND '08 848 M.Y.'08 AND '09

Recall Bulletin RCL-08-005 Voltage Regulator

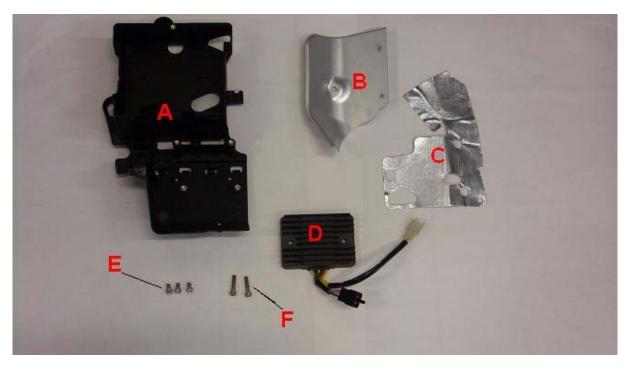
Assemble kit components no. 69924371A below and the voltage regulator

- A) Battery support
- B) Heat guard
- C) Battery compartment protection
- D) Voltage regulator
- E) Screws M 6 x 10
- F) Screws M 6 x 22
