PRODUCT CAMPAIGN BULLETIN

APPLICABILITY: 2008~09MY Tribeca
SUBJECT: VDC G Sensor

NUMBER: WVG-17
DATE: Dec. 2008

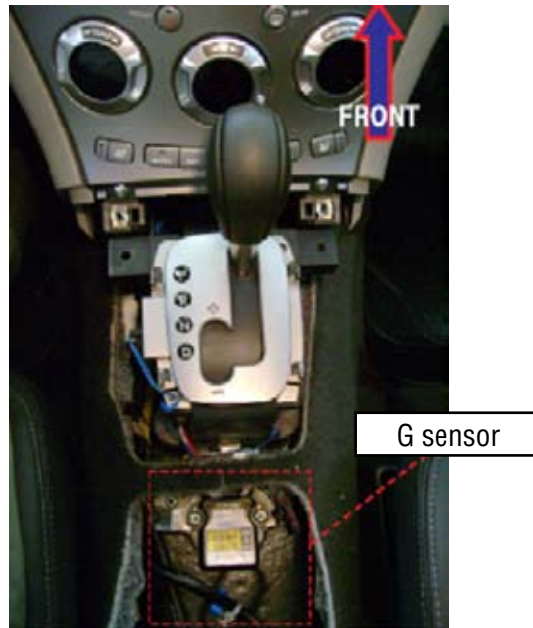
The VDC G sensor is located in the center of the console just below the transmission shifter.

Note: the center console was removed for illustration purposes.

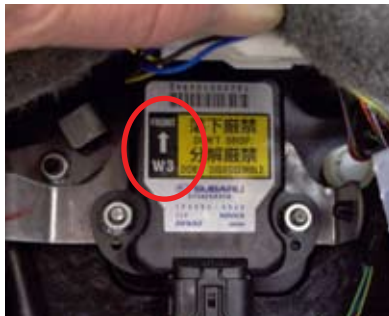
Correct Position (arrow is pointing towards the front of the vehicle.)

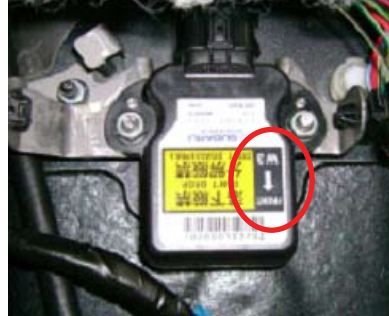
Incorrect Position (arrow is pointing towards the rear of the vehicle.)
