# **FOREST RIVER, INC**

## **GEORGETOWN BAGGAGE DOOR TRIM RECALL 08V-664 January 2009**

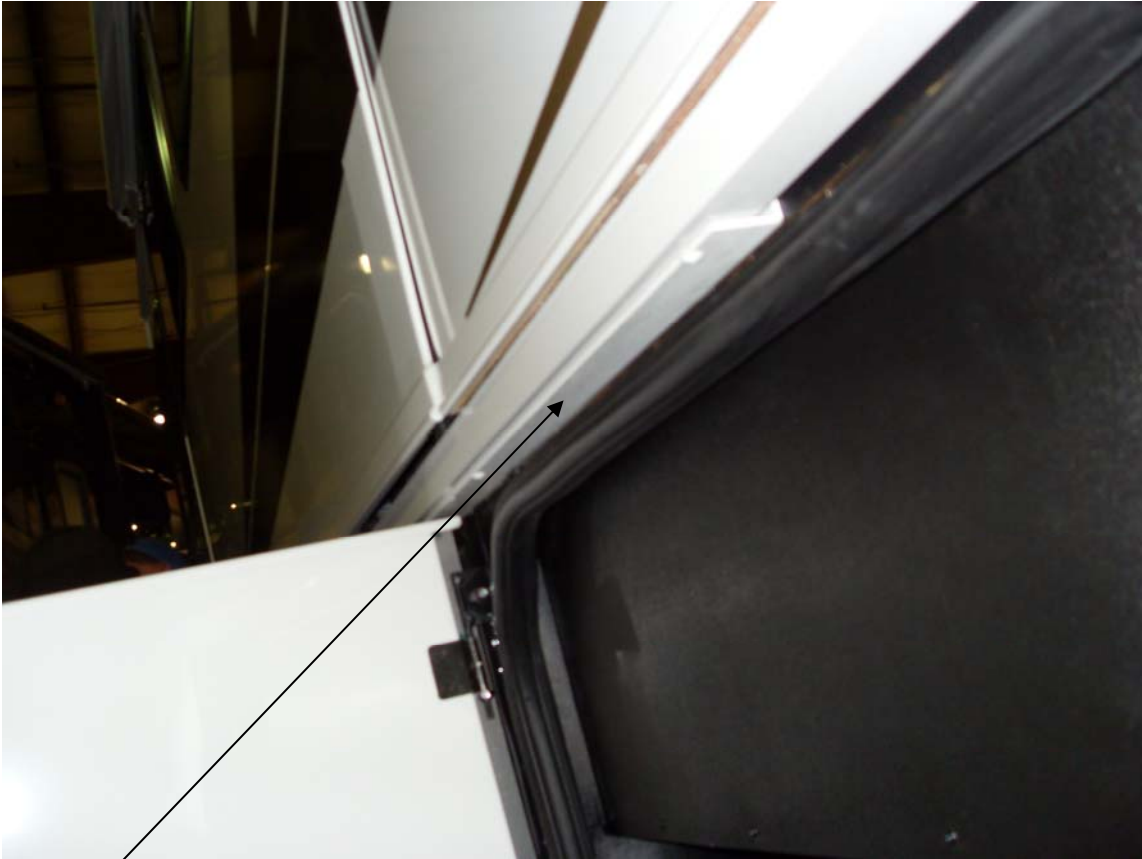
**Subject:** Forest River Georgetown models have been produced with an aluminum baggage door trim under main floor slide rooms that may loosen and detach from the vehicle.

**This is an example of the aluminum baggage door trim that may loosen or detach. It will only be found under main floor slide out rooms.**

**Correction:** Following the diagrams attached, add fasteners to secure the aluminum baggage door trim to prevent any possibility of failure. The aluminum baggage door trim will only be found under main floor slide out rooms.
