## Safety Recall

**Subject:** Incorrect Installation of Air Suspension Rear Axle U-Bolts

**Bulletin:** R0027

**Campaign #:** M0140

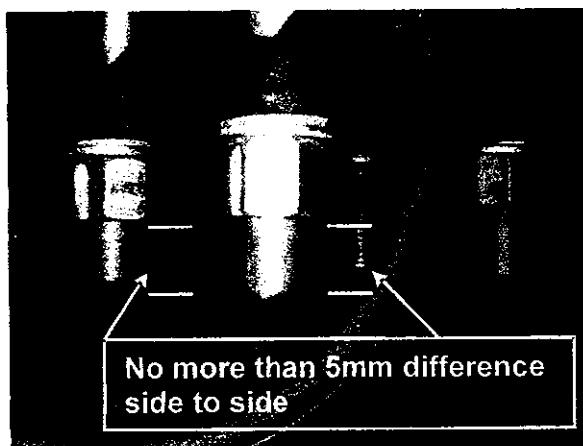
2. In comparing the height of the thread protruding through each U-bolt nut, there should not be more than a 5mm difference between the thread height from one side to the other side. If a difference of more than 5mm is not present, no further action is required. If a difference of more than 5mm exists, proceed to step 3.
