# RECALL CAMPAIGN BULLETIN

NTB09-001

## VOLUNTARY RECALL CAMPAIGN 2005 – 2009 FRONTIER, XTERRA, PATHFINDER, FRONT AIR BAG CRASH ZONE SENSOR

**CAMPAIGN ID #:** R0807

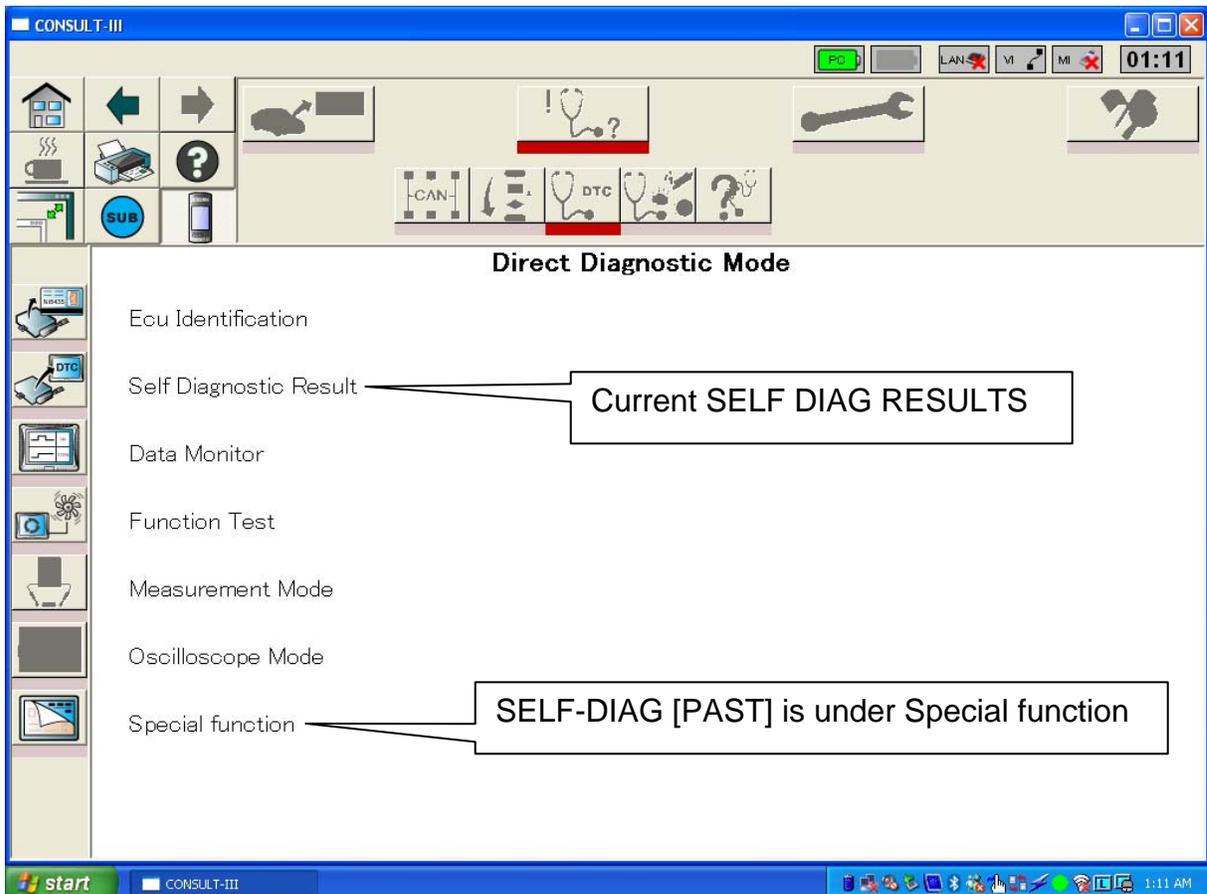
Figure 1

1. Set the parking brake.
2. Connect C-III to the vehicle.
3. Use C-III to check for Air Bag DTCs.
  - a. Navigate C-III to Air Bag Direct Diagnostic Mode.
  - b. **Make sure to check both SELF DIAG RESULTS and SELF-DIAG [PAST].**
    - SELF-DIAG [PAST] is under Special function.

- If there are any DTCs stored for AIR BAG other than B1033, B1034 and/or B1035, perform repairs as needed, and then erase DTC before continuing with this procedure.
- Diagnosis and repair for DTCs other than B1033, B1034, and/or B1035 is not covered by this bulletin.

**NOTE: All DTCs (except B1033, B1034, and B1035) must be repaired and erased before continuing with this procedure.**

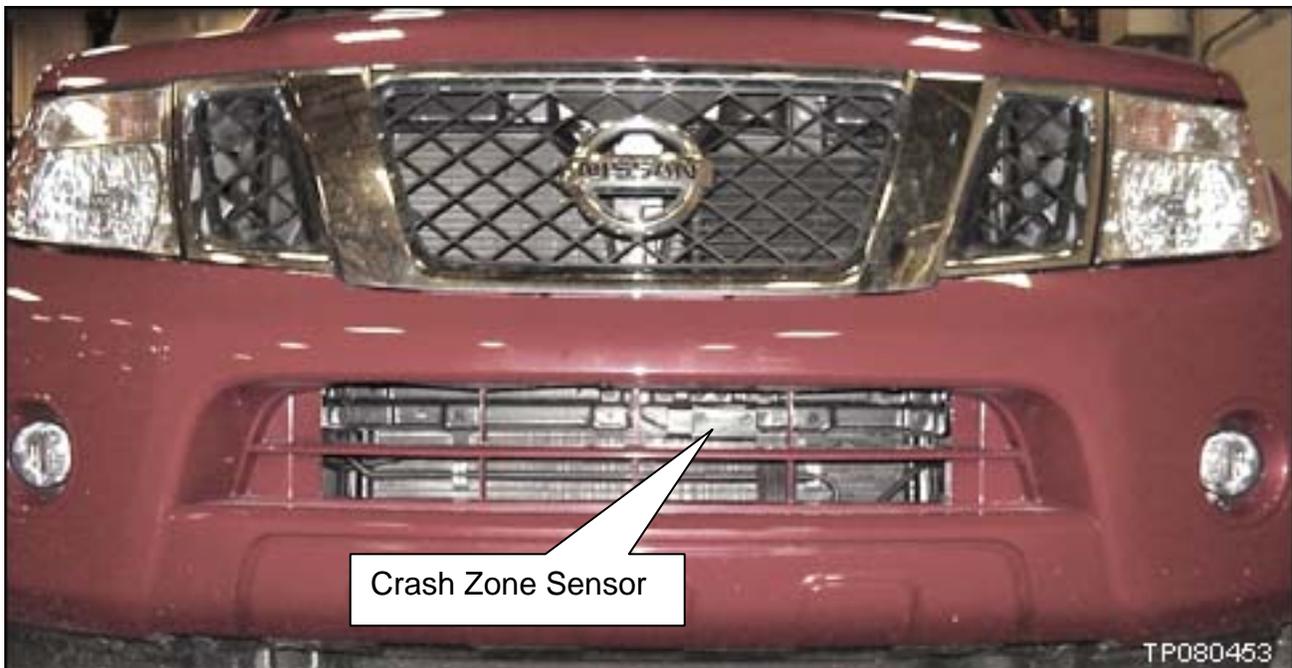
Figure2

8. Locate the Crash Zone Sensor (see Figure 2).

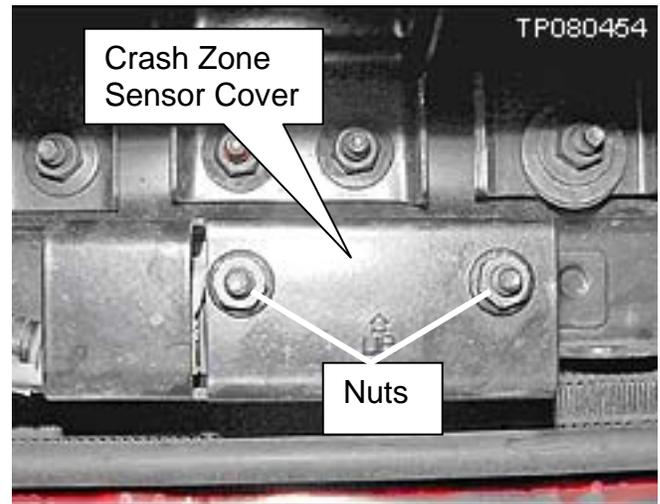
Figure 3

9. Remove the 2 Crash Zone Sensor nuts shown in Figure 3.

- Discard these nuts. They will not be reused.

10. Remove the Crash Zone Sensor Cover.

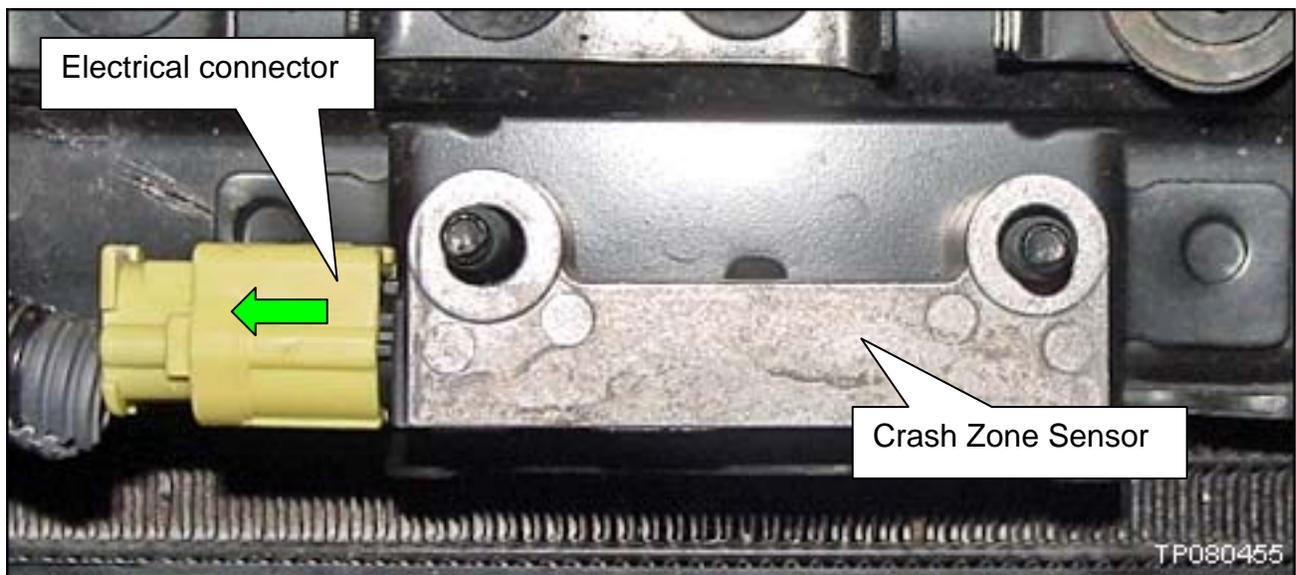
Figure 4

11. Disconnect the electrical connector shown in Figure 4.

12. Remove the old Crash Zone Sensor.

13. Install the new Crash Zone Sensor in reverse order.

- Reuse the original cover.
- Make sure to use the new nuts included with the new sensor.
- Torque nuts to 10.8 N.m (1.1 kg-m, **96 in-lb**).
