Recall Bulletin

PRODUCT SAFETY RECALL

SUBJECT: Engine Compartment Fire

MODELS: 1997-2003 Buick Regal GS
1997-2003 Pontiac Grand Prix GTP
Equipped with a 3.8L V6 Supercharged Engine (RPO L67 – VIN 1)

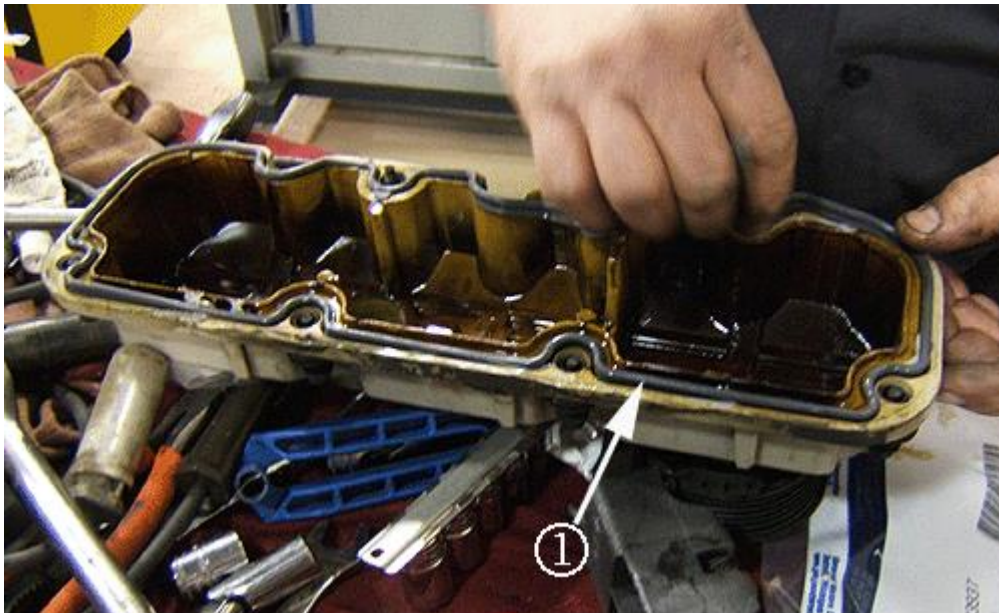
2076766

Warning: Ensure the new valve cover gasket is fully seated into the new valve cover groove. Use due care when installing the valve cover and gasket to the engine ensuring not to bump the valve cover or drag it over top of the rocker arms causing the gasket to come out of the groove. Inspect the mating surfaces of the valve cover and cylinder head to ensure the valve cover gasket is installed properly. Failure to do so may result in an oil leak and/or an engine fire.

6. Install a new left or front valve cover gasket (1) into the new valve cover and make sure that the valve cover gasket is seated properly in the valve cover groove. The old valve cover is shown for illustrative purposes only.
 - 6.1. Install the six valve cover bolts and the six grommets into the valve cover.
 - 6.2. Apply medium strength thread lock compound (blue) to the six valve cover bolt threads.
 - 6.3. Install the NEW valve cover and gasket (1) to the cylinder head.
 - 6.4. Tighten the valve cover bolts to 10 Nm (89 lb in).
 - 6.5. Verify that the valve cover gasket is properly installed (see the warning above).

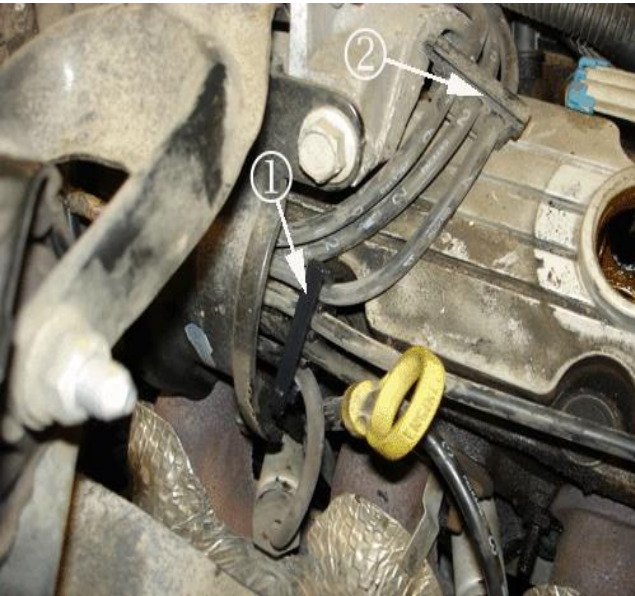
2257359

Note: Do NOT position the retainers above an exhaust runner.

9. Ensure that spark plug retainer (1) is connected to spark plug wire 4 and spark plug wires 1, 3, and 5. Make sure that spark plug wires 2, 4 and 6 are secured to the original retainers and under the left engine mount strut bracket (2). Verify the spark plug retainers are secured (completely latched) and they are NOT touching or over an exhaust runner.

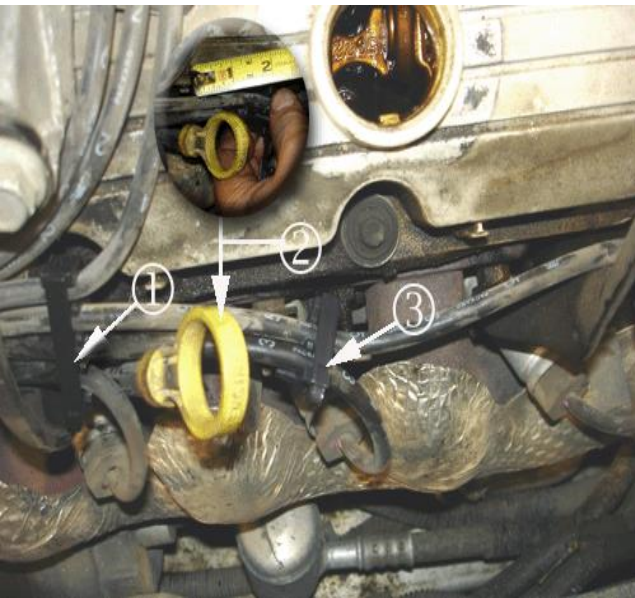
2257363

Note: Do NOT position the retainers above an exhaust runner.

10. Ensure that spark plug wires 3 and 5 are routed behind the oil level indicator and lift bracket. Verify that spark plug retainers (1 and 3) are positioned above the #1 and #3 cylinder spark plug wire boots as shown above. Verify that spark plug retainer (3) is approximately 50mm (2 in) from the oil level indicator (2). Verify the spark plug retainers are secured (completely latched) and they are NOT touching or over an exhaust runner.
