SUBJECT: Vehicle Safety Recall - SC0342
Headlight Switch

Date	Number	Page
01/22/10	SC0342	1(6)

Headlight Rocker Switch Failure

CX, CXN

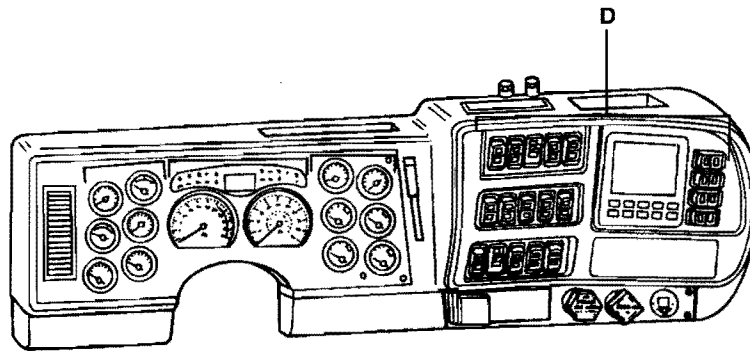
Figure 1 — Remove D-Panel

2. Remove the D-panel.

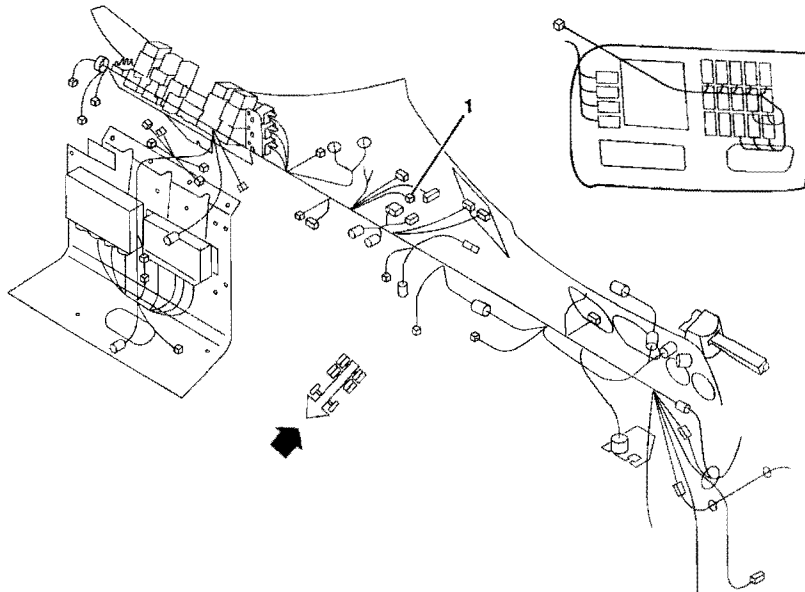
Figure 2 — Disconnect 6Pin Connector

3. Disconnect the 6-pin D-panel connector.

1. 6-Pin Connector

4. Connect the headlight jumper harness (part No. 41MR41165M) between the cab 6-pin cab-to-D-panel harness connectors.
5. Install the relays (part No. 25171095) into the relay sockets of the harness legs labeled "Head Lamp Relay" and "Marker Relay."
6. Using self-tapping screws, secure the two relays to an accessible location on the cab bulkhead behind the instrument panel.
7. Secure the jumper harness ring terminal to the cab ground stud located behind the ABC (gauge cluster)-panel.

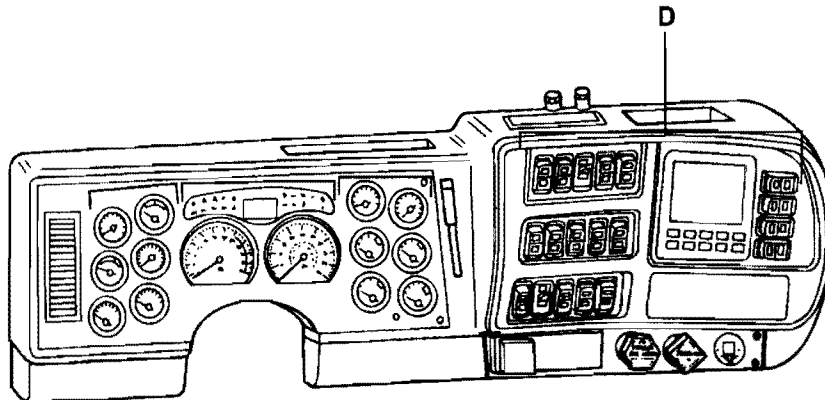
Figure 3 — Remove D-Panel

2. Remove the D-panel.

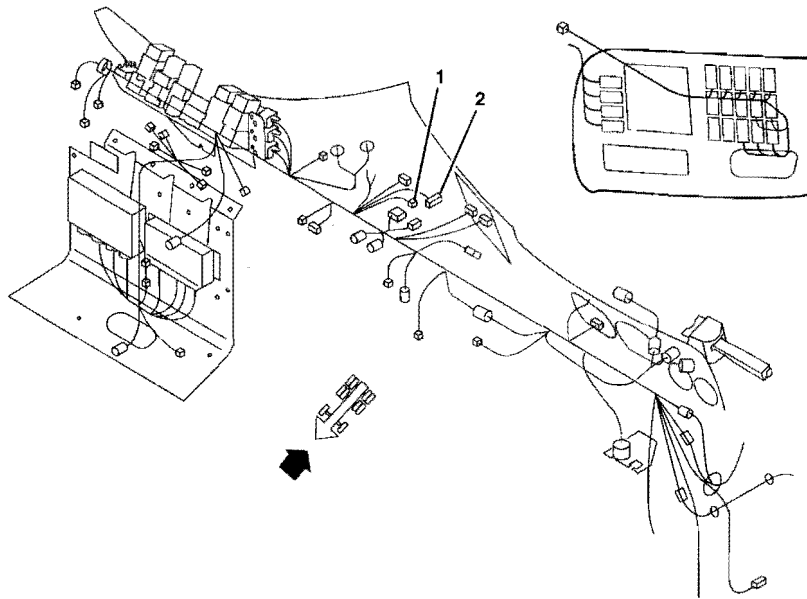
Figure 4 — Disconnect 4-Pin and 30-Pin Connectors

3. Disconnect both the 4-pin and 30-pin D-panel connectors.

1. 4-Pin Connector	2. 30-Pin Connector
--------------------	---------------------

4. Install the headlight jumper harness (part No. 41MR4166M) between the 30-pin chassis-to-D-panel harness connectors and between the 4-pin chassis-to-D-panel harness connectors.
5. Install the relays (part No. 25171095) into the relay sockets of the harness legs labeled "Head Lamp Relay" and "Marker Relay."
6. Using self-tapping screws, secure the two relays to an accessible location on the cab bulkhead behind the instrument panel.
7. Reinstall the D-panel.
8. Reconnect the batteries by connecting the positive battery cable(s) first, and then the negative cable(s).

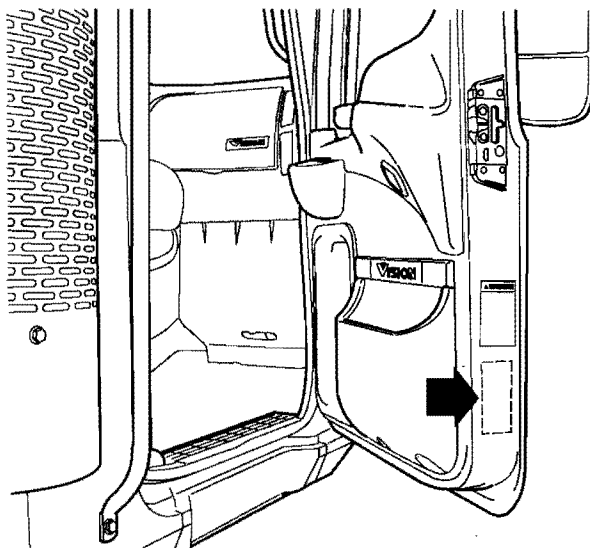
Figure 5 — Campaign Completion Label Location

To signify that the campaign has been completed, use a permanent-type marker (such as a Sharpie®) to write the campaign number (SC342) and completion date in the spaces provided on the Campaign Completion label located on the lower edge (below the door latch) of the passenger-side door. If a label is not already affixed to the door, apply a label (part No. TS897) and supply the information as required. Campaign Completion labels are available in packs of 50 and can be ordered by faxing a completed BR313 to Pacesetters Business Services at 610-264-9465.
