Safety Defect and Noncompliance Report Guide for Equipment
PART 573 Defect and Noncompliance Report Form

Furnish the manufacturer's identification code for this recall (if applicable):
NHTSA assigned no. is **09E-028**

Make: Model Valor Stainless Exhaust Tips

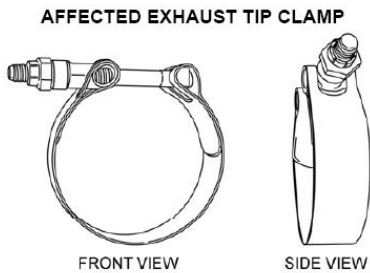
Due to improper heat treatment during the manufacturing process, the original clamp used to secure the Toyota Stainless Steel Exhaust Tip to the exhaust pipe may develop microscopic cracks. Eventually the crack may expand causing the clamp to break. In the worst case, the original clamp and the Toyota Stainless Steel Exhaust Tip may fall off the vehicle's exhaust pipe and become a road hazard.

Fig. 1 Affected Exhaust Tip	Dealer to be	Fig. 2 Interim Exhaust Clamp	letter mailed	Fig. 3 New Exhaust Tip
06/11/09

The original clamp (Fig. 1) was replaced by an interim clamp (Fig. 2) on 9/12/08 and the Stainless Exhaust tip assembly part no was changed when the new improved clamp (Fig. 3) was added. On 10/28/08.
