Safety Defect and Noncompliance Report Guide for Equipment  
**PART 573 Defect and Noncompliance Report Form**

On **T.B.D.**, Southeast Toyota Distributors, LLC decided that (a defect which relates to motor vehicle safety) exists in items of motor vehicle equipment listed below, and is furnishing notification to the National Highway Traffic Safety Administration in accordance with 49 CFR Part 573 Defect and Noncompliance Reports.

Make: Model Valor Stainless Exhaust Tips

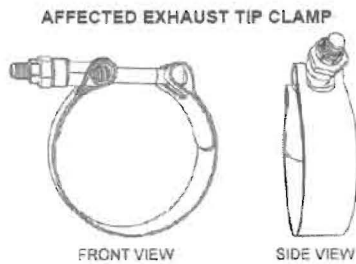
Fig. 1 Affected Exhaust Tip

Due to improper heat treatment during the manufacturing process, the original clamp used to secure the Toyota Stainless Steel Exhaust Tip to the exhaust pipe may develop microscopic cracks. Eventually the crack may expand causing the clamp to break. In the worst case, the original clamp and the Toyota Stainless Steel Exhaust Tip may fall off the vehicle's exhaust pipe and become a road hazard.

The clamp that secures the Stainless Exhaust tip to the exhaust pipe may fail causing the Stainless Exhaust Tip to fall off.

The original clamp (Fig. 1) was replaced by an interim clamp (Fig. 2) on 9/12/08 and the Stainless Exhaust tip assembly part no was changed when the new improved clamp (Fig. 3) was added. On 10/28/08.
