Subject: Ford Motor Company (Ford) Recall No. 09S07 - Certain 2009 Model Year Ford Ranger, 4x2 Vehicles Front Spindle Fracture

49 CFR Part 573 -- DEFECT INFORMATION REPORT
09S07 -- 2009 MODEL YEAR FORD RANGER VEHICLES
FRONT SPINDLE FRACTURE

SUBJECT: DEMONSTRATION / DELIVERY HOLD: Safety Recall 09S07:
Certain 2009 Model Year Ford Ranger 4x2 Vehicles
Front Wheel Spindle Inspection

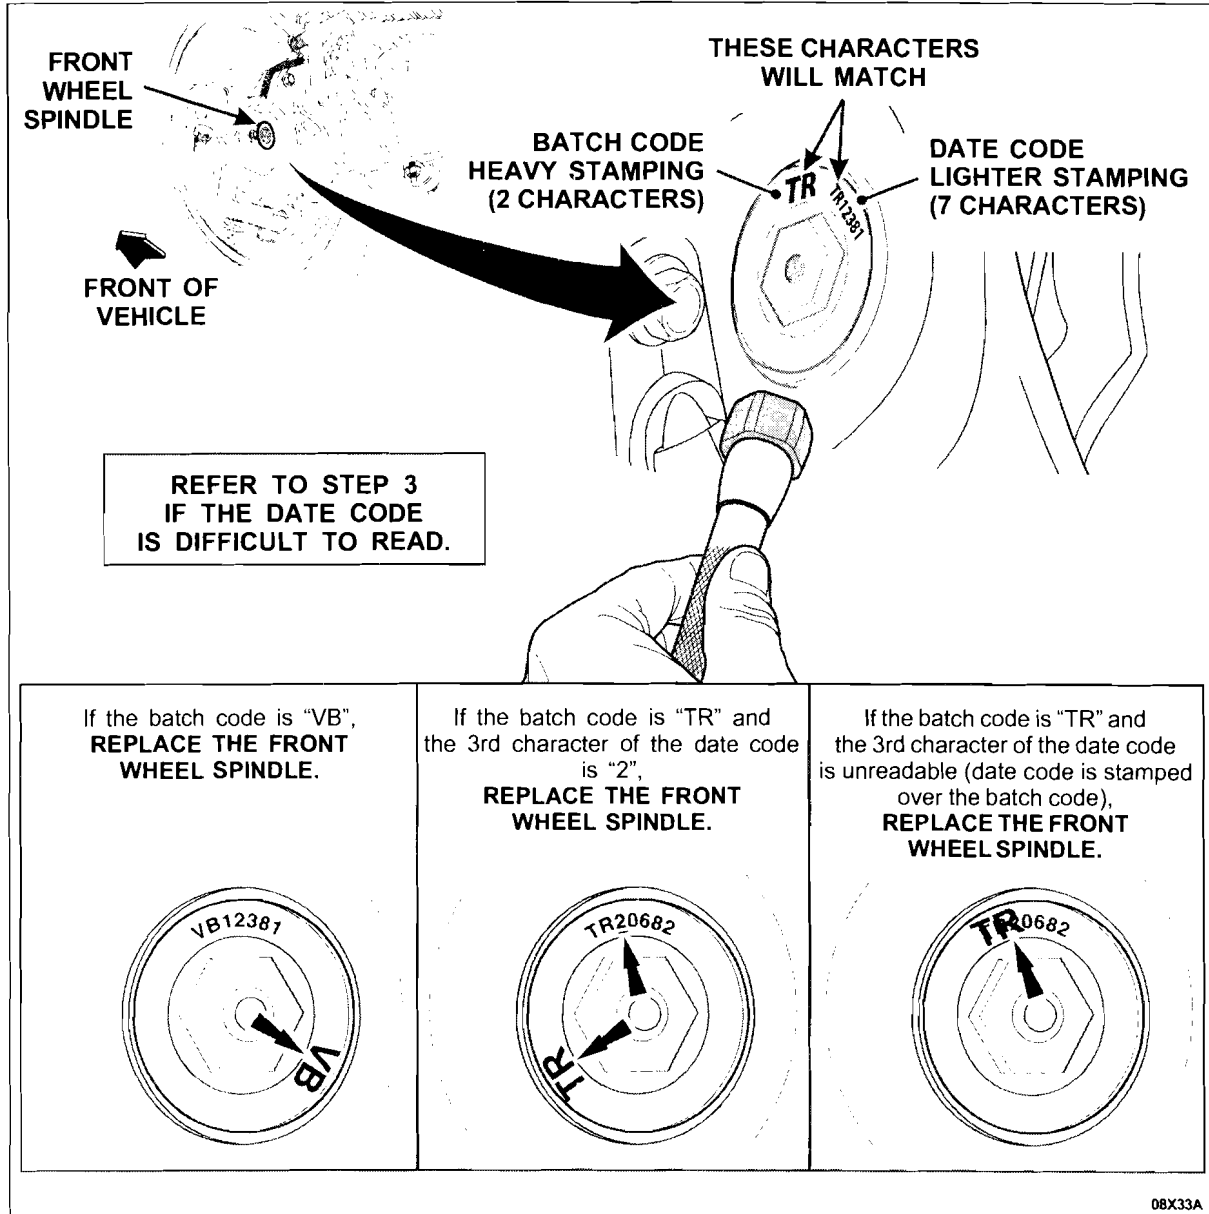
FIGURE 1

- Turn the front wheels so that a clear visual inspection of the inner spindle area can be performed on both the LH and RH front wheel spindles. Using a flashlight, inspect the front wheel spindle batch code and date code. See Figure 1.

NOTE: The third character of a TR spindle will either be a 1 or a 2. Spindles with "TR1" **DO NOT** require replacement.

NOTE: Spindles with a batch code other than VB or TR **DO NOT** require replacement.

4. For the front wheel spindles that require replacement, proceed to the Service Procedure.

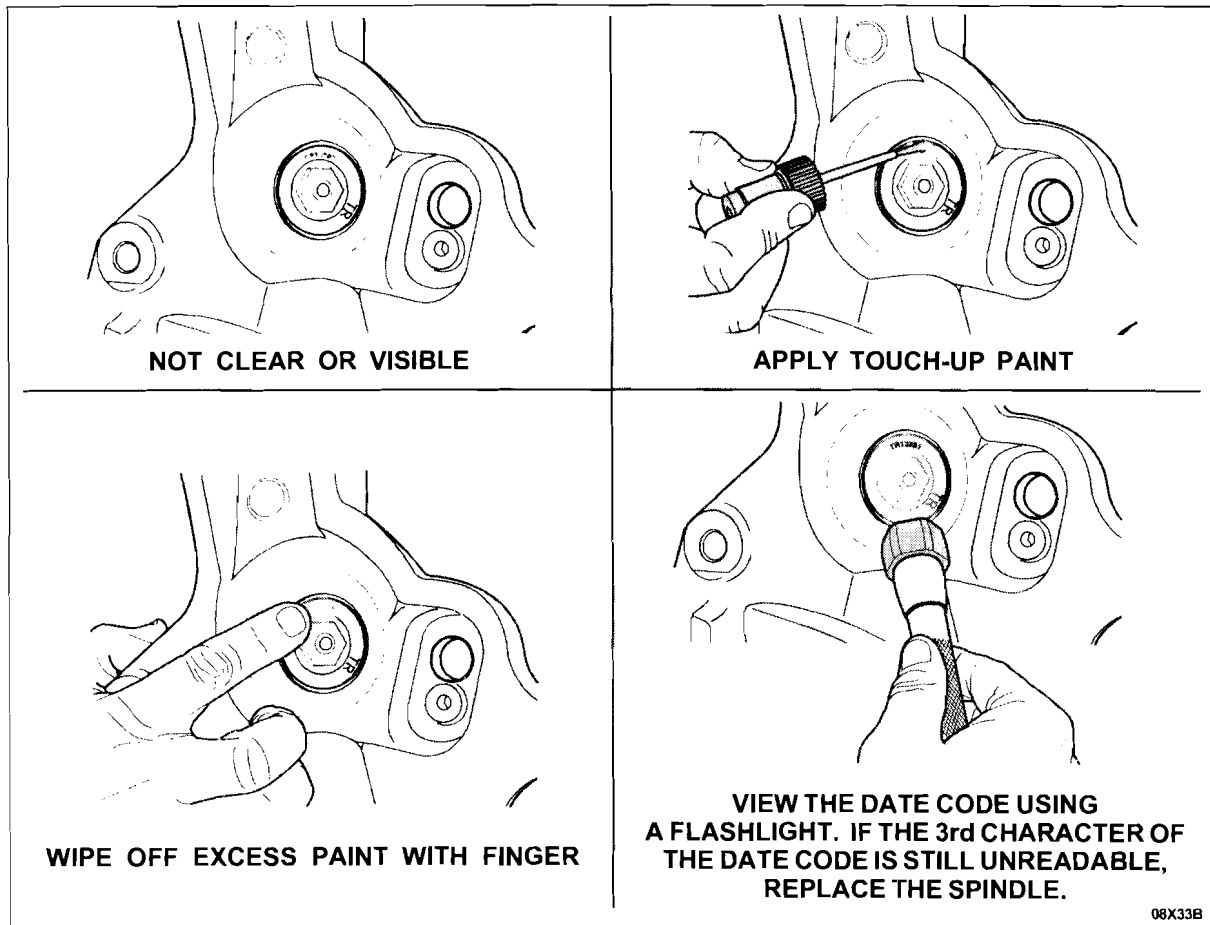
FIGURE 2

IF A TR SPINDLE DATE CODE IS NOT CLEAR

3. If the front wheel spindle date code is NOT clear or visible on a TR spindle, fill the character stamping with white or yellow touch-up paint to improve visibility. See Figure 2.
 - Apply a layer of white or yellow touch-up paint over the date code.
 - Using your finger, remove the excess paint. DO NOT use a shop towel. The towel will remove too much of the paint and impair the ability to read the date code.
