Recall A-0901: Quick Release Valves

Re: Report Pursuant to 49 CFR 573.6  
Autocar, LLC Recall No. A-0901  
NHTSA Recall No. 09V-060  
**Update and Notice of Delay of Owner Notification**

## Locations of Autocar QRV

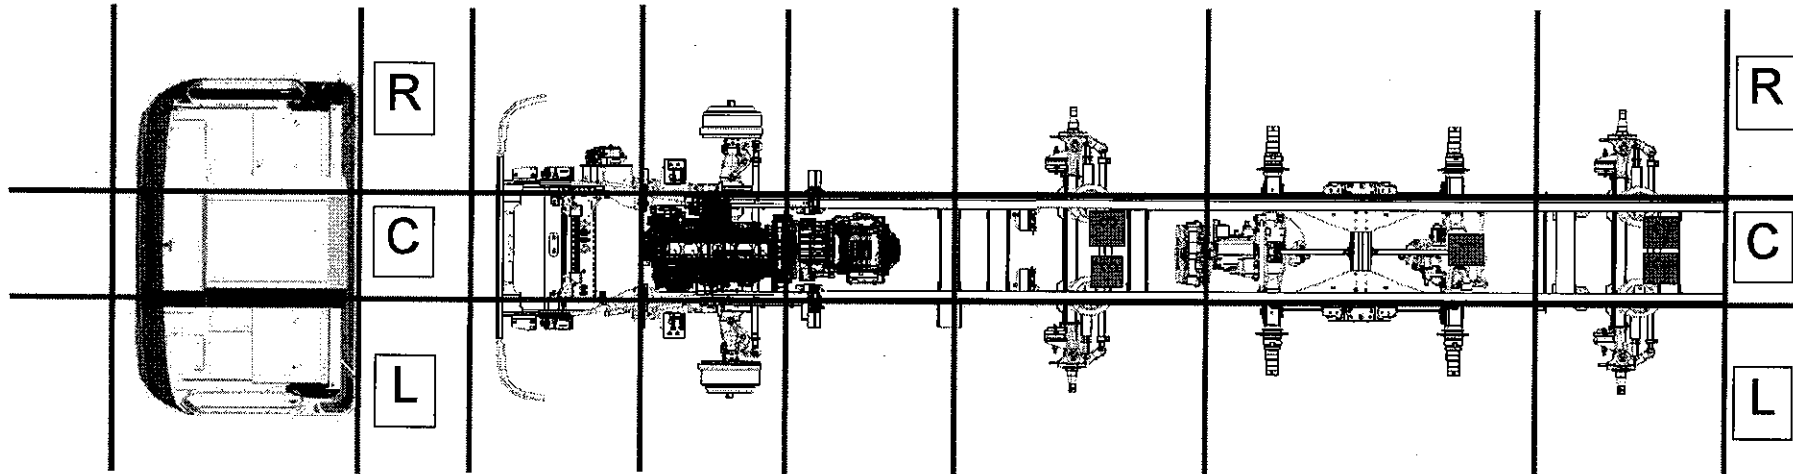
#3 Picture for Pusher (auxiliary) axles - looks like the #2 only on a cross member near the pusher axle
