**09V-091
(13 Pages)**

Battery Isolator Installation

Date: March 6, 2009

Applies to: All C5500, W-5, and F-650 Company Stores built before March 6, 2009.

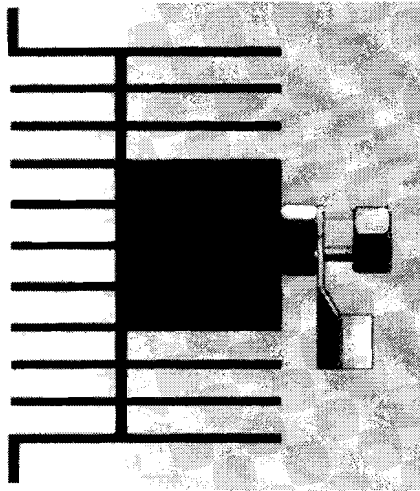
Correct

7. Replace the nut on the stud. It may be necessary to remove the lock washer in order to ensure the nut is seated fully.
8. **IMPORTANT:** Verify that no cables touch the blue cooling fins of the isolator. (see image below)

6. Inspect the cables on the stud (remove if necessary) to ensure that all cables are installed such that the body of the cable lug points away from the isolator (see image after step 8). Spread out cables so all lugs can sit flush.

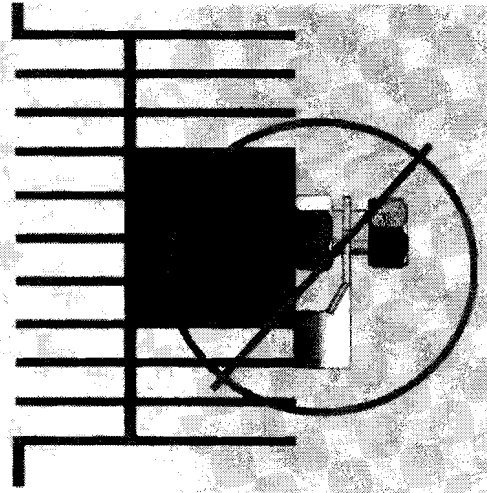
Incorrect

A cable may be installed on the battery isolator with the body of the cable lug facing the isolator. With all cables tightened down on the stud, this cable lug may be pressed against the cooling fins of the isolator. This contact poses a risk of electrical short which could result in cables overheating.

The power converter was removed for inspection and bench testing. No problems were found with the power converter or inverter. Upon detailed inspection of the isolator evidence of electrical arcing was found near the stud for the auxiliary battery bank. One cable on the stud was noted as being installed with the body of the lug pressing against the cooling fin of the isolator.

Wear through the electrical tape on the cable lug allowed a short to the body of the isolator. The isolator is mounted on an aluminum box along with the inverter, power converter, and outlet box for the power converter outlet, each of which provides a path to ground. This electrical short directed battery current through the 12AWG ground wire of the power converter circuit back to the distribution panel to ground. The current exceeded that safe capacity of the ground wire and caused the melting witnessed.

Step 1: It is recommended that all Company Stores built on C5500, W5, or F650 chassis be inspected for cable installation to ensure all cables are installed with the lug body facing away from the isolator with none in contact with the cooling fins.
