Re: Keystone RV Company
Defect and Non-Compliance Report

SERVICE ADVISORY # 09-119

Hornet Propane Lines

Models Included: 2010 Hornet 32 RLSS Travel Trailers

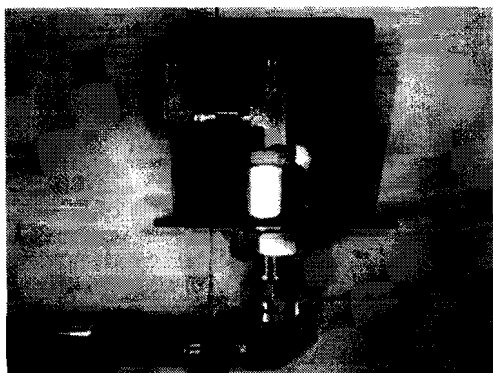
Fig. 2 (before)

Keystone RV Company is conducting a voluntary RECALL notification campaign in accordance with the National Traffic and Motor Vehicle Safety Act. It has been determined that on some vehicles the LP manifold may come in contact with the passenger side rear tire. A propane leak, in the presence of an ignition source, could result in a fire and/or explosion causing property damage and/or personal injury. This service advisory will explain how to correct the situation by moving the manifold approximately 2".

- Step 3.** Loosen the bulk head nut, and manifold inlet elbow. Rotate the inlet elbow 180 degrees, and the LP manifold 180 degrees, tighten both fittings. See figure 2 (before) and figure 3 (after).
- Step 4.** Reassemble the LP manifold to the stove and refrigerator copper lines.
- Step 5.** Secure the LP manifold bracket to the slideout room bar in the new location. The bracket will be located approximately 2" to rear from the original location.
