Re: PART 573 NOTICE RE MERITOR WABCO STEER ANGLE SENSORS

Safety Defect and Noncompliance Report Guide for Vehicles
PART 573 Defect and Noncompliance Report

Re: Part 573 Defect Information Report relating to certain Electronic Stability Control Steering Angle Sensors shipped by Meritor WABCO Vehicle Control Systems between July 2007 and November 3, 2008

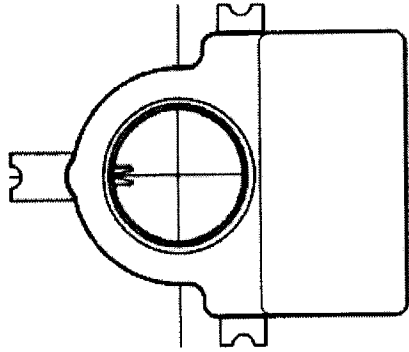
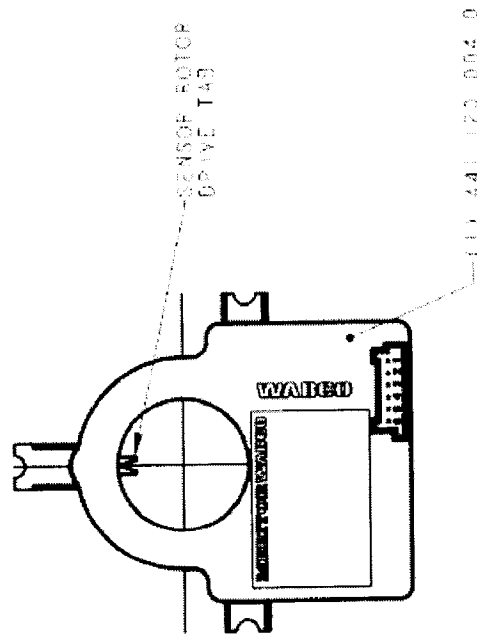
Appendix B: Illustration of Steer Angle Sensor

The Steer Angle Sensor driving tab fits in a groove in the steering column shaft, causing the sensor rotor to turn with the steering wheel. The SAS provides the Electronic Stability Control system with the driver selected steering angle, a critical input necessary to detect loss of directional stability. With a broken SAS driving tab, the ESC yaw rate sensor and lateral accelerometer will measure a difference in vehicle direction when the driver makes a turn without a corresponding change in steer angle. This could be interpreted by the ESC as a directional instability, requiring intervention by brake activation of a selected wheel.

Meritor WABCO's investigation indicates that internal SAS friction can develop between the sensor gears and sensor housing as a result of external forces experienced on the vehicle including vibration. If the developed friction is great enough, the driving tab can shear as the driver turns the steering wheel. Laboratory test data indicates incorporation of grease on SAS components during assembly significantly reduces the likelihood of internal frictional increases resulting in adequate SAS durability when properly installed in the steering column.

The identified defect will be remedied by notifying buyers of vehicles built with the affected product and requesting that they take the vehicles to certified dealers capable of inspecting the Steer Angle Sensors' serial numbers and replacing suspect Steer Angle Sensors, having a serial number below 3000, with the most recent SAS design level provided by Meritor WABCO. On vehicles requiring Steer Angle Sensor replacement, an ESC calibration procedure will have to be conducted prior to the vehicle returning to service.
