Safety Defect and Noncompliance Report Guide for Vehicles  
**PART 573 Defect and Noncompliance Responsibility and Reports** (i)

Furnish the manufacturer's identification code for this recall (if applicable): 09E-013

**Glaval Bus, A Division Of Forest River, Inc.**

## ***K410 Identification Method***

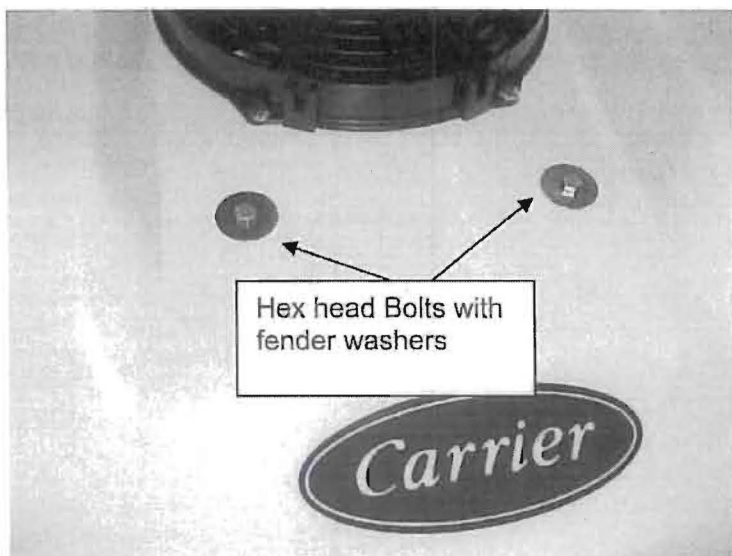
In order to check if your K410 rooftop condenser needs to be updated please look at the unit, if the cover is secured by Hex head bolts with fender washers (2 in the front and 4 in the back). Reference the Fig 1 below. If this is the case, then your unit was already retrofitted and **no further action is needed**.

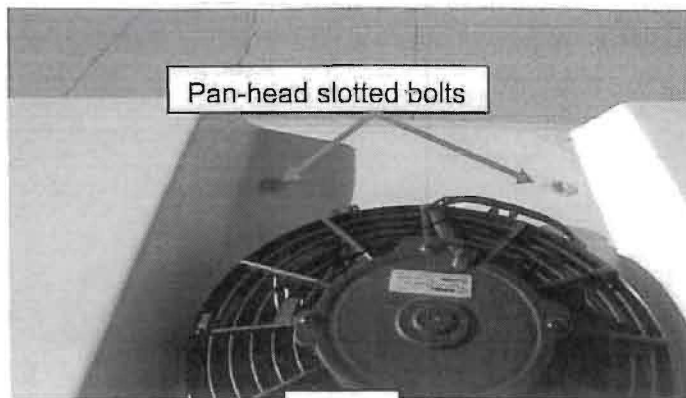
Fig 2

If the cover of your K410 is secured by Pan-head slotted bolts (fig 2), then it will need to have a, PN# 74-62047-00, retrofit kit installed by a Carrier authorized dealer or at your shop. Please call 1-800-450-2211 to have the retrofit kit(s) send. Carrier will pay all costs to have this kit installed on your unit(s). Please have the serial number(s) of the units(s) ready for our records.

Carrier recommends that until the K410 is modified, that the cover be removed and the high pressure switch is disconnected. (**Warning ! Do not operate the air conditioning on the bus without the K410 cover secured on the unit**). The cover should be stored in a safe place until retrofit kit can be properly installed and the cover replaced.
