**Re: Defect Information Report – Supplemental Report No. 2  
09V-219, FL-#552 Emergency Exit Window Release Mechanism**

Subject: RECALL 09V-219 – Emergency Exit Window Release Mechanism

RECALL #09V-219

SUBJECT: EMERGENCY EXIT WINDOW RELEASE MECHANISM

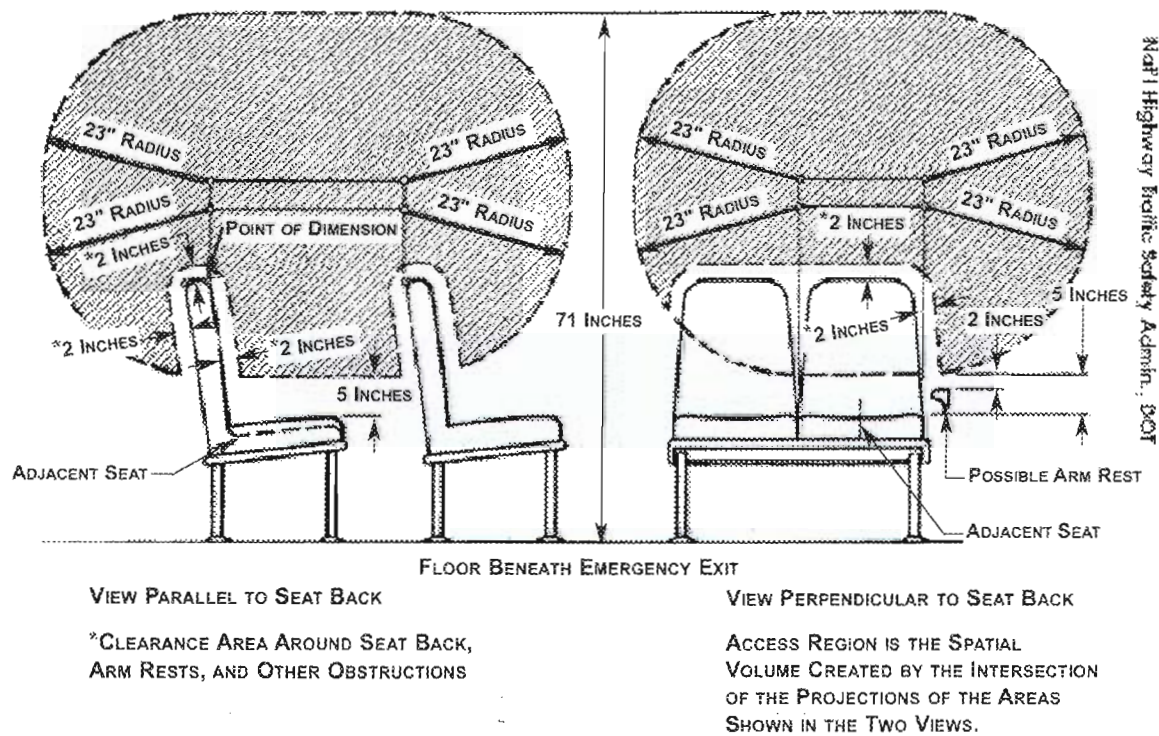
**FIGURE 1 - LOW-FORCE ACCESS REGION FOR EMERGENCY EXITS HAVING ADJACENT SEATS**

A minimum of two inches is required between an emergency push-out release handle and the adjacent seat. Check to see if your push-out window release handles are within the two inch minimum requirement.

If the handles are closer than two inches to any portion of the seat, continue with this repair. **Figure 1**
