**Re: Defect Information Report – Supplemental Report No. 2  
09V-355, FL-554, TRW I-GEN 3 Steering Shaft**

## Subject: TRW IGEN 3 Steering Shaft Welds

October 2009  
FL554A-I  
NHTSA #09V-355

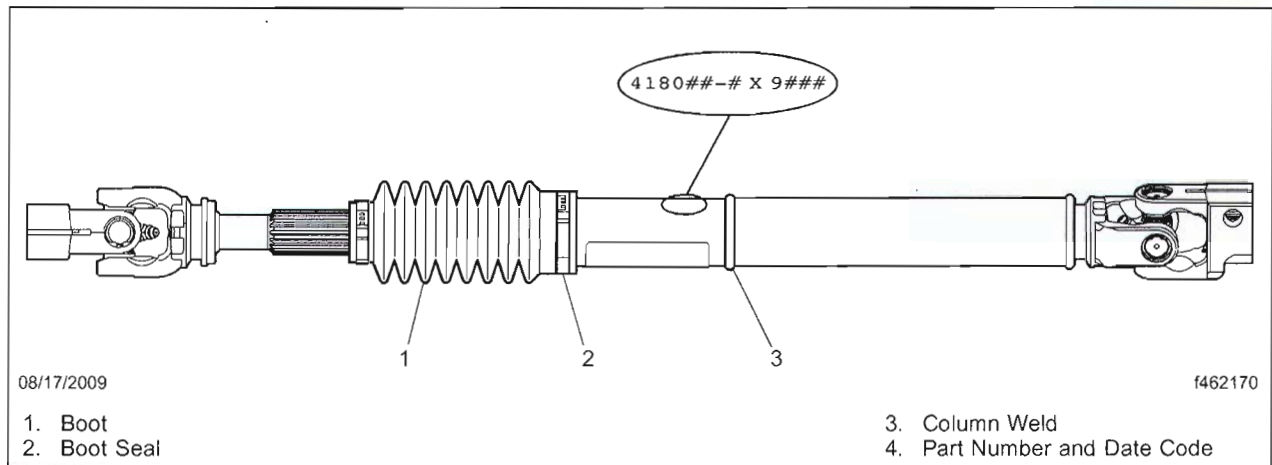
Fig. 1, TRW IGEN 3 Intermediate Shaft

4. If the intermediate shaft is not an IGEN 3 model (shown in **Fig. 1**), no further action is necessary.  
If the part number on the IGEN 3 intermediate shaft does not match one of the formats listed in the left column of **Table 4**, no further action is necessary.  
If the date code on the IGEN 3 intermediate shaft does not fall between 9111 and 9146, no further action is necessary.

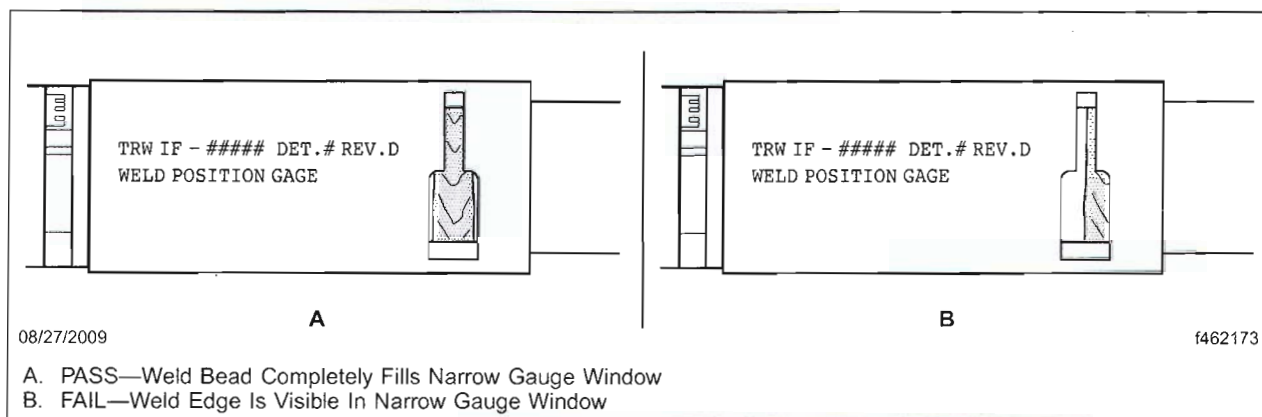
**Fig. 3, Gauge Measurement**

7. Visually inspect the full circumference of the weld seam in the narrow gauge window. See **Fig. 3**. Check for the following:

- the weld bead completely fills the narrow gauge window;
- the joint line is not visible between the two column tubes (the joining edge is covered by the weld);
- the tube is not visible.

8. If the column meets all three criteria listed in the previous step, mark the column with white or yellow paint next to the part number to show that it has passed inspection. On the RO, include the intermediate shaft part number and the date code. These will be recorded on the recall claim.
- If the column does not meet all three criteria listed in the previous step, replace the intermediate shaft. On the RO, include the intermediate shaft part number and the date code. These will be recorded on the recall claim.
9. Clean a spot on the base label (Form WAR259), write the recall number, FL554, on a blank red completion sticker (Form WAR260), and attach it to the base label to indicate the work has been completed.
