On September 4, 2009, Honda Motor Co., Ltd. (HMC) determined that a potential defect relating to motor vehicle safety exists in the swingarm weld of certain 2002 model year VTX1800 motorcycles, and is furnishing notification to the National Highway Traffic Safety Administration in accordance with 49 CFR Part 573 Defect and Noncompliance Reports.

**Identification of potentially affected vehicles:**

**Defect description:**

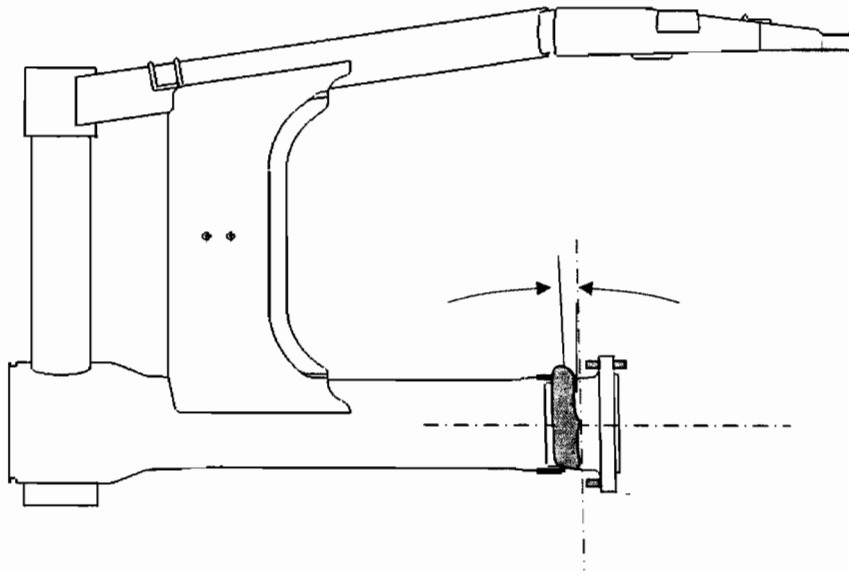
The weld bead at the final drive mounting flange (part of swingarm) may not have been properly positioned around the entire circumference, resulting in areas with insufficient weld penetration. Insufficient weld penetration can result in weld cracking and breakage. If the weld breaks while riding, the rider's ability to control the motorcycle will be adversely affected. There may also be a loss of forward drive if the propeller shaft disengages from the final drive. Either scenario could potentially lead to a crash.

The owners of all affected vehicles will be contacted by mail and asked to take their vehicle to a Honda dealer. The dealer will inspect the swing arm flange weld and, if necessary, replace the swing arm. The inspection and repair will be performed free of charge.
