Safety Defect and Noncompliance Report Guide for Vehicles
PART 573 Defect and Noncompliance Responsibility and Reports¹

On September 29, 2009, Coach & Equipment Manufacturing Corp. [MFR] decided that a defect which relates to motor vehicle safety exists in the motor vehicles listed below, and is furnishing notification to the National Highway Traffic Safety Administration in accordance with 49 CFR Part 573 Defect and Noncompliance Responsibility and Reports.

SERVICE BULLETIN

EC Series Electrical System Mandatory Product Improvement

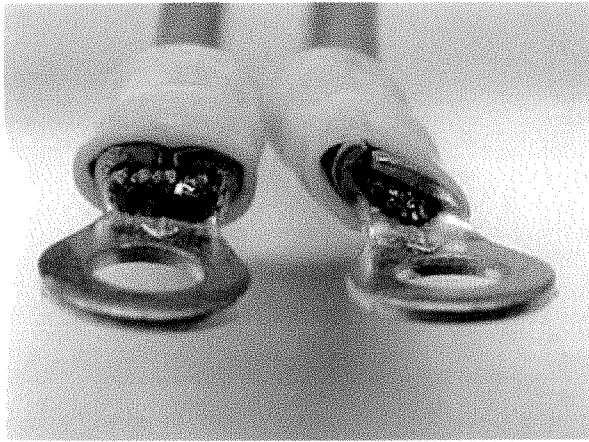
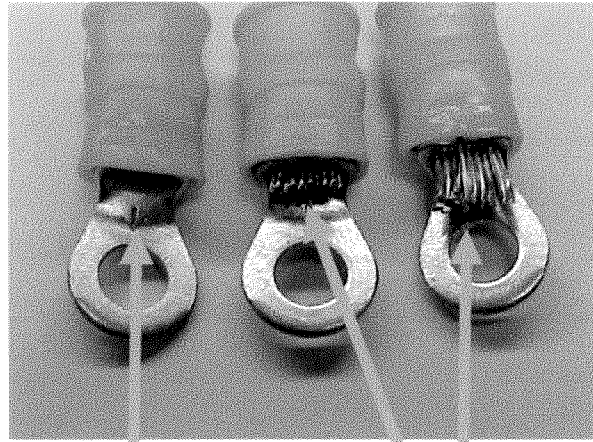
Fig 1

Correct Position

Poor Position In Crimper

Correct

Poor Wire strands Too long

1. Crimps on the wires going to the terminal strip of the relay board should be uniform and tight. There should be no bare wire visible between the wire insulation and the terminal, and strands flush with terminal barrel. (Fig 1 & Fig 2)

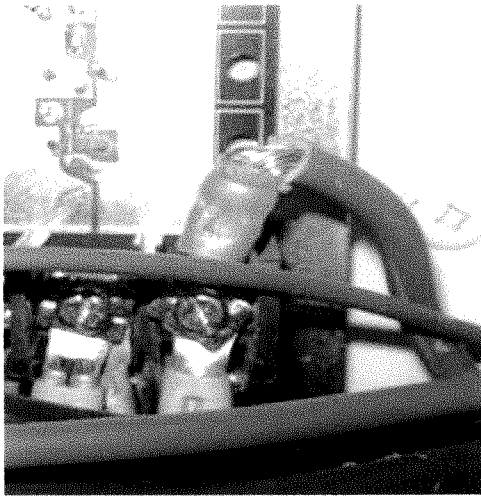
Fig 2

Poor Crimp

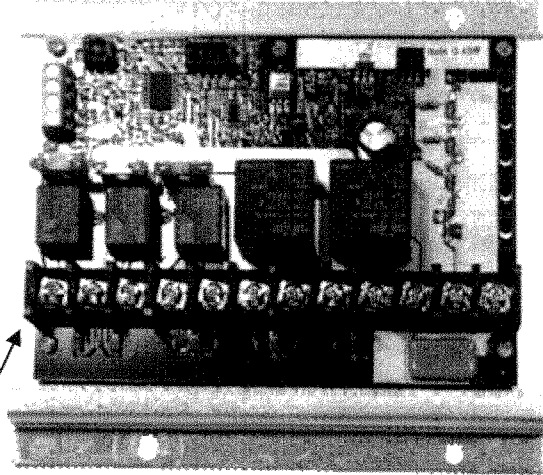
Fig 3

Torque all Torx type screws to 18 in/lbs

3. All screws on the terminal strip should be replaced with the Torx type screw, supplied in the product improvement kits for EC2.0, EC2.5 & EC3.0, and ***MUST BE*** torqued to 18 in/lbs. (a torque screwdriver is available on a loan basis, from Trans/Air) (Fig 3)

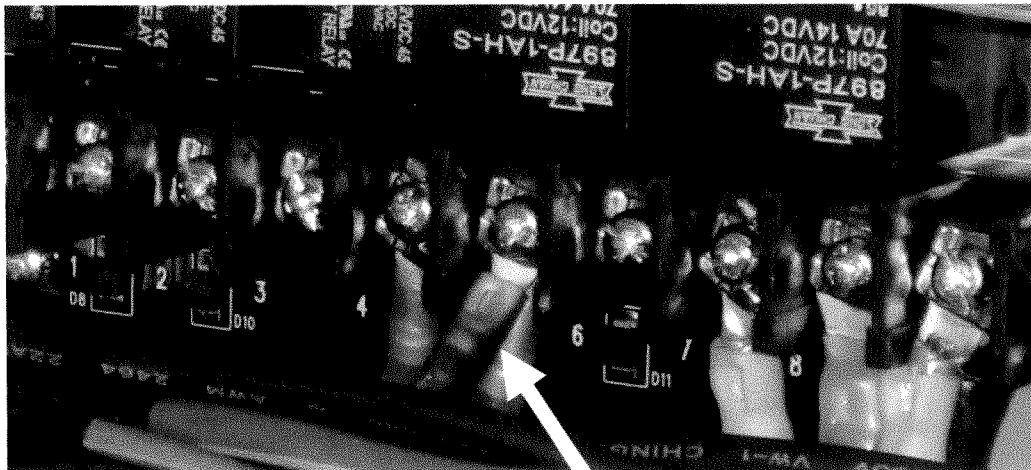
Fig 4

Heat discoloration of a poor (loose) crimp

4. EC2.0/2.5 - Inspect the board overall. Look for any discoloration or evidence of heat. Inspect the area in front of, and above the EC2.0/2.5 relay board. If there are any refrigerant hoses laying against the board or directly above the board, please contact Trans/Air for a relay board cover to eliminate any chance of condensate contacting the relay board. Hoses that may be near the board must be secured properly, to eliminate movement toward the relay board.
