**SUBJECT:** NHTSA Recall No. **09V-021**  
Transport Canada Recall No. **09-011**

### Safety Recall Notice

**Subject:** Telma Retarder Installation

| SUPERCEDES: NONE | DRAWN: RYSER | CKD: | | | TORQUE SPECS, DRIVELINE & TELMA | | | |

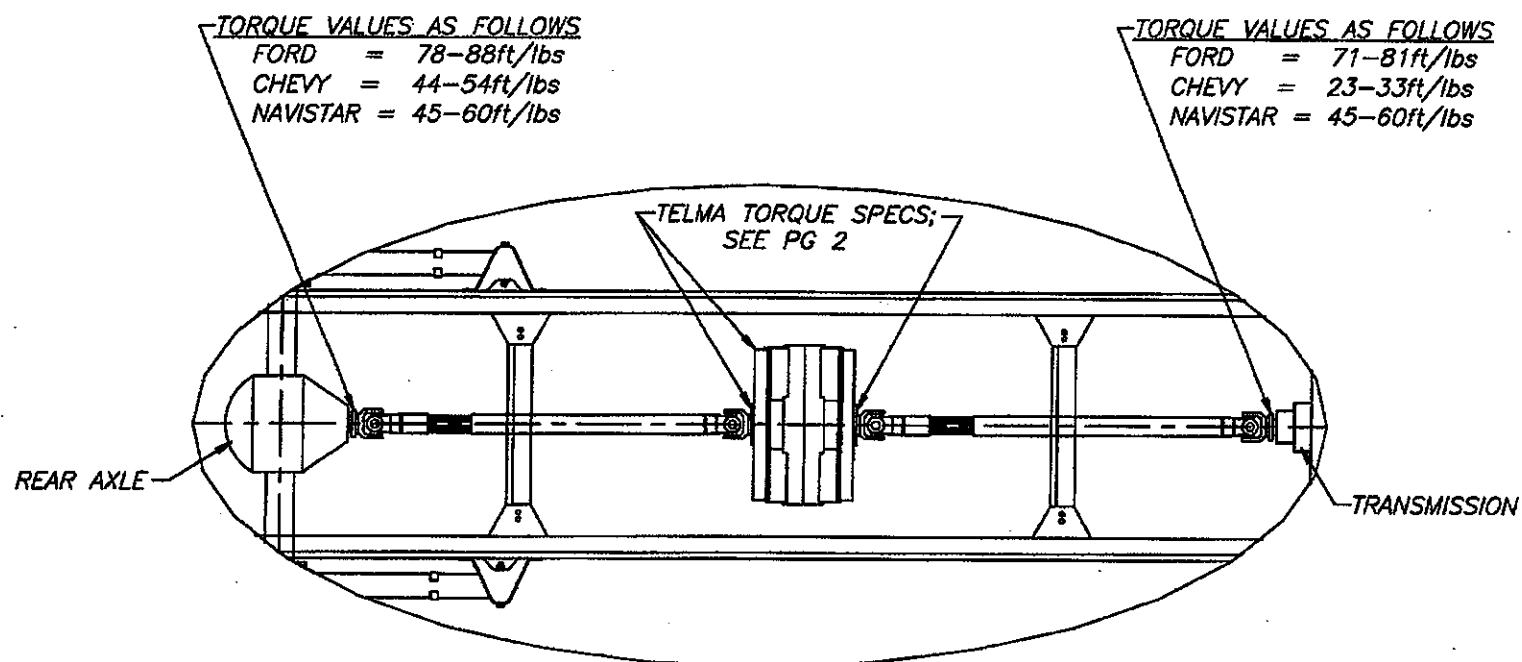
- TIR03109 relay box
- bracket
- mounts using chassis bracket bolts
- TIR03109
- 9/16" BOLTS: 150 LB-FT
- TIR03121 DRIVER (LEFT) SIDE
- 150 LB-FT
- 65 LB-FT
- TIR03122 PASSENGER (RIGHT) SIDE
- 3/8-24UNF FLANGE YDKE (INDEX 158)
- NUT TORQUE 40-48 LB-FT

USE MEDIUM STRENGTH LOCTITE ON ALL  
FASTENERS AND MARK WITH PAINT  
AFTER TIGHTENING TO PROPER TORQUE
