BLUE BIRD

**R09PB**

**SUBJECT: RECALL R09PB BATTERY POWER CABLE ROUTING**

# Battery Cable Routing **RECALL**

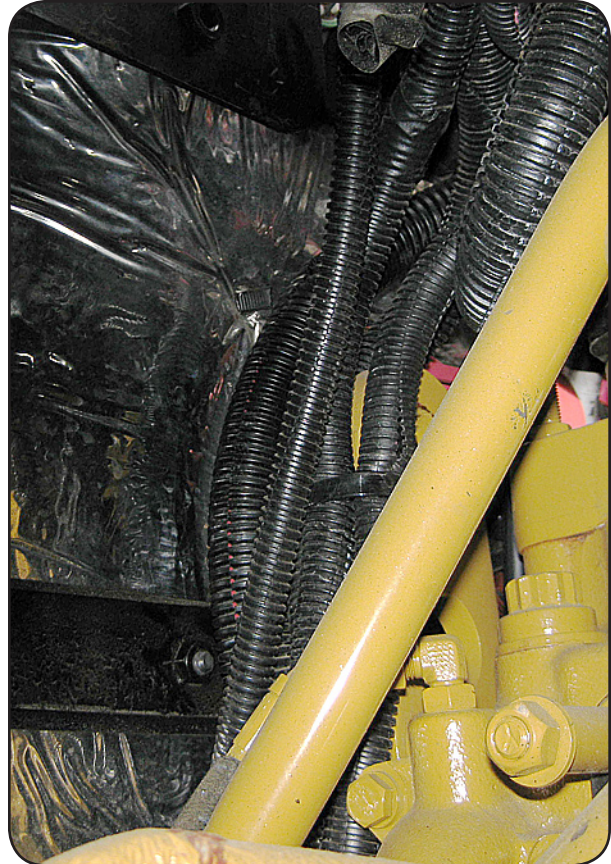
*This procedure requires thorough inspection of all battery cables for abrasion damage in the area at the rear of the engine*

- 4** Thoroughly inspect all the cables identified in step 3 for indications of contact with and/or chaffing against the rear of the engine. Ensure there is a minimum of 1/2" clearance between the battery cables and any part of the engine.

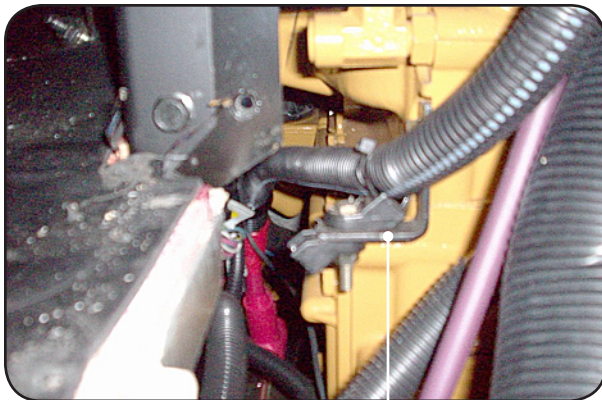
L-shaped bracket

A saddle block is bolted to this bracket, and supports a battery cable, attached by a cable tie. Inspect the battery cable for contact with the saddle block's mounting bolt or with any portion of the engine, as follows:

- If any chaffing or other damage is evident, perform **Sub Procedure A: Cable Protector Installation**.

- If no chaffing or other damage is evident, but clearance between the cable(s) and any part of the engine is less than 1/2", reposition and secure the cable to obtain 1/2" clearance. If the cable cannot be repositioned, perform **Sub Procedure A: Cable Protector Installation**.

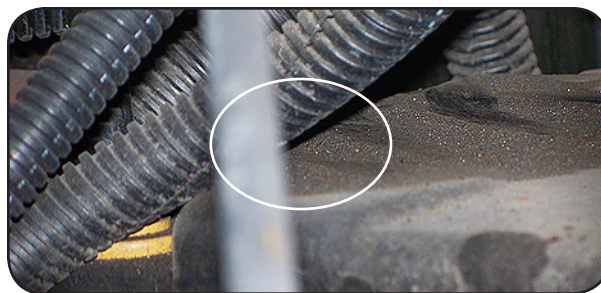
Example of battery cable loom resting against engine

- If no damage is evident, and the required 1/2" minimum clearance is provided, proceed to step 8.
- If clearance between the cable(s) and any part of the engine is less than 1/2", perform **Sub Procedure A: Cable Protector Installation**.

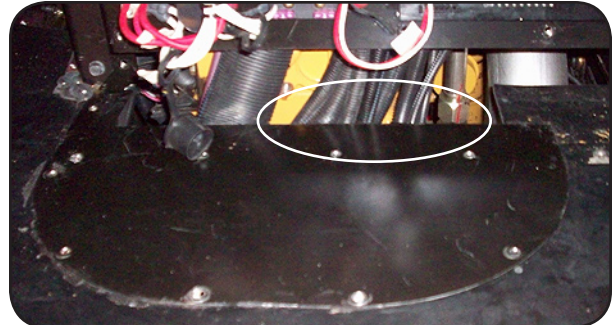
Area of possible cable damage against front edge of transmission cover plate

- If no contact between the transmission cover and harnesses is evident, proceed to step 8.
- If any evidence is found of chaffing or other damage due to contact against the transmission cover, perform **Sub Procedure B: Relocate Transmission Cover**.

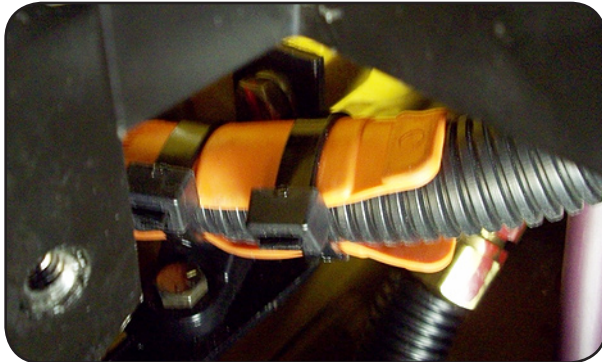
**1** If any evidence of cable loom contact with the engine, chafing, or other damage is evident, or if clearance between the battery cable(s) and any part of the engine is less than the required minimum ½" but cannot be repositioned, inspect further to determine the extent of damage:

- If the loom has been rubbed, but no damage to the battery cable inside has occurred, then install cable protector (BB # 0040818) between the engine and battery cable. Wrap the protector around the cable loom and secure it with two Cable Ties (BB # 0029999) as shown below.
