- > Recall 4707H 1998-2002 Mazda B-Series Cruise Control Deactivation Switch
- > Recall 5409D 2010 Mazda3 Emission Harness
- ➤ MSP23 2010 Mazda3 Malfunction Indicator Light Illumination (DTC P2183, P0111)

2010 Mazda3 Upcoming Service Campaign

Electronic Field Communication eFC Number: eFC-A-09-00002	Date:	Wednesday, April 15, 20	Action 009
Subject: STOP DELIVERY/HOLD - 201 SAFETY RECALL 5409D.	0 MAZDA3 E	MISSION HARNESS VC	LUNTARY
Originating Name: Gabriela Laur Email ID: glaur@mazdausa.com	Dept: Phone:	TSD 949-442-6590	
Summary: Stop Delivery/Hold for 2010 Mazda through April 10, 2009 due to voluntary safety			7, 2008
See Also eFC Number(s): eFC-I-09-00022,eFC-I-09-00022a,	, ,		
Dealer Communication: Yes ⊠			·
Additional Contacts:

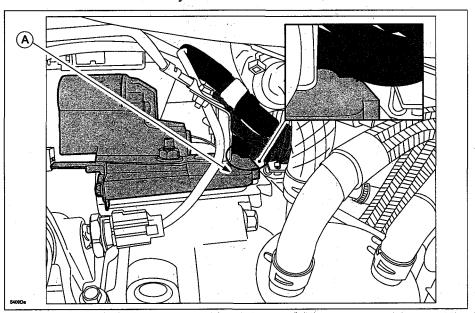
The emission harness may contact the engine starter housing (A) causing damage to the harness, and in some rare cases, the damage may cause the emission harness wiring to short to ground. This shorting to ground will cause the MIL to illuminate and / or driveability concerns.

VIEWED FROM UNDERNEATH THE VEHICLE (LOOKING UP) WITH UNDERCOVER REMOVED

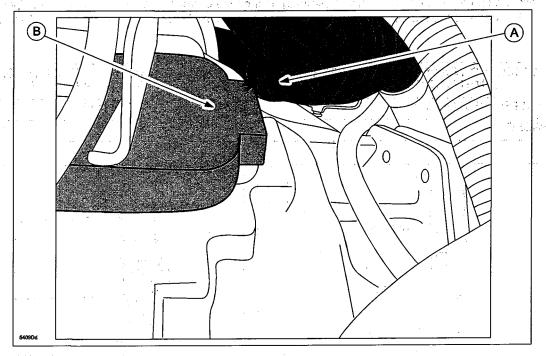
- 3. Carefully inspect the harness (A) in the area closest to the engine starter housing (B). DOES THE HARNESS TOUCH THE ENGINE STARTER HOUSING?
 - YES Go to next step.
 - NO Go to PROCEDURE "B".

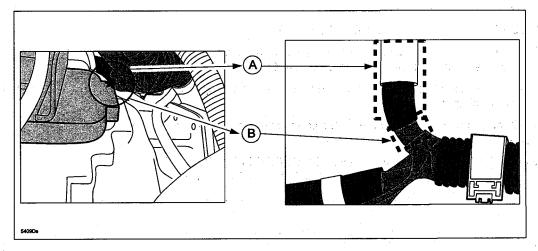
- 4. Inspect the vehicle's harness and compare to the illustration below to determine procedure.
 - Starter contacts area of corrugated sheath (A) Go to PROCEDURE "B".
 - Starter contacts area of tape (B) with no corrugated sheath Go to PROCEDURE "C".

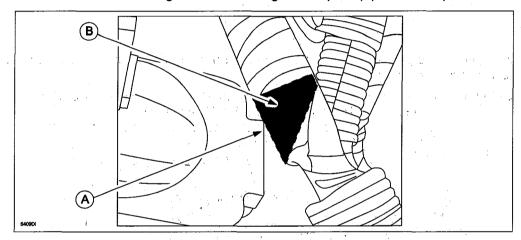
NOTE: This procedure prevents water entry if harness tape was damaged by engine starter housing contact.

1. Note the area of harness at the engine starter housing contact point (A) to be waterproofed as shown (B).

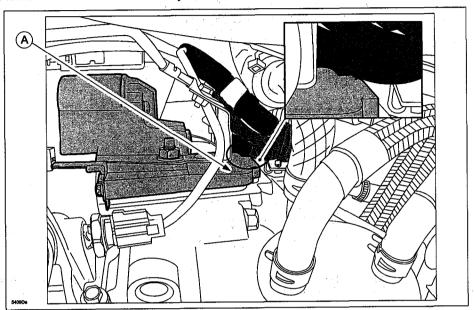
The emission harness may contact the engine starter housing (A) causing damage to the harness, and in some rare cases, the damage may cause the emission harness wiring to short to ground. This shorting to ground will cause the MIL to illuminate and / or driveability concerns.

VIEWED FROM UNDERNEATH THE VEHICLE (LOOKING UP) WITH UNDERCOVER REMOVED

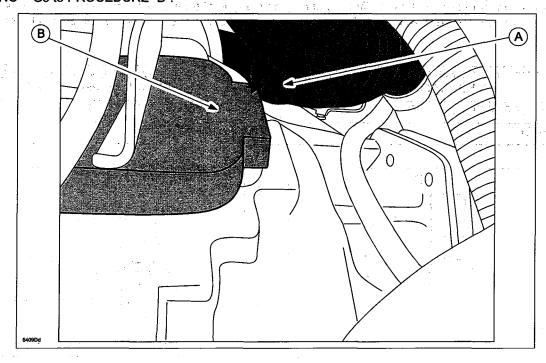
- 3. Carefully inspect the harness (A) in the area closest to the engine starter housing (B). DOES THE HARNESS TOUCH THE ENGINE STARTER HOUSING?
 - YES Go to next step.
 - NO Go to PROCEDURE "B".

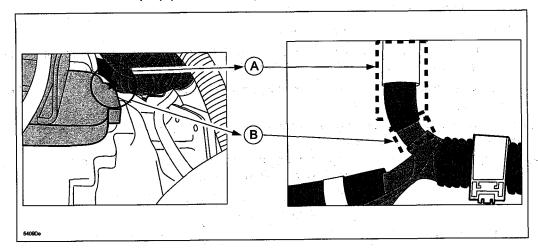
- 4. Inspect the vehicle's harness and compare to the illustration below to determine procedure.
 - Starter contacts area of corrugated sheath (A) Go to PROCEDURE "B".
 - Starter contacts area of tape (B) with no corrugated sheath Go to PROCEDURE "C".

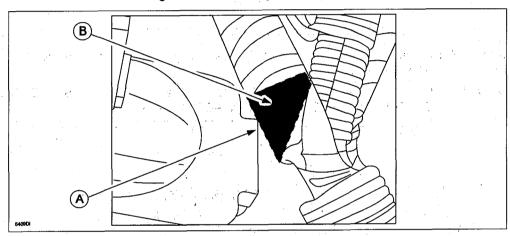
NOTE: This procedure prevents water entry if harness tape was damaged by engine starter housing contact.

1. Note the area of harness at the engine starter housing contact point (A) to be waterproofed as shown (B).
