Safety Recall Circular

Code: **66D6**

**Subject: 2007-2009 Touareg 2
Roof Edge Spoiler**

REVISED
September 2009

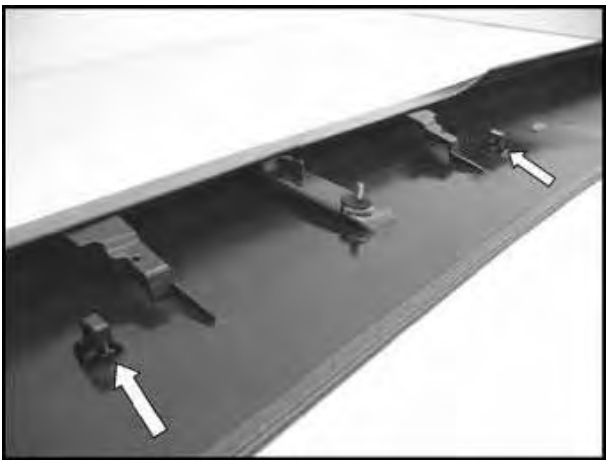
Tip: Broken off clips -arrows- do not affect the fit of the spoiler and can be removed before the assembly

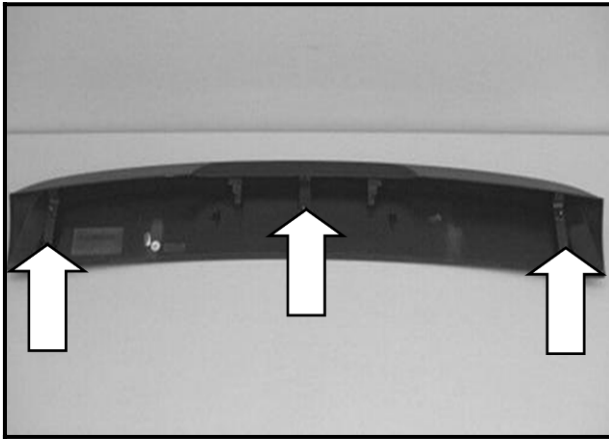
- ⇐ On these three points -arrows- reinforcements will be bonded
- ⇐ Inspect mounting points -arrows- for damage. **If damage is found, contact Campaign Helpline at 800-741-2919**
