# Safety Recall Circular

Code: **66D6**

**Subject: 2007-2009 Touareg 2  
Roof Edge Spoiler**

**REVISED**  
January 2018

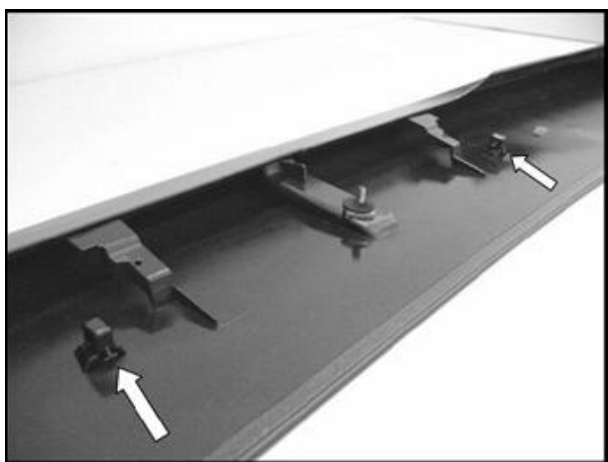
Tip: Broken off clips -arrows- do not affect the fit of the spoiler and can be removed before the assembly

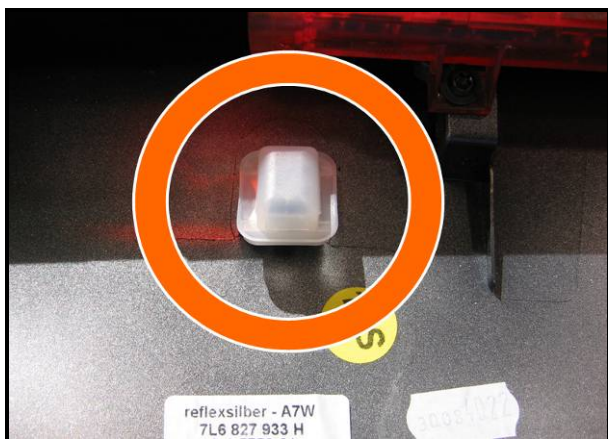
Tip: To avoid leaks, the two relevant clamping pieces  
-circle- must be reinstalled into the rear hinged window

**Water leaks caused by not reinstalling these pieces are not covered under this action**

- Reinstall the two clamping pieces, if necessary

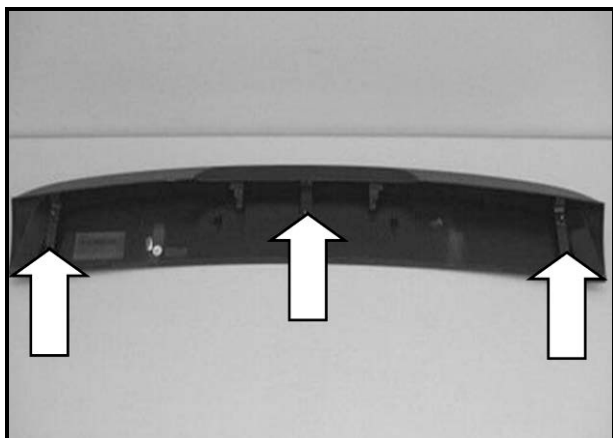
- ⇐ On these three points -arrows- reinforcements will be bonded
- ⇐ Inspect mounting points -arrows- for damage. **If damage is found, contact Campaign Helpline at 800-741-2919**

Tip: On some rear spoilers, reinforcements may have already been bonded and/or the middle reinforcement may not be filled

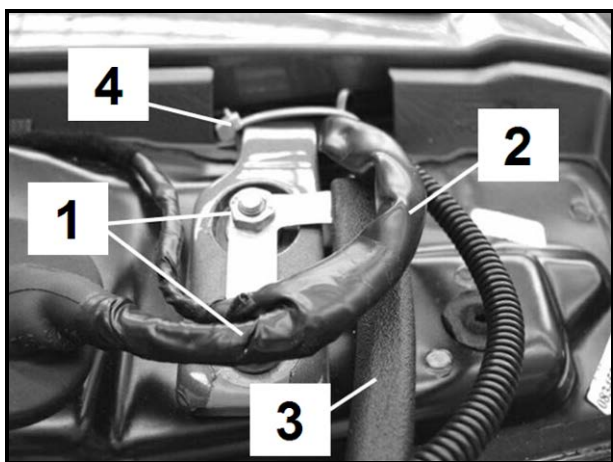
Tip: Due to bonding of the right reinforcement, the cable routing on the right side must be altered before reinstalling the rear spoiler

- ⇐ Remove nuts -1- and position the aerial -3- below the wiring loom -2- and retighten nuts to 9 Nm (7 lb-ft)

- ⇐ Install tie wrap (N 909 377 02) -4- as shown, and clip excess material from tie wrap
