**Recall Campaign 09V-257: Repair Airbag Harness**

E82, E88 (1 Series)

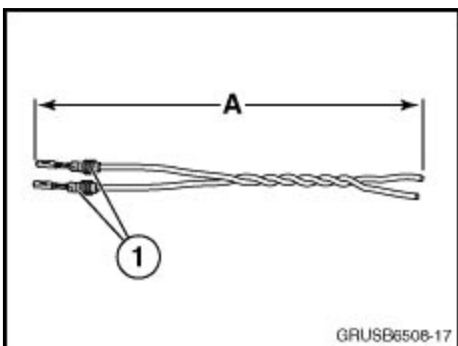
7. Carry out a visual inspection of the driver's side and front-passenger side to see if one or both of the cable harnesses have already been repaired. In the case of a wiring repair, the wire colors in pin locations 16, 17, 19 and 19 will be **orange/yellow**.

6. Remove the fabric tape (1) and push back the protective sleeve

8. For harnesses **NOT** previously repaired, follow the repair procedure from step 9.
