## Product Recall

Subject: RECALL 09V-287 – Emergency Exit Windows Binding

**RECALL #09V-287**  
**EGRESS TO NON-EGRESS**

## RECALL #09V-287 EGRESS REPAIR

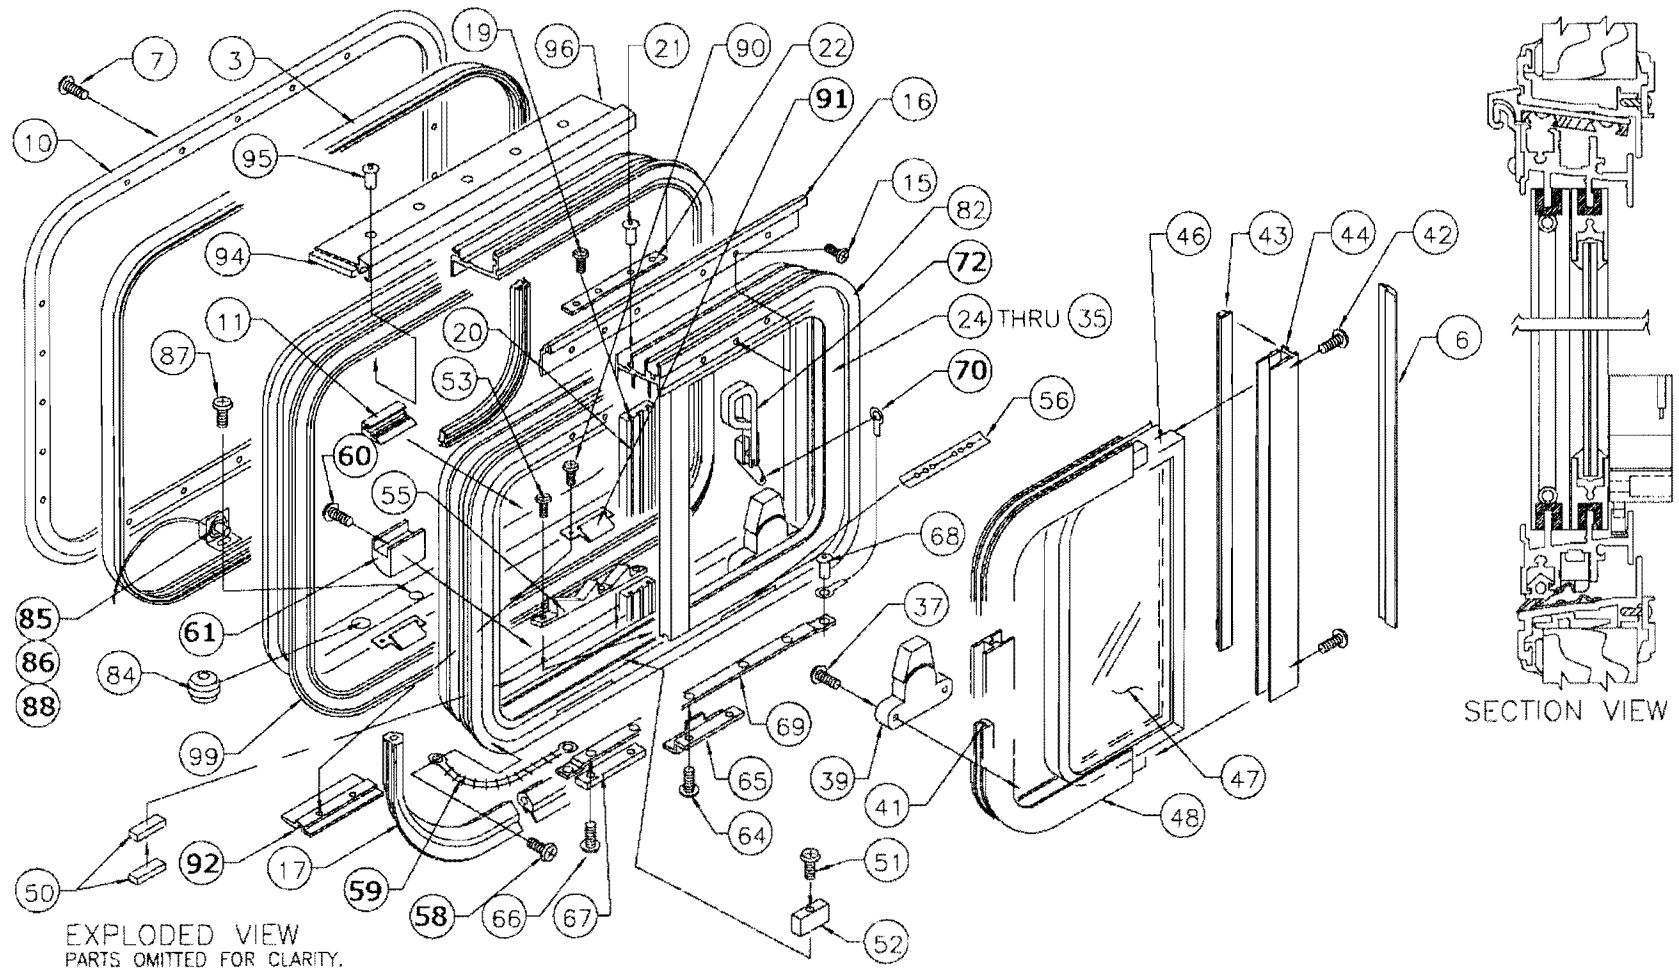
FIGURE 1

All of the parts described in this procedure are shown in **Figure 1**. The balloon numbers are used in the procedure. These same balloon numbers are used in the Bill of Material for this model window. Some of the windows purchased by Thomas are what we call "specials", or "Serial Number" windows. There are some differences between these special windows and the standard models, but these differences are not in the latch system. The drawing found on page 6 of this document shows a section through the bottom of the window with the latch parts removed and the added screws that secure the window closed.

**Step 2-** Review Figure 1.

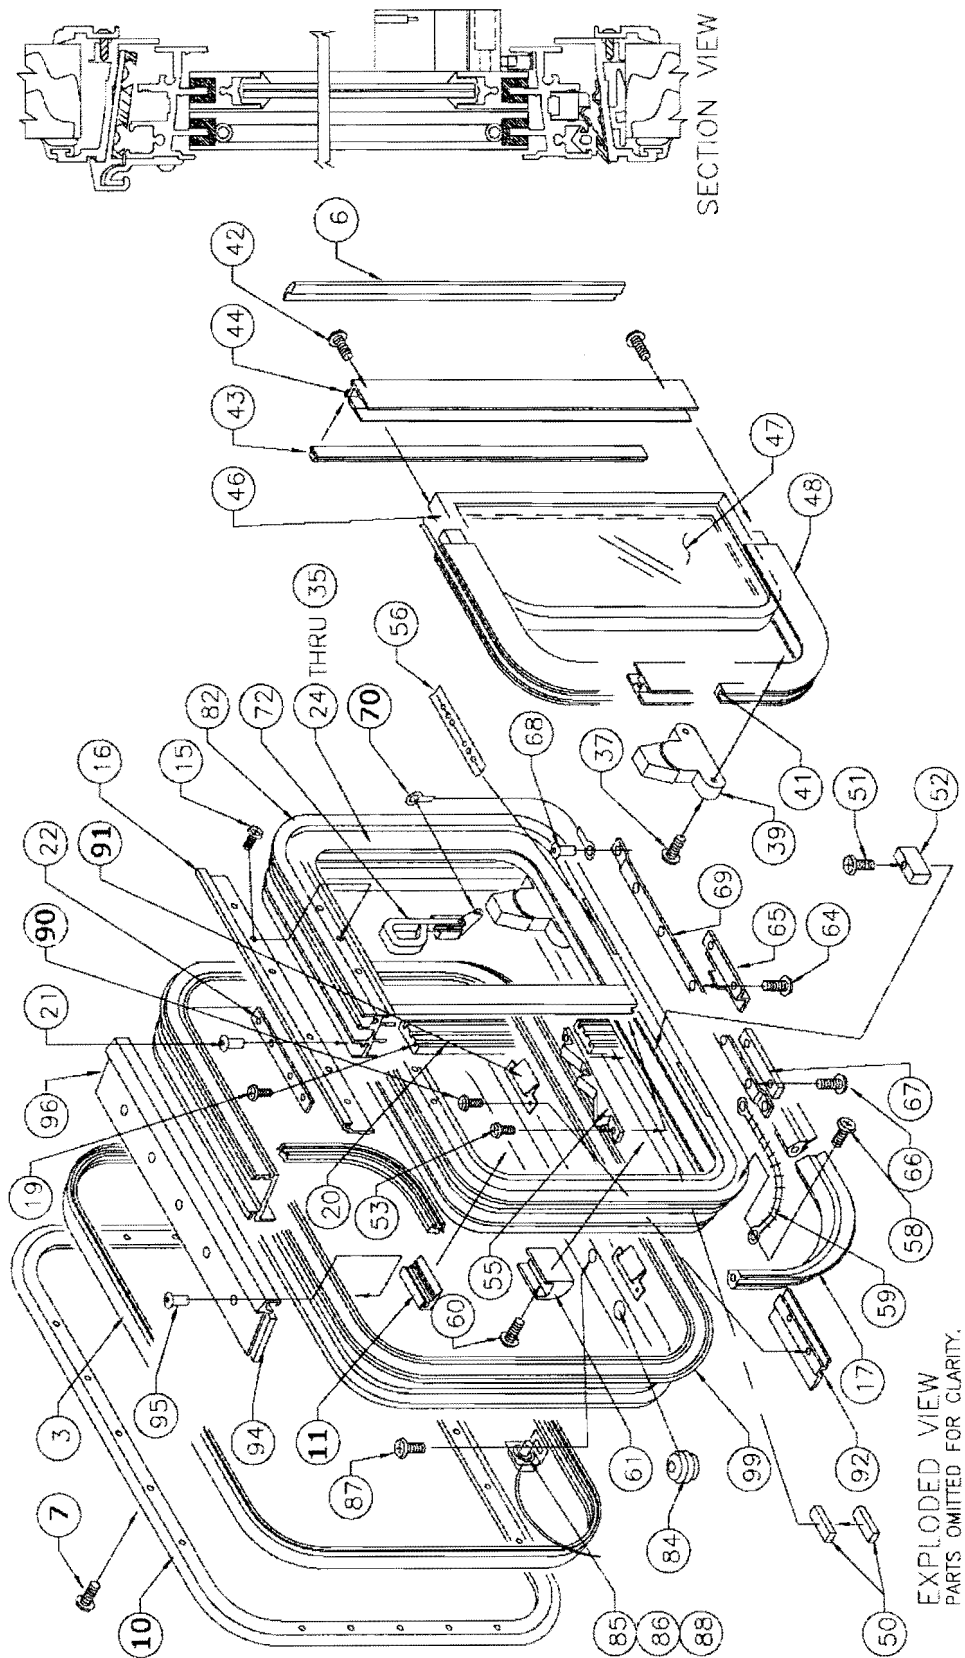
FIGURE 5

**Egress Repair Procedure #5 – Correct Opening Size and Frame Clearance (Review Figure 5.)**

1. Remove the clamp ring screws (#7) and the clamp ring (#10) from the inside of the window; retain for reinstallation..
2. Remove the window from the outside by pulling the bottom of the window out at an angle. Cut the push-out position switch wire at the splice. Then slide the window down so that the top will clear the roof drip edge and remove window from the unit.
3. Measure each window opening at each corner and center. The window specifications call for an opening height of 28.75" +/- .03.
