SAFETY RECALL BULLETIN

SUBJECT:		No:	SR-09-003
SEAT AIR BAG BRACKET ANCHOR — SAFETY RECALL CAMPAIGN		DATE:	September, 2009
		MODEL:	See below
CIRCULATE TO:	<input type="checkbox"/> GENERAL MANAGER	<input checked="" type="checkbox"/> PARTS MANAGER	<input checked="" type="checkbox"/> TECHNICIAN
<input checked="" type="checkbox"/> SERVICE ADVISOR	<input checked="" type="checkbox"/> SERVICE MANAGER	<input checked="" type="checkbox"/> WARRANTY PROCESSOR	<input type="checkbox"/> SALES MANAGER

Header Section: Certain 2010 Endeavor seat side air bag anchor bracket inspection

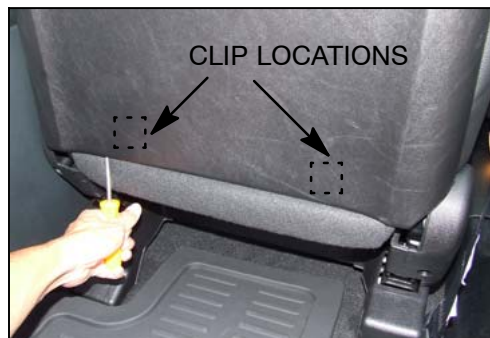
- Remove the seatback panel as follows:

- Insert a trim stick or screwdriver between the seatback panel and lower edge of the seat, and push toward the center of the seat to unseat the two lower clips securing the panel on each side.
- Pull the lower edge of the panel out and slide the panel downward to remove it. If necessary, strike the top center of the panel to release the upper clips.

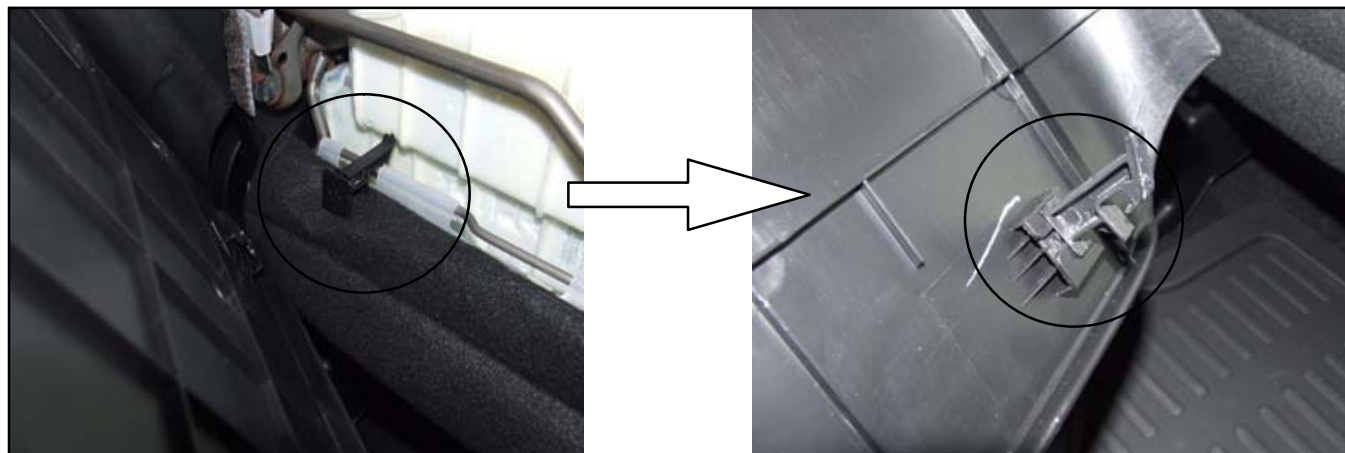
- Remove the two clips from the lower section of the seatback, and reinstall them on the panel as shown below.

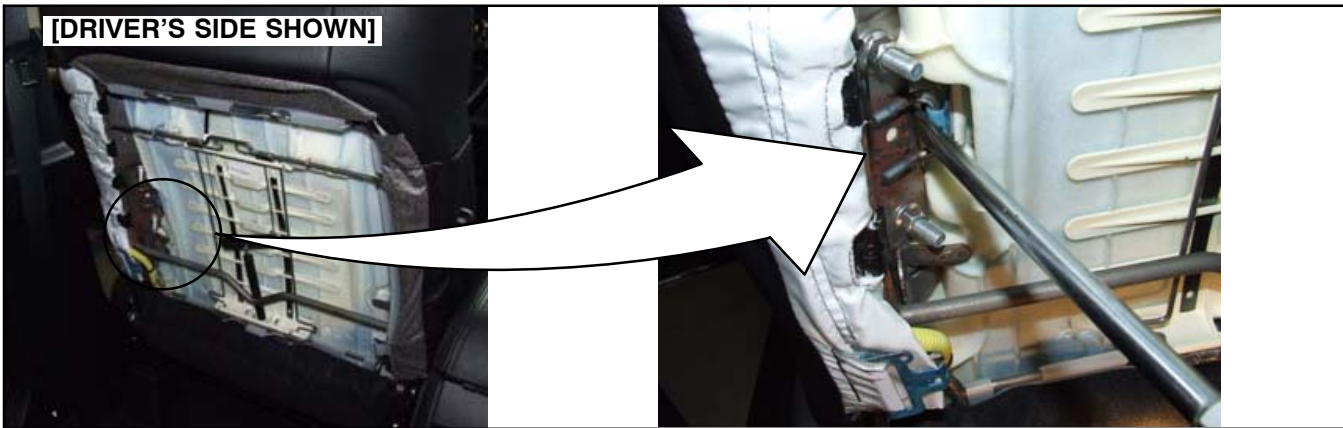
On affected vehicles, some seat-mounted side airbag frames may have an insufficiently welded airbag retainer bracket. If this retainer bracket is not sufficiently welded to the frame, the seat mounted side airbag may not properly deploy in a side impact. This bulletin describes inspection procedures to verify the weld condition at the airbag retainer bracket on both driver's and front passenger's seats. If the weld is insufficient, replace the seatback assembly.

3. Inspect the side airbag anchor welds as follows:

- a. Use a large flat-tip screwdriver 12" in length. Insert the screwdriver between the seatback frame and the anchor hook.

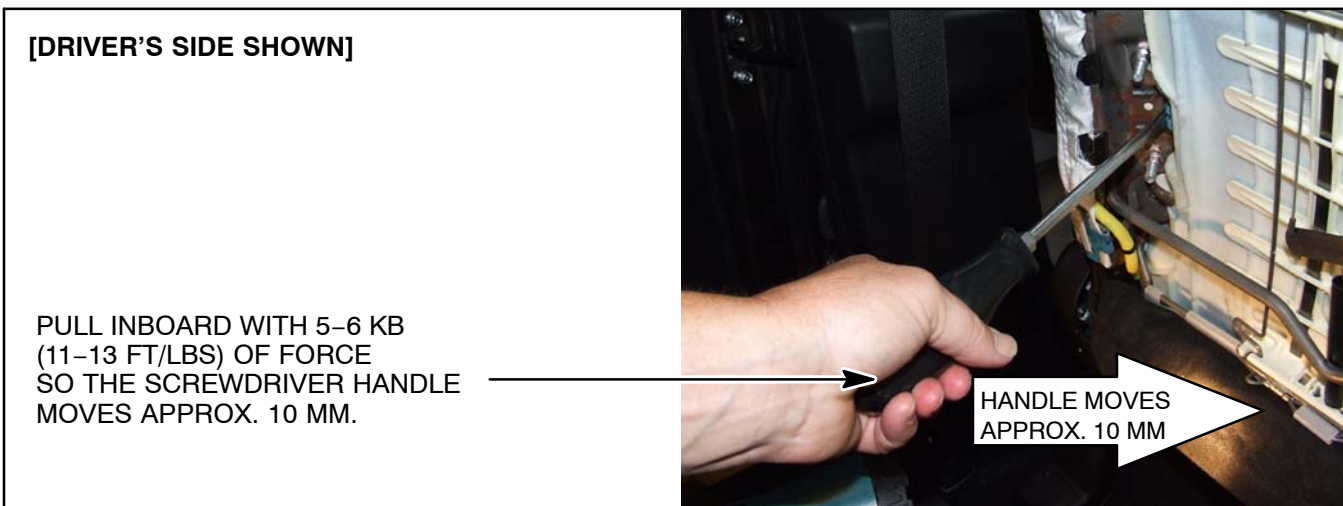
- b. Grasping the screwdriver firmly, pull it inboard (toward the center of the vehicle) with 5–6 kg (11–13 ft/lb) of force just until the seat frame flexes slightly, **so that the handle end of the screwdriver moves approximately 10mm.**

USE ONLY 5–6 KG (11–13 FT/LB) OF FORCE. DO NOT PULL WITH EXCESSIVE FORCE!

- c. **If the bracket welds crack or break, replace the seatback.** Follow the seatback replacement procedures in Group 52B of the 2010 Endeavor service manual. Please notify Tech Line if seat back replacement is necessary. Retain the packaging of the new seatback to return the old seatback.
4. **If the bracket weld does NOT crack or break,** reinstall the seatback panel as follows:
- a. Confirm the two lower clips are installed on the seatback.
- b. With the bottom of the seatback panel angled slightly rearward, insert the upper portion of the panel into the seatback. Be sure that the upper clips are engaged.
- c. Place your hands on the lower portion of the panel and push until the lower seatback clips engage the seat frame.
