# Service Bulletin

## SAFETY RECALL

### 2002 VTX1800C Swingarm, Final Drive Flange Weld Inspection

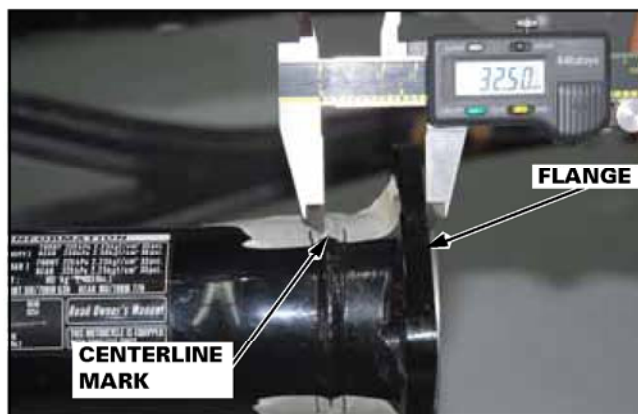
Certain units could have an improperly positioned drive flange weld that lacks sufficient penetration. If the weld breaks while riding, it could cause the rider to lose control and lead to a crash.

**Flange-to-Centerline, Reference Distance: 32.5 mm**

- If at least three of the four centerlines are less than 32.5 mm from the flange, the swingarm is good, the inspection is complete and the motorcycle can be reassembled. Proceed to IDENTIFICATION.
- If two or more of the centerlines are 32.5 mm or greater from the flange, the weld is improperly positioned. Identify each out of range weld centerline by marking the corresponding tape with an "X." *Call Honda TechLine for confirmation of your measurements and to order the replacement swingarm and information labels.*

8. Set and lock your calipers to 32.5 mm. Place the caliper against the final drive flange as shown and compare the distance of the weld centerline to the caliper on all four tapes. The weld centerline should be less than 32.5 mm from the flange.
