Subject: Supplemental Information for Safety Recall 9LG
Potential Floor Mat Interference with Accelerator Pedal

2010 MODEL YEAR LEXUS IS250C, IS350C

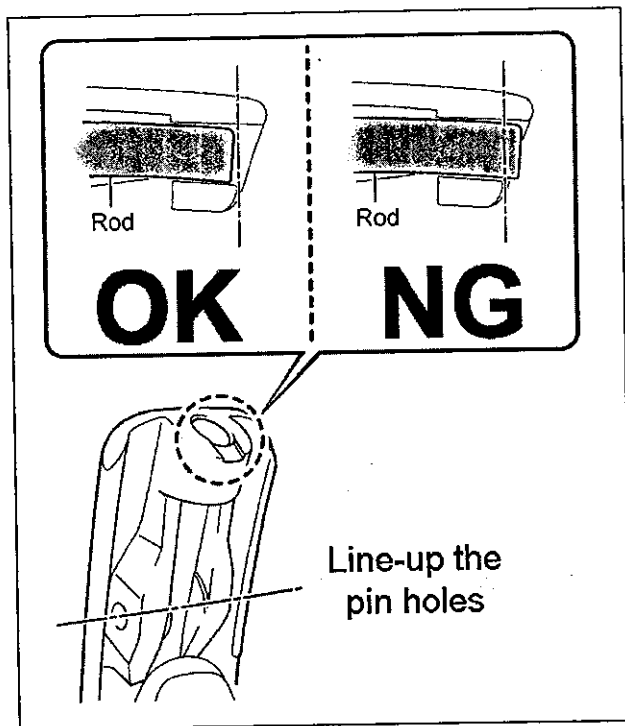
3. CHECK THE ROD LENGTH

If the rod NG:

- Continue with step 4 and file the pedal rod.

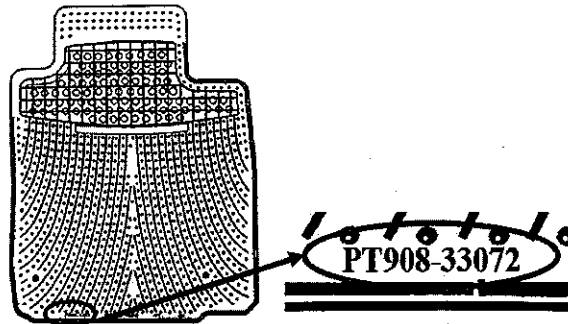
Locate the ten digit floor mat part number on the bottom of the back side of the mat as illustrated below.
PLEASE NOTE, the floor mat part numbers are 12 digits but only the first ten are shown.

- If a Recalled All Weather Floor Mat (AWFM) has been identified, remove the AWFM from the vehicle and **CUT THE RECALLED AWFM SO THAT IT CANNOT BE REUSED.**
- You may remove the semi-permanent installation plastic straps for the carpeted floor mat once the repair is completed.
