Wayne Hutchinson / TMS Toyota Customer Services
Quality Compliance
February 2, 2010
Approved By: Bob Waltz

To: All Toyota Dealers
From: Toyota Customer Services

Safety Recall (Special Service Campaign) – 90L
Certain 2007 – 2010 Model Year Camry and Camry Hybrid Vehicles
Potential Floor Mat Interference with Accelerator Pedal
Phase 1 – Vehicles Equipped with Accelerator Pedals Manufactured by Denso Corporation
*******URGENT*******

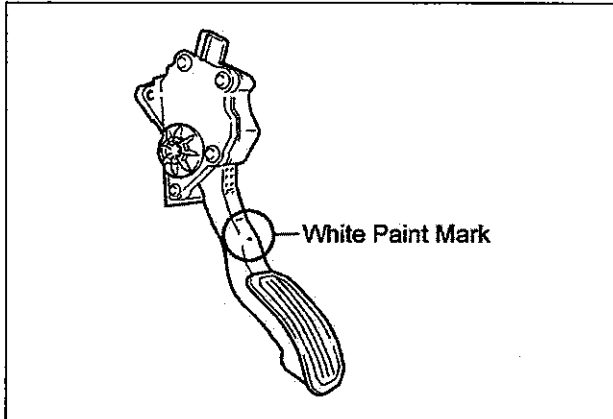
1. INSPECT THE ACCELERATOR PEDAL ASSEMBLY

- a) Verify if the accelerator pedal assembly has a white paint mark in the location shown.

- The accelerator pedal requires modification. Make sure to perform the modification process during the Work Procedure.

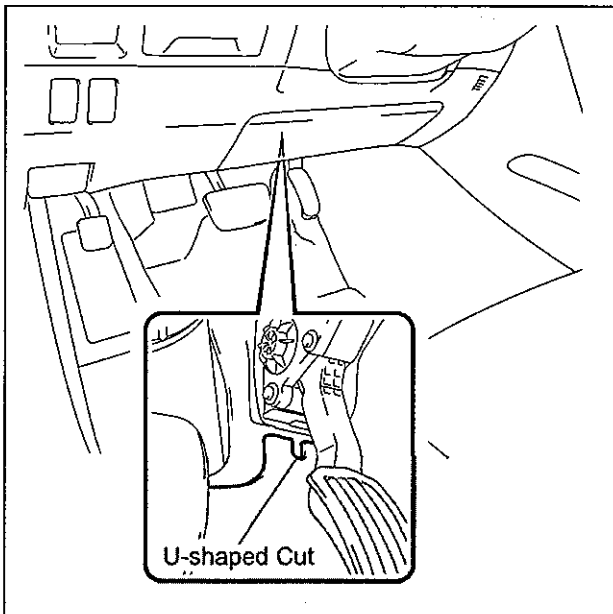
2. INSPECT THE FLOOR CARPET

- a) Verify if the floor carpet has a "U" shaped cut in the location shown.

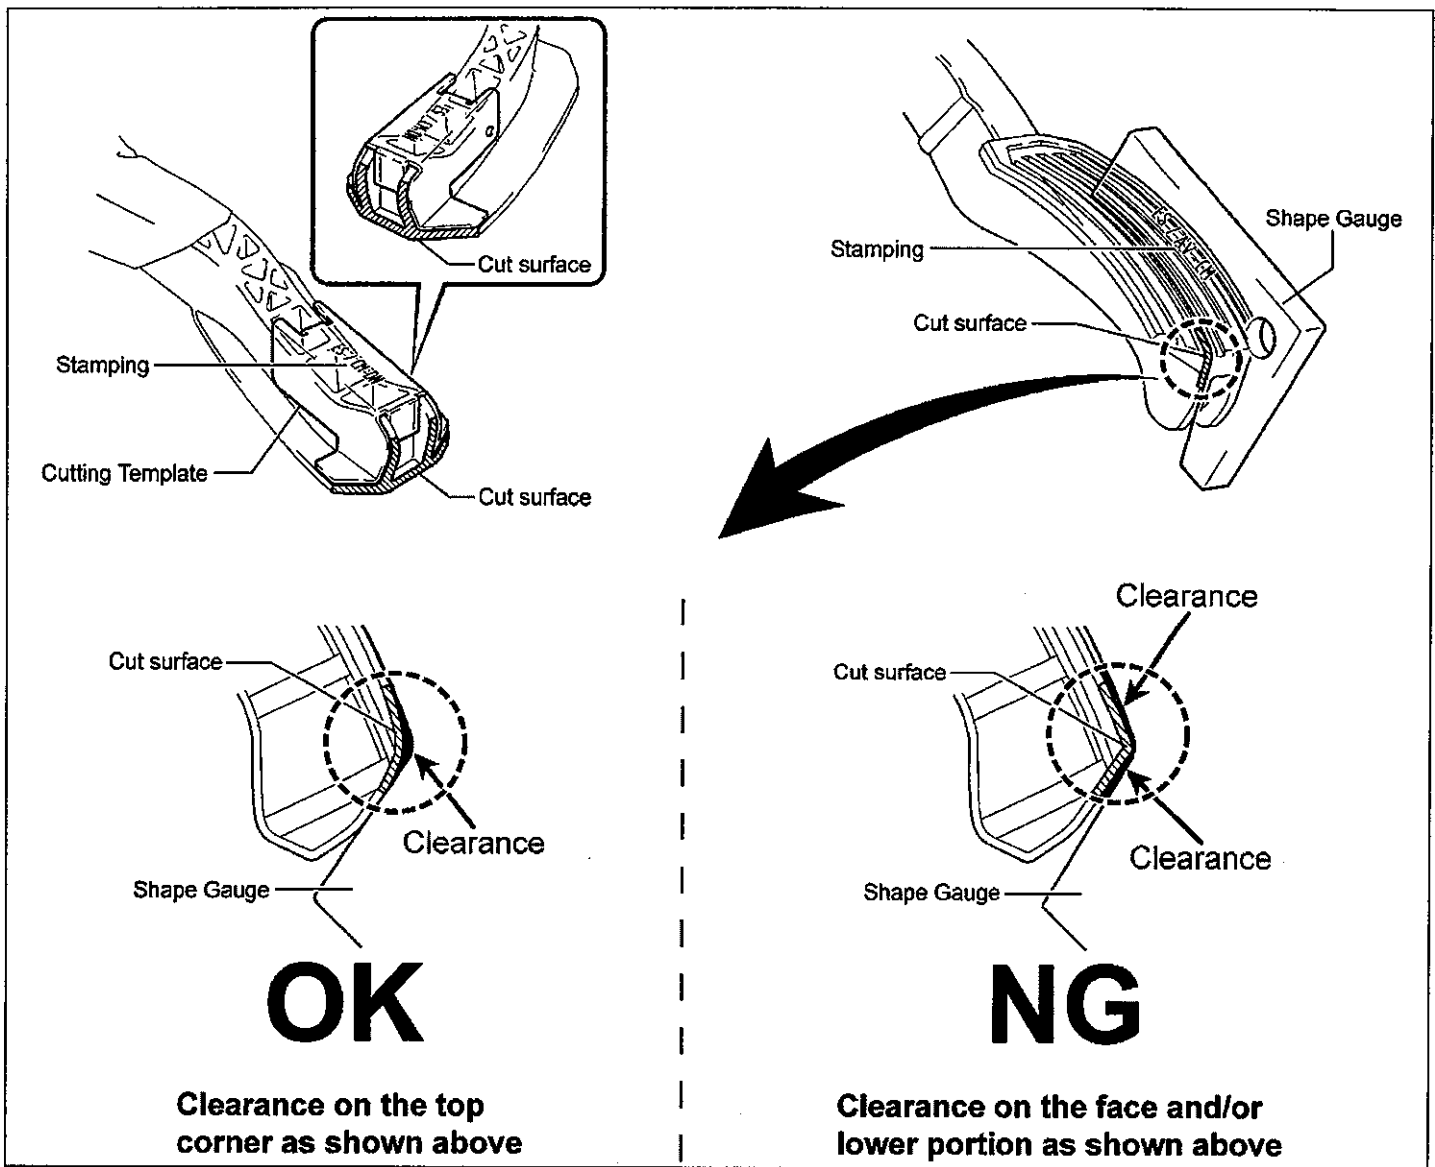
10. CHECK THE SHAPE OF THE PEDAL

- a) Using the correct cutting template and shape gauge, check the shape of the pedal.

- Always wear protective eyewear, gloves, and dust mask when sanding or filing.
- A tolerance of -1.0 mm is permissible between the final cut surface and the template.

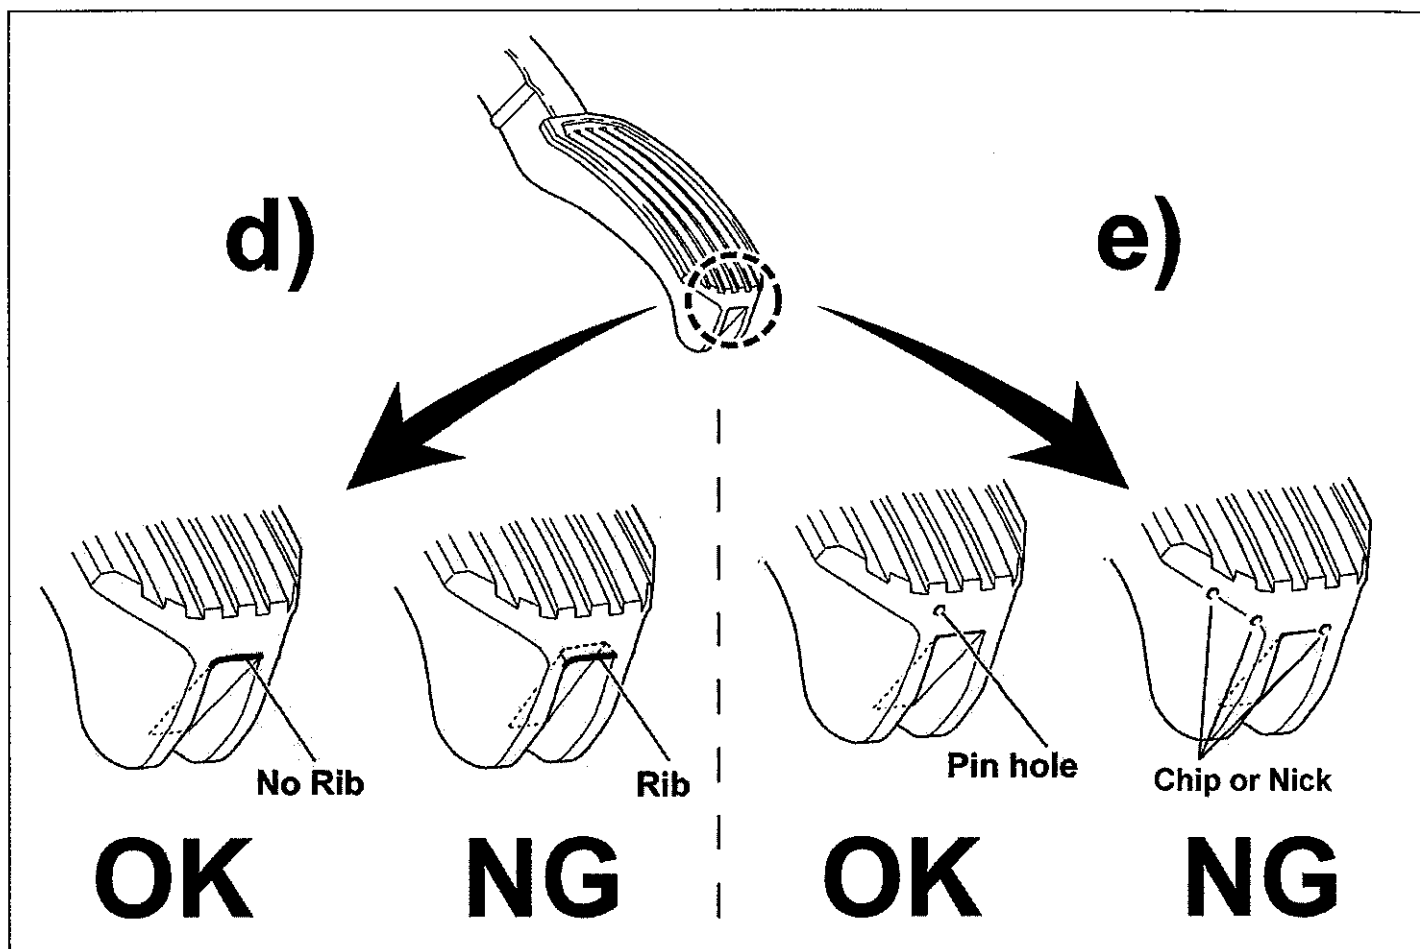
- d) Check for a rib as shown. If there is a rib, file it until it is gone.
- e) Check for any chips or nicks on the finished surface edge. If there are any chips or nicks, file the edge to make them smooth.
- f) DENSO accelerator pedal modification is now complete.

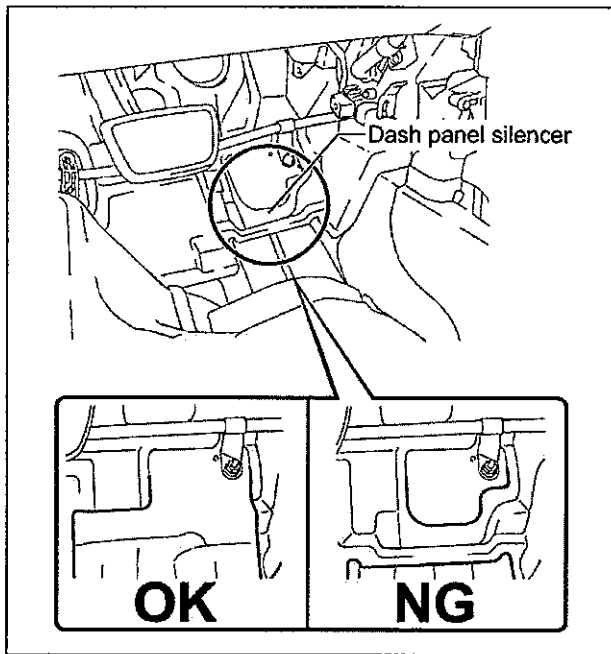
3. INSPECT THE LOWER PORTION OF THE FABRIC FLOOR SILENCING MATERIAL

- a) Inspect the lower portion of the fabric floor silencing material.
 - If OK, proceed to step 4 "RUBBER PAD APPLICATION" below.
 - If NG, please refer to APPENDIX "B" for "CUT THE FLOOR SILENCING MATERIAL"

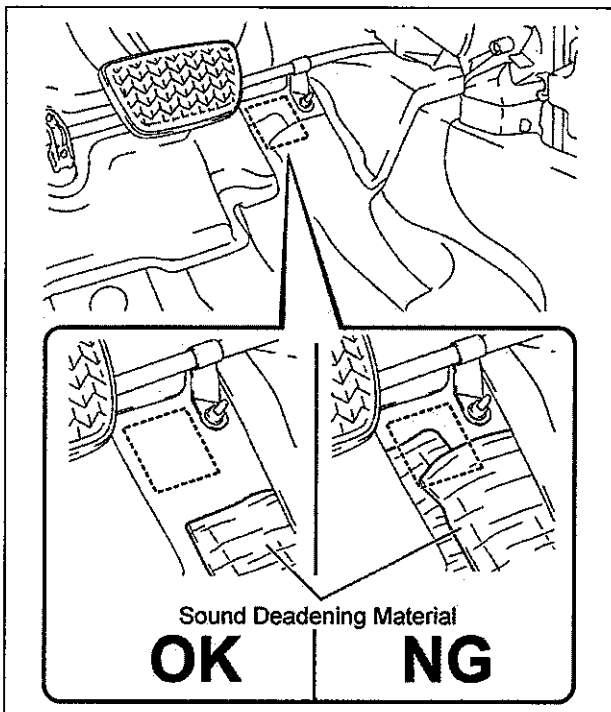
4. RUBBER PAD APPLICATION

- a) Inspect the rubber pad application area for sound deadening material.
 - If OK (no sound deadening material in pad application area), proceed to step "b" below.
 - If NG (sound deadening material found in application area), please refer to APPENDIX "C" for "REMOVE THE SOUND DEADENING MATERIAL".

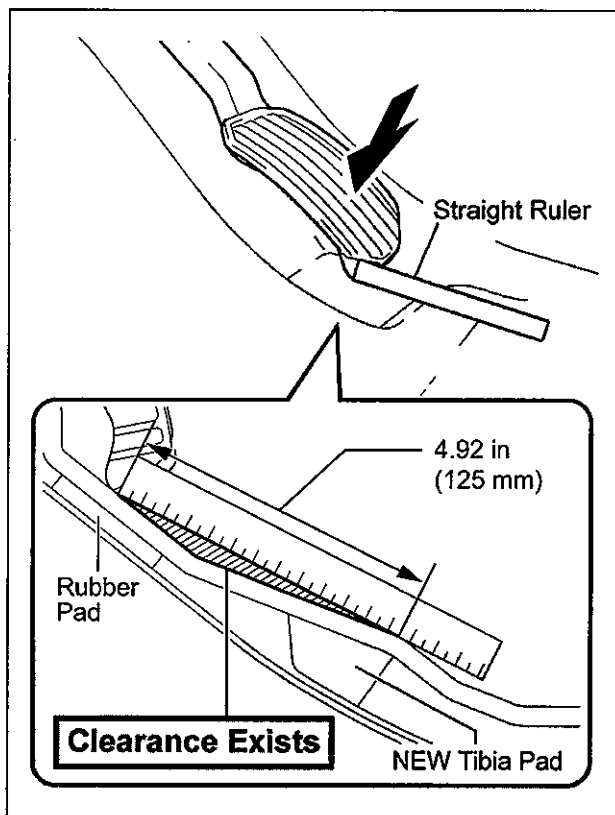
2. INSPECT THE FLOOR CARPET

- With the accelerator pedal fully depressed, confirm clearance exists between the floor carpet and the straight ruler as shown.
- If no clearance exists, reshape the carpet again.
- Confirm the claw and all fasteners of the floor carpet are securely attached.
